**INITIAL INSPECTION REPORT OF VEHICLE NO. SDZ 6779M .**

**ACCIDENT INVOLVING SDZ 6779 M & GZ 4773 G ON 15 MARCH 2019 ALONG CARPARK AT BUKIT BATOK WEST AVENUE 6 AT ABOUT 1220 HOURS**

## ADJUSTMENT ON REPAIR COST FOR VEHICLE NO. SDZ 6779M

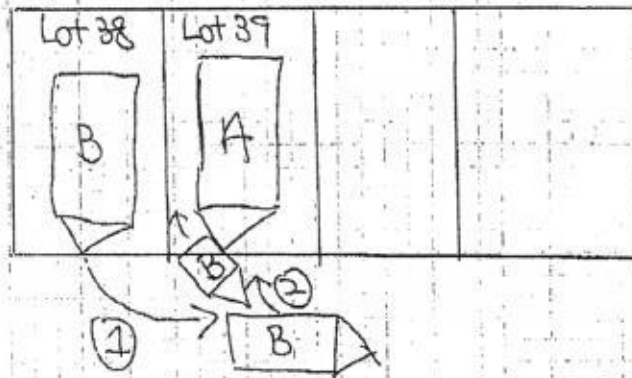
SKETCH PLAN

Veh A: 50Z6779M

Veh B: 6Z4773G

On the stated date & time, My vehicle was parking stationary at Blk 109 Bukit Batok West Ave 6 car park Lot 39. Vehicle B (6Z4773G) was trying to drive out from Lot 38 but there was vehicle ~~there~~ so vehicle B reverse ~~back~~ back into lot 38 and the vehicle middle body hit onto my vehicle front right portion.
