Preliminary Advice

Insured Vehicle No	: GBC8700X	Accident Date	: 11/03/2019
TP Vehicle No	: SKH9551U	Assignment Date	: 19/03/2019
Make	: TOYOTA ESTIMA	Est. Duration of Repair	: 18.00
Date of Inspection	: 19/03/2019		
Inspection At	: MESSRS V8 MOTOR WERKZ PTE LTD (HQ) BLK 9, #01-44 SIN MING INDUSTRIAL EST SECTOR C SINGAPORE 575630

VEHICLE DAMAGE INSPECTION REPORT

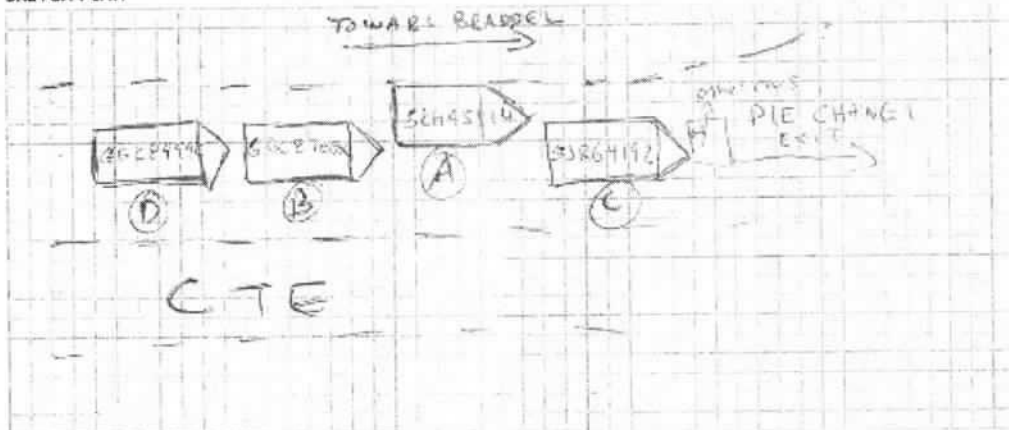
Sketch Plan #2

I was driving along CTE towards PIE CHANGE exit. BMW (SJR6419Z) slowed down as there are a few cars slowed down in front of me. Two lorries behind my car hit each other and (GBR8700X) hit my car. I also swerved a bit to the ~~right~~ and scratch the car (SJR6419Z) in front of me. I sustained a neck pain due to this accident.
