CHINA TAIPING INSURANCE (S) PTE LTD Ref : CC6/CTI19005010/Uka3n2  3 ANSON ROAD #16-00 SPRINGLEAF TOWERSINGAPORE 079909  Code : CTI  1. Policy Particulars :- THIRD PARTY CLAIM Insured Veh. GBE 6247R Veh. Inspected SLT 8996B Policy No. DMCVSN3009291901 Coverage (\$) 0.00 Claim No. SNM19D201243C02/7 Excess (\$) 0.00 Assign From Assign Date 20/03/2019  2. Vehicle Particulars & Condition Make & Model KIA CERATO K3 (A) c.c 1591 Engine No. HIDDEN Year of Reg. 2017 Chassis No. KNAFX411MJ5752202 Colour WHITE Odometer 13546 Steering IN ORDER Brakes IN ORDER Modification SPORTS RIM General GOOD  3. Conditions of Tyres  R/H Front Tyre 205/55 R16 NEXEN 6 mm L/H Front Tyre 205/55 R16 NEXEN 6 mm L/H Rear Tyre 205/55 R16 NEXEN 6 mm THE VEHICLE SUSTAINED DAMAGES AT THE REAR PORTION.	Affiliated to Federation Internationale Des Experts En Automobile					
SPRINGLEAF TOWERSINGAPORE 079909	CHINA TAIPING INSURANCE (S) PTE LTD Ref : CC6/CTI19005010/Uka3n2

### ADJUSTMENT ON REPAIR COST FOR VEHICLE NO. SLT 8996B

### PHOTOGRAPHS FOR VEHICLE NO. SLT 8996B

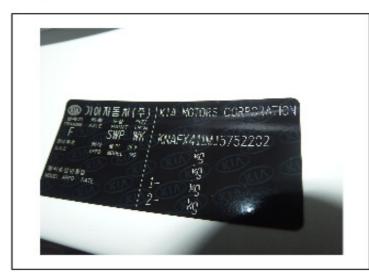
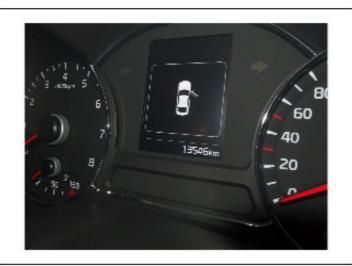
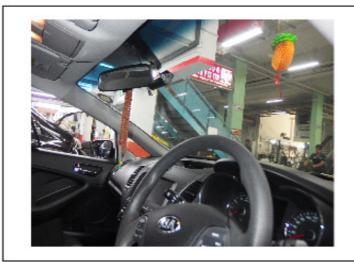
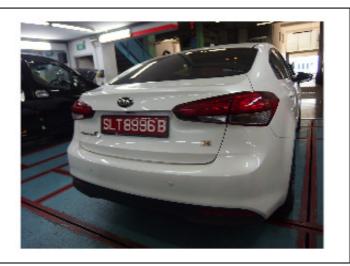
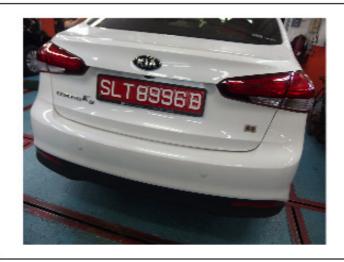
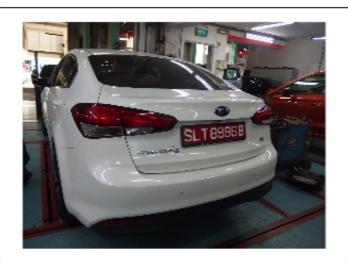
INSPECTION

4. Description of Damages  THE VEHICLE SUSTAINED DAMAGES AT THE REAR PORTION.	R/H Rear Tyre	205/55 R16	NEXEN	6 mm		
THE VEHICLE SUSTAINED DAMAGES AT THE REAR PORTION.	L/H Rear Tyre	205/55 R16	NEXEN	6 mm		
	THE VEHICLE SUSTAINED DAMAGES AT THE REAR PORTION.					
DAMAGES SEE DETAILS.		ETAILS.

RECOMMENDED COST OF LUMP SUM REPAIRS		4,000.00
(TO ITS PRE-ACCIDENT CONDITION)
