SPY 633U

Subaru Forester

**\* SDY633U - OD RECOVERY CLAIM - AIG INSURED - ARRANGE SU...**

## VEHICLE DAMAGE INSPECTION REPORT

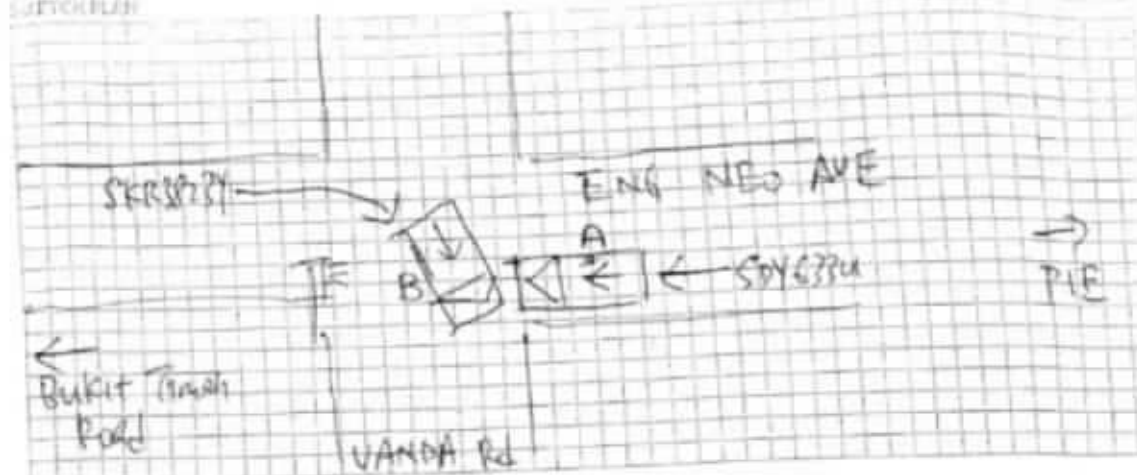
SKETCH PLAN

I was driving on Eng Neo Ave towards Bukit Timah Road. At the junction with Vanda Road, the traffic light was green in my favour. I was near the junction when the other car (SKR 3823Y) suddenly turned right, and his left side was in my path. I could not stop in time and crashed into the left side of that car.

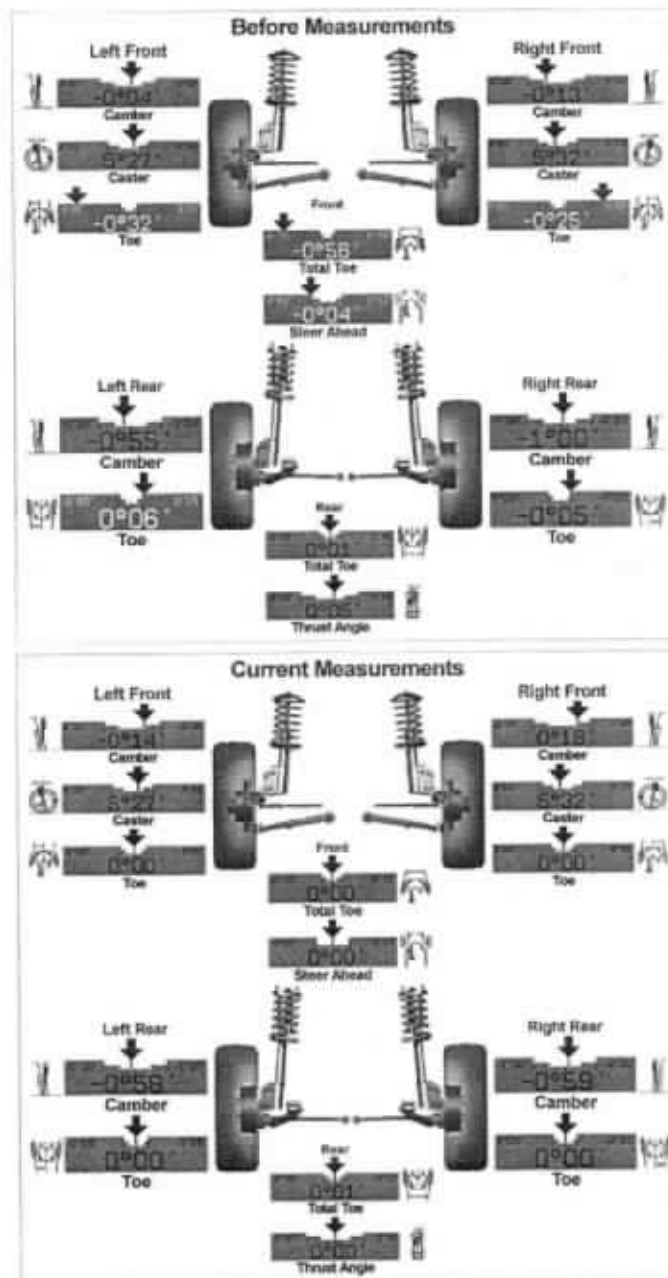
**Subaru : Forester : 2016-18 (SJ)**  
**4-Wheel Total Alignment**

Work Order: R001193  
 Name 2: TEO PING SIONG  
 Company: 993 BUKIT TIMAH ROAD  
 License: SDY633U  
 Year: 16  
 Technician: KUGAN  
 Odometer: 59611  
 Date: 5.4.19 14:59
