ASSIGNMENT (Office)

To Inspect Vehicle No.

SLM3718H

VEHICLE DAMAGE INSPECTION REPORT

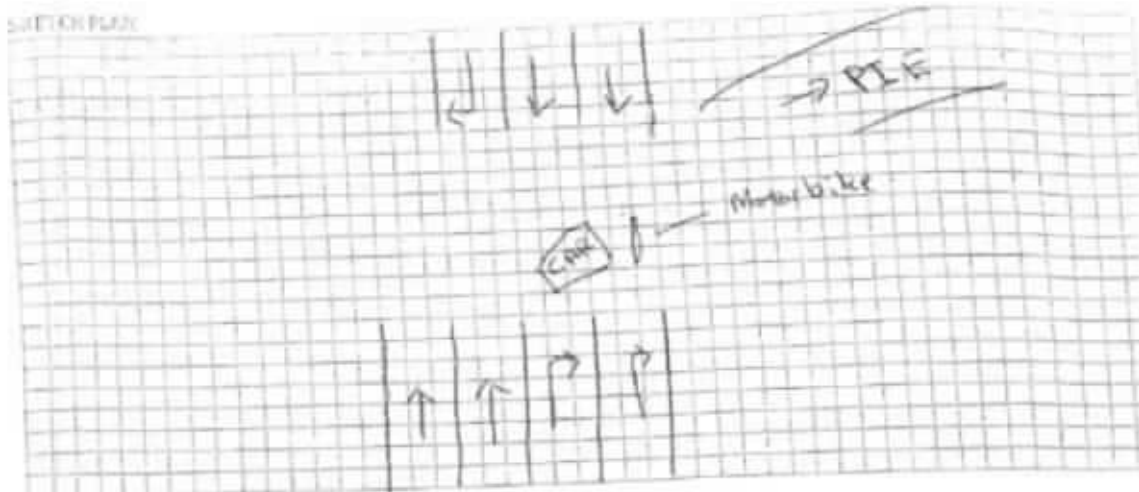
SKETCH PLAN

Around 2pm on 17 Mar 2019. Weather is clear with moderate traffic condition. I was driving alongside Pioneer Road North, turning right towards PIE at traffic junction. There shall be a green arrow in my favour. However a Grab delivery bikes appeared from opposite direction going straight along Pioneer Road North towards Pioneer Road. My car front hit the side of the motorbike.

The rider managed to control his motorbike and stopped at pavement. However he complained of foot injury and had to be convey to hospital by the ambulance.
