AIG C03/AIG19005108/Exd302

Vehicle No	: SLW9079B	Accident Date	: 16/03/2019
Make	: AUDI Q2	Policy No.	: 1800023129-01
Assignment Date	: 21/03/2019	Excess	: S\$800.00
Date of Inspection	: 20/03/2019	Est. Duration of Repair	: 25.00
Inspection At	: PREMIUM AUTOMOBILES PTE LTD (BENOI) 24 BENOI SECTOR SINGAPORE 629857

The vehicle sustained impact / damages o/s body and parts claimed are consistent to the accident.

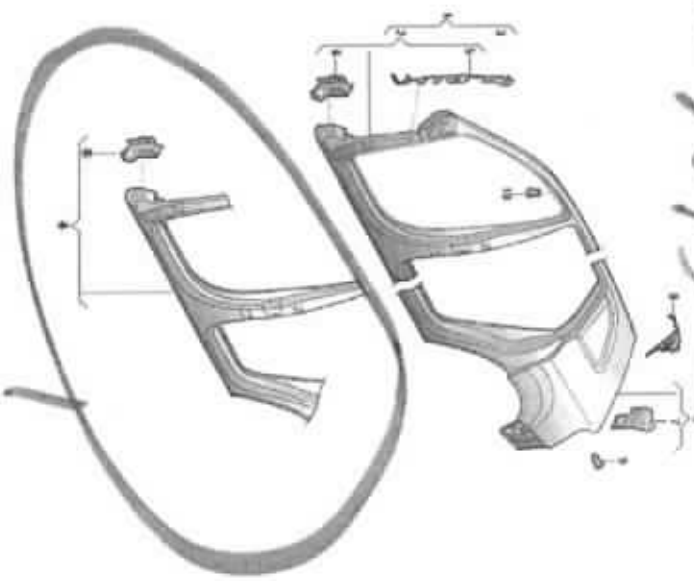
Attached, please find our parts diagram for 'B' pillar replaced. You may refer to B4 paint photographs.

this part
replaced.

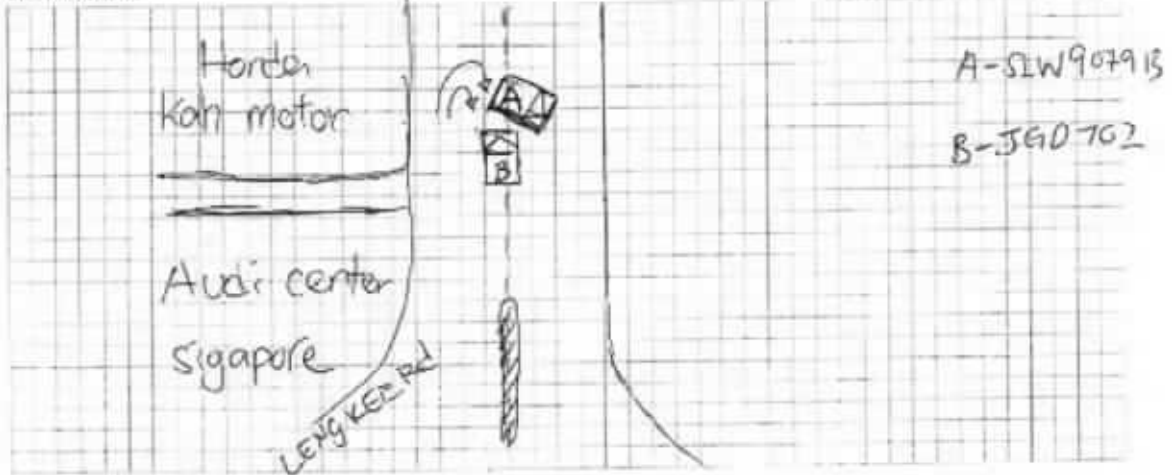
Sketch Plan #2

DESCRIBE CIRCUMSTANCES OF THE ACCIDENT

Please refer to the police report No. T/20190316/2023
