- PRE-REPAIR INSPECTION - ACCIDENT INVOLVING OUR INSURED VEHICLE SJW6773Z AND SJM1113P ON 16/03/...

ACCIDENT INVOLVING SJM 1113P & SJW6773Z ON 16 MARCH 2019 ALONG YISHUN AVE 5 AT ABOUT 18:50 HRS

VEHICLE DAMAGE INSPECTION REPORT

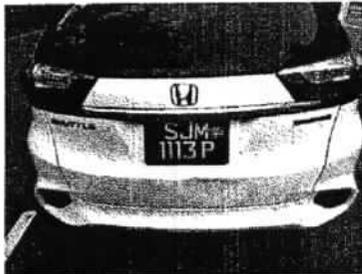
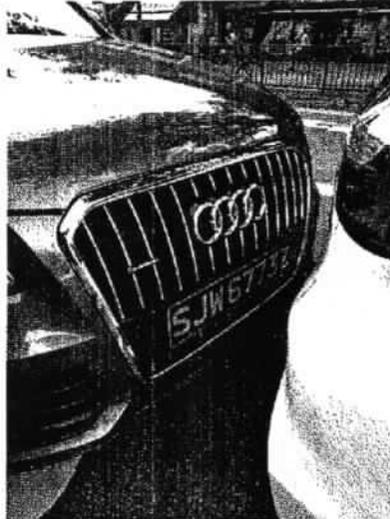
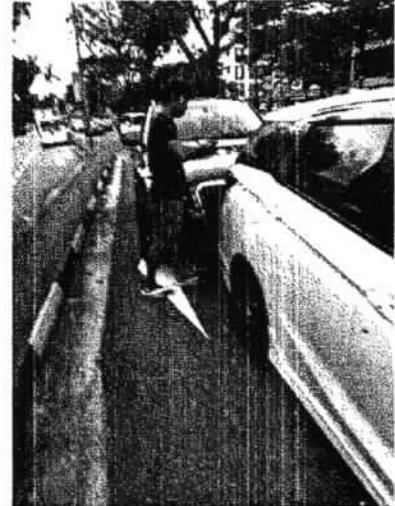
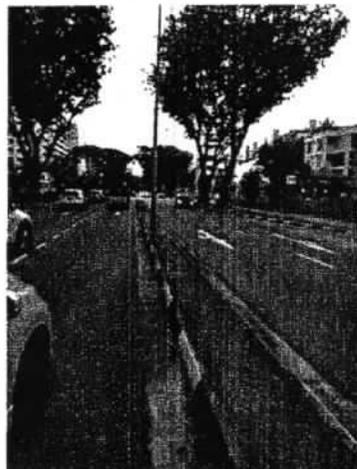
Cars Pixs

SJW 6773Z driven by Mr Khoo Boon Wei Damien, S7341257I, suddenly hit into the back of my car, SJM1113P driven by myself, Robert Loh Chee Seng, S1471740D. This cause the back and bumper of SJM1113P to be dented.

No.	Qty	Part No.	Particulars	Condition	Repairer's	Amount	
1	1		*REAR BUMPER	Deformed	0.00 F	*- F	
2	1		*REAR BUMPER CLIPS	Necessary	0.00 F	*- F	
3	1		*REVERSE SENSOR	Shorted	0.00 F	*- F	
4	1		*REAR END PANEL	Repair	0.00 F	*- F	
5	1		*TAILGATE	Buckled	0.00 F	*- F	
6	3		*TAILGATE EMBLEM	Necessary	0.00 F	*- F	
7	1		*TAILGATE GLASS MOULDING	Necessary	0.00 F	*- F	
8	1		*TAILGATE GLASS SEALANT	Necessary	0.00 F	*- F	
					Total Parts (S\$)	0.00	0.00
