To Inspect Vehicle No: SJJ 5848Y

Make: Honda Fit cc 1339  
 Colour: Pink A/C: Insured / Std / NI / NA  
 Sp. Reading: 68069 T/Radio: Insured / Std / NI / NA

The UIC / Chassis frame / Body Structure affected due to collision.

## VEHICLE DAMAGE INSPECTION REPORT

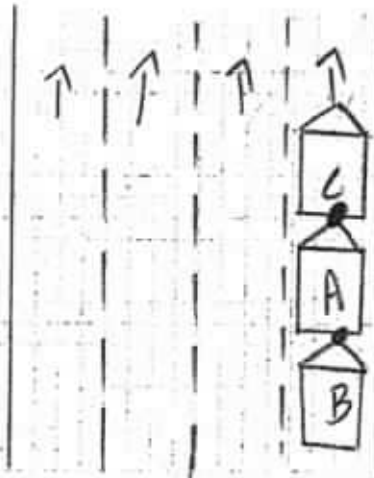
SKETCH PLAN

Vehicle A: SJJ5898Y  
 B = VP591E  
 C = SJF7898E

I feel an impact from behind and cause my  
 vehicle (A) hit onto vehicle (c). ~~Then~~ After I checked,  
 it was a chain collision.
