Preliminary Advice

Vehicle No : SKR319G Make : LOTUS ELISE Assignment Date : 21/03/2019 Date of Inspection : 22/03/2019 Inspection At : EUROSPOITS AUTO PTE LTD (HQ) 24 LENG KEE ROAD #01-03 SINGAPORE 159096	Accident Date : 15/03/2019 Policy No. : DMPCSN1836771800 Excess : S\$4,000.00 Est. Duration of Repair : 6.00
---	---

The vehicle sustained impact / damages front portion and parts claimed are consistent to the accident.

VEHICLE DAMAGE INSPECTION REPORT

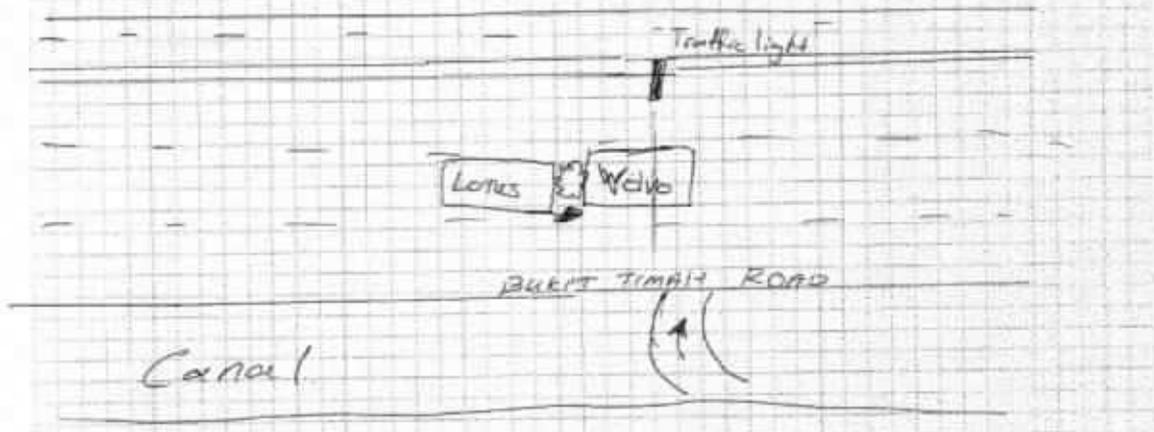
SKETCH PLAN

DESCRIBE CIRCUMSTANCES OF THE ACCIDENT

At 9:25 am driving on a 3 lane road on Bukit Timah going to work. I was in the centre lane following a grey volvo at around 40-50 km/h.

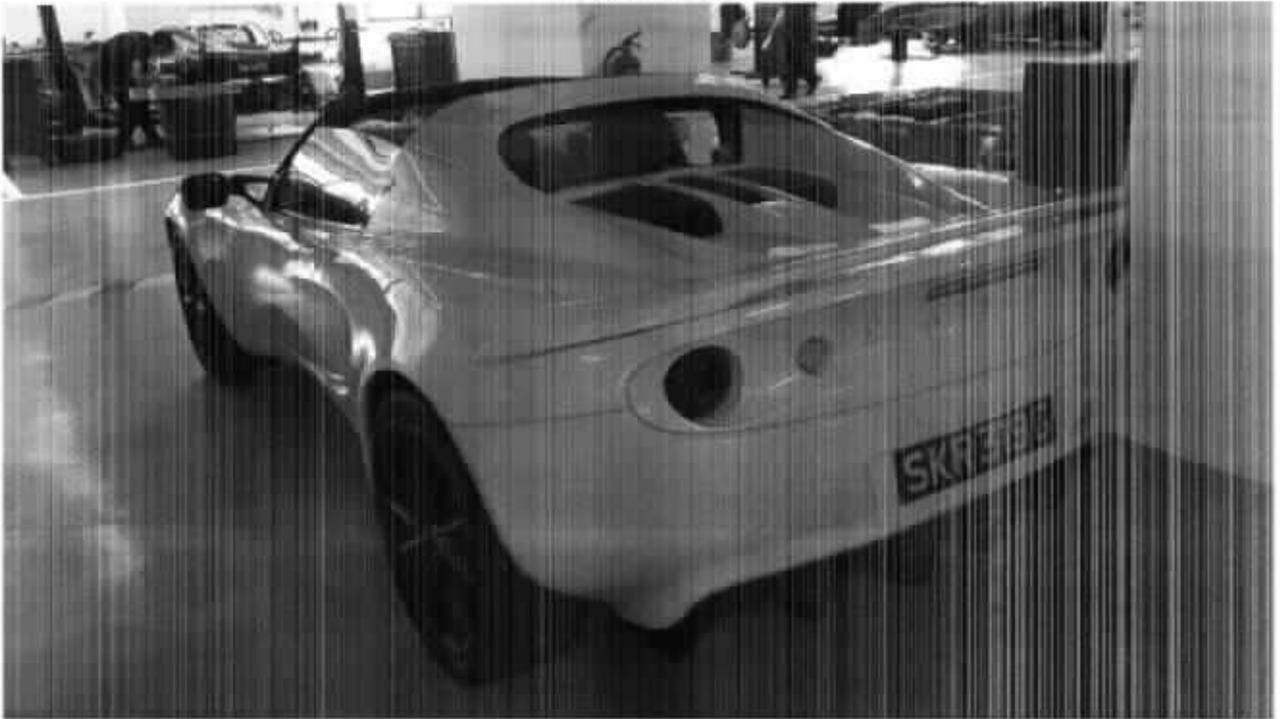
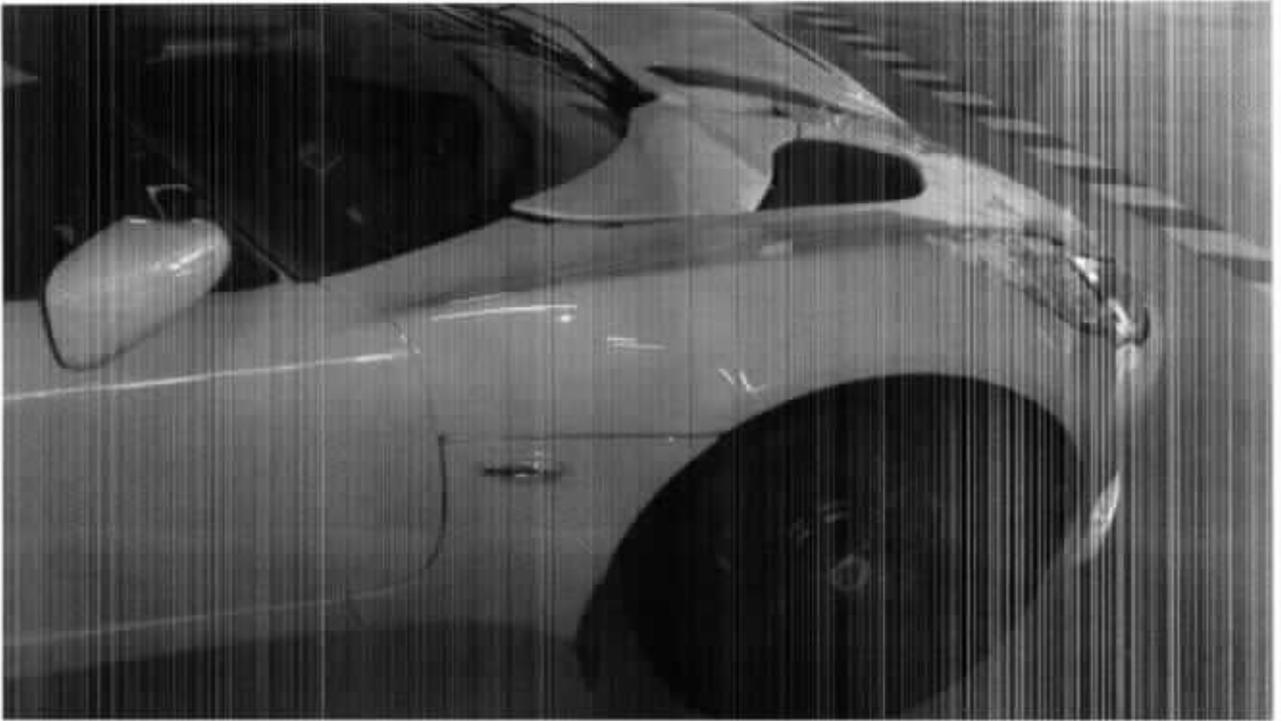
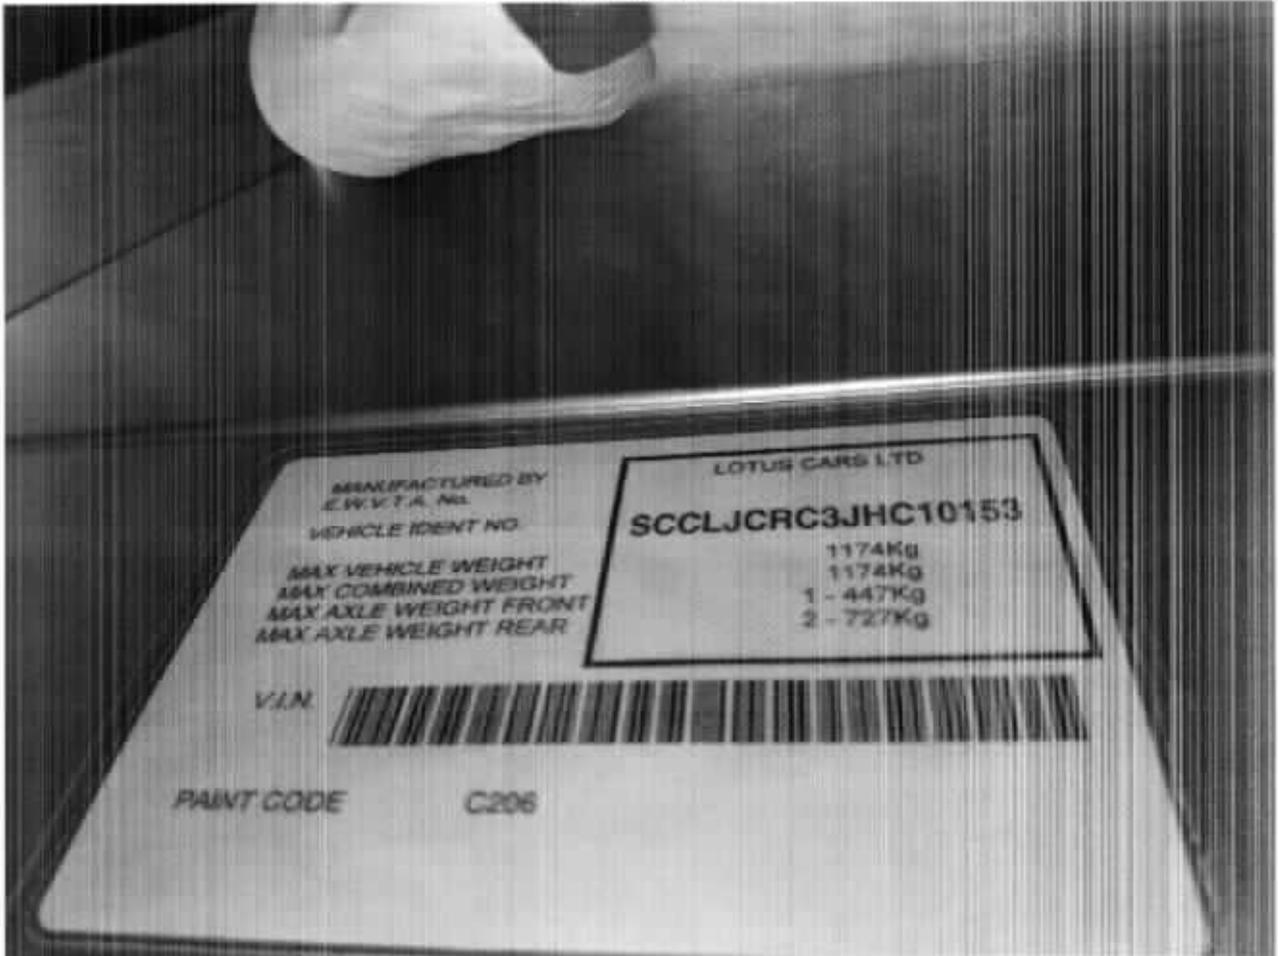
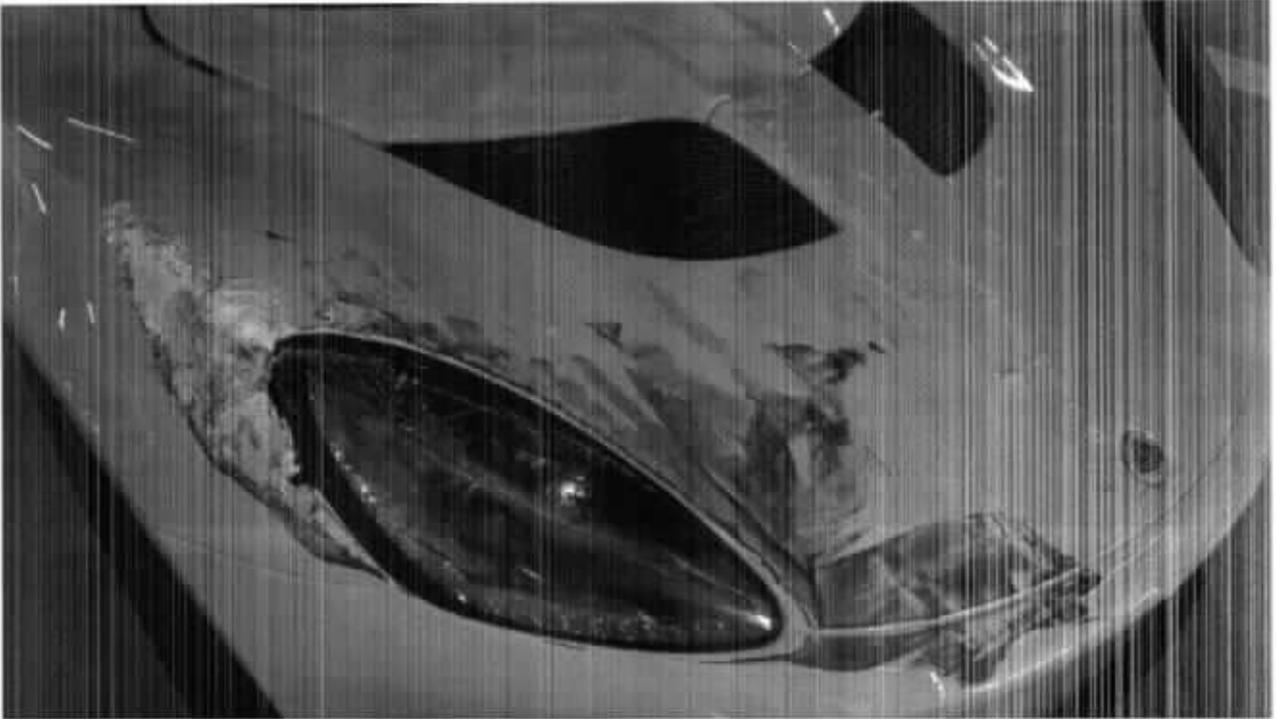
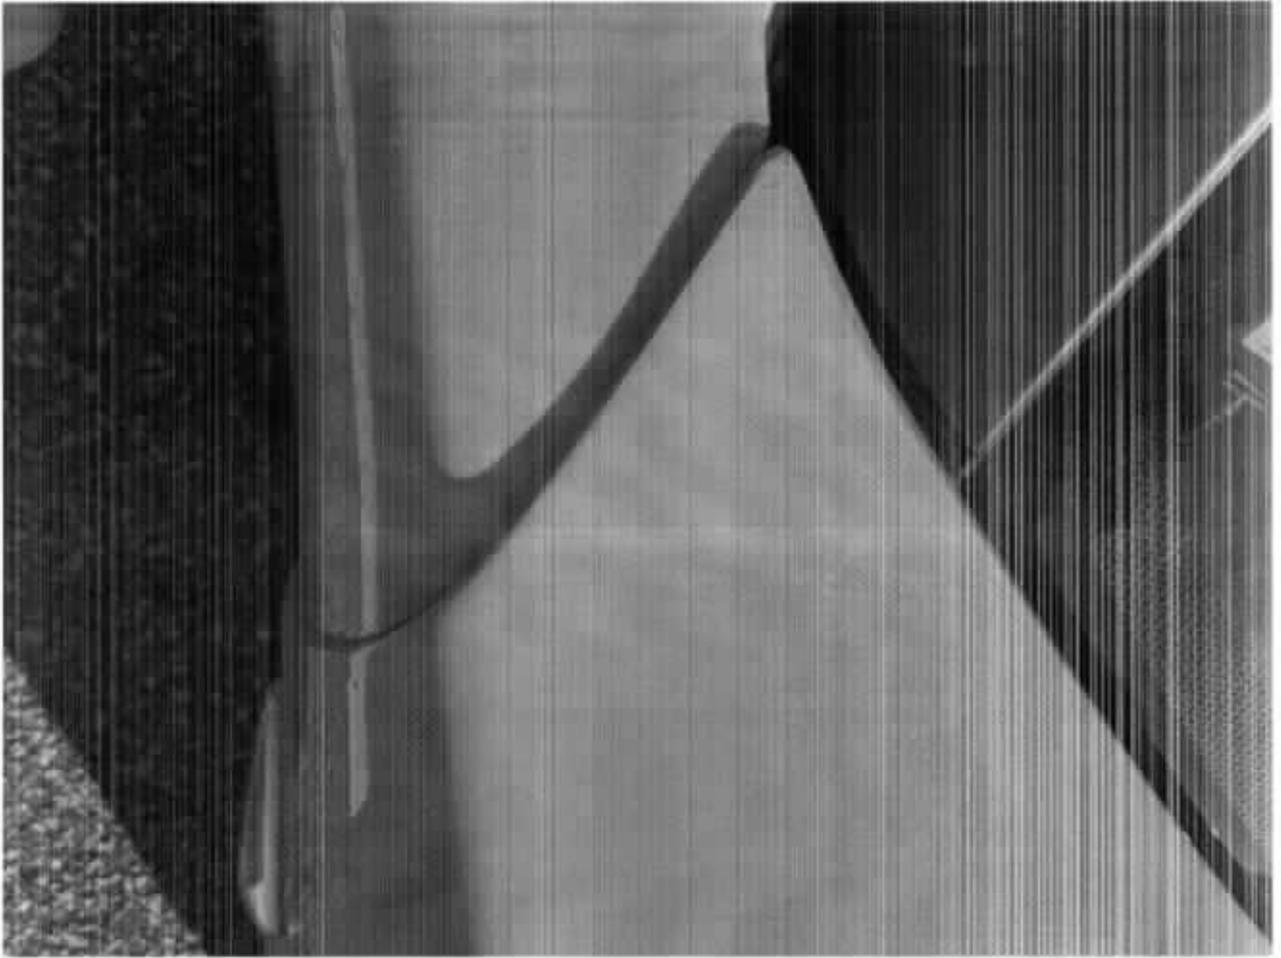
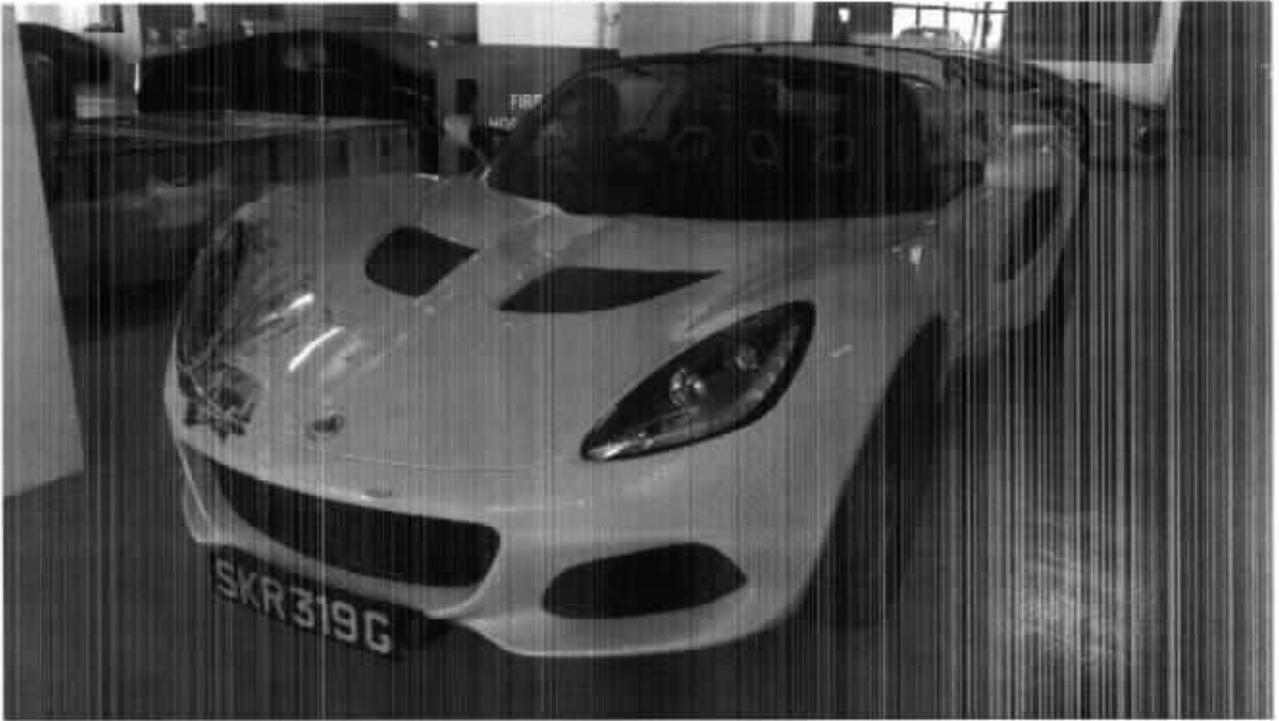
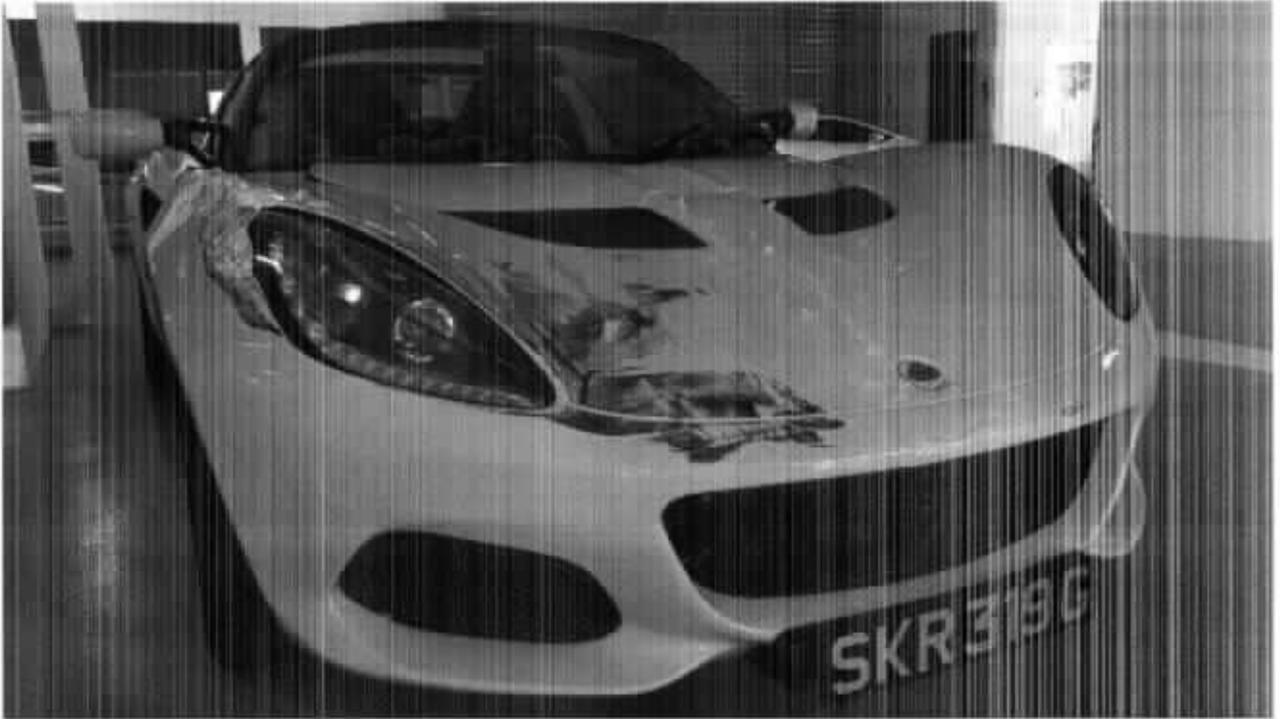
Accident Photo

The vehicle sustained impact / damages front portion and parts claimed are consistent to the accident.

(X) The vehicle is repairable at our adjusted amount. We have also confirmed excess and policy coverage. Kindly let us have your authorisation.

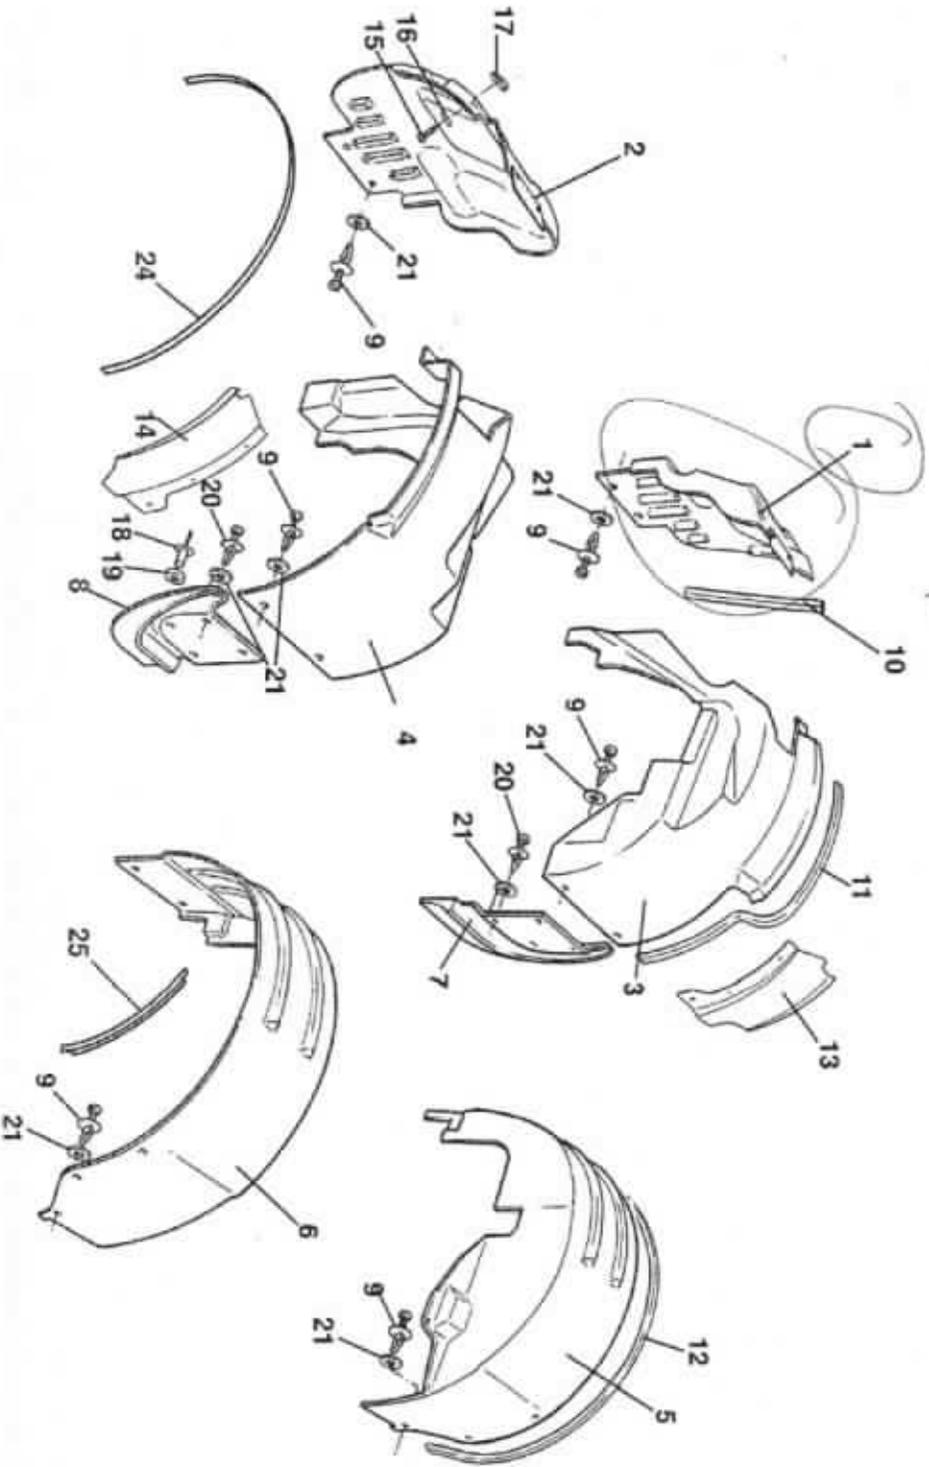
Front LH wheel arch front panel headlamp access.
