# TP Claims against NTUC Income: Follow-Through Survey

## 1. Policy Particulars :- THIRD PARTY CLAIM

## 4. Description of Damages

**ADJUSTMENT ON REPAIR COST FOR VEHICLE NO. SHF 52Z**

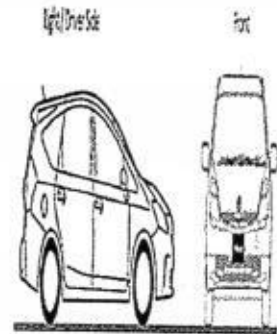
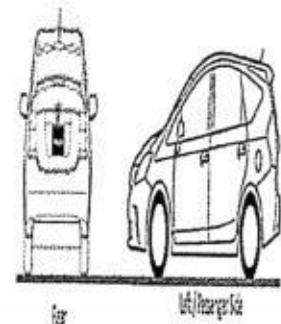
Right Side

The UIC / Chassis frame / Body Structure affected due to collision.

THE VEHICLE SUSTAINED DAMAGES AT THE O/S BODY.  
DAMAGES SEE DETAILS.

Qty	Description of Parts	Condition	Estimate By Workshop (\$)	Our Adjusted (\$)
<b>REPLACEMENT OF PARTS</b>				
1	PANEL SUB-ASSY, FENDER REAR RH (DISC 25%)	BUCKLED	824.80	618.60
1	CAP SUB-ASSY, WHEEL (DISC 25%)	SCRATCHED	175.80	131.85
2	PIXEL STICKER @ \$60.00 (SN)	NECESSARY	120.00	120.00
1	FILLER, RR BUMPER, RH	NOT NECESSARY	119.90	-
1	WHEEL, DISC	NOT NECESSARY	1,555.10	-
1	TYRE	NOT NECESSARY	126.74	-
1	PANEL SUB-ASSY, REAR DOOR, RH	TO REPAIR SEE LABOUR	1,243.90	-
1	MOULDING ASSY, BODY ROCKER PANEL, RH	TO REPAIR SEE LABOUR	576.00	-
1	COVER, RR BUMPER ASSY	TO REPAIR SEE LABOUR	423.90	-
			5,166.14	870.45
<b>LABOUR</b>				
	PANEL BEATING & BODYWORK. INCLUSIVE OF THE REPAIR OF PANEL SUB-ASSY, REAR DOOR, RH; MOULDING ASSY, BODY ROCKER PANEL, RH AND COVER, RR BUMPER ASSY.		845.00	800.00
	SPRAY PAINT.		1,674.00	700.00
	TO APPLY RUST-PROOFING ON AFFECTED AREA.		100.00	20.00
	TO CHECK WIRING AND SYSTEM FUNCTION.		80.00	20.00

TO TRANSFER DOOR MECHANISM.	NOT NECESSARY	120.00	-
	TO DO WHEEL ALIGNMENT / TYRE BALANCING.	NOT NECESSARY	120.00	-
	TO REMOVE AND REFIT TYRE.	NOT NECESSARY	120.00	-
	TO REMOVE AND REFIT TYRE RIM (SPRAYING PURPOSE)		120.00	30.00
	TO WASH AND VACUUM.	NOT NECESSARY	60.00	-
	TO REPLACE SUNDRY PARTS.	NOT NECESSARY	100.00	-
			3,339.00	1,570.00
<b>GRAND TOTAL</b>			<b>8,505.14</b>	<b>2,440.45</b>
<b>RECOMMENDED COST OF REPAIRS (CONFIRMED)</b>				<b>2,440.45</b>
