**RE : QUOTATION FOR ACCIDENT REPAIRING VEHICLE NO.: XB5499S**

### DAMAGE ASSESSMENT REPORT

Insured Veh.	SGY 2065K	Veh. Inspected	XB 5499S
Policy No.		Coverage (\$)	0.00
Claim No.	MT/1035703-002	Excess (\$)	0.00
Assign From	CYNTHIA ANG	Assign Date	22/03/2019

**ADJUSTMENT ON REPAIR COST FOR VEHICLE NO. XB 5499S**

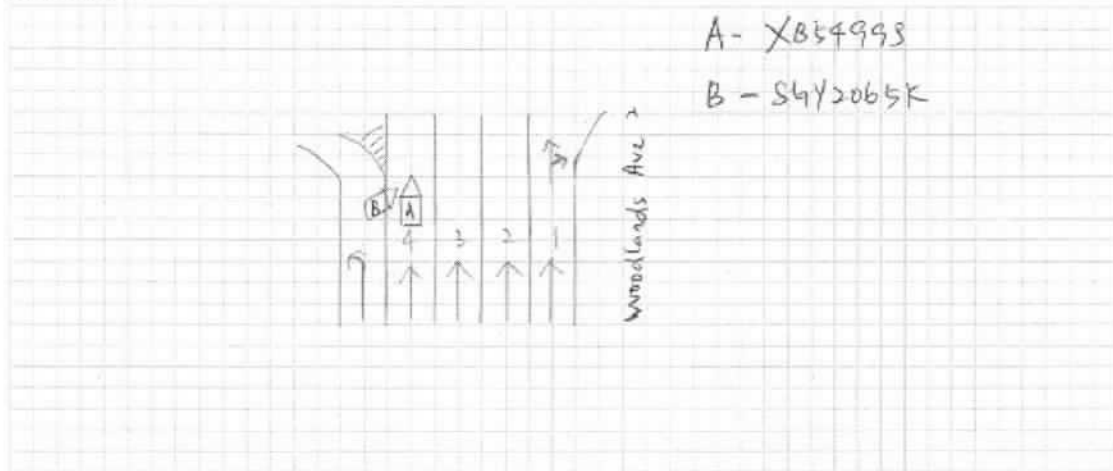
### SKETCH PLAN

On 12/03/19 around 26:40, I was driving my lorry (XB5499S) and travelling from Tuas towards Woodlands Ave 2, on my way back to home. I was in Lane 4 going straight, suddenly a car (SGY2065K) signal turn on left signal and suddenly he changed his mind and dash out to right. The car crashed into my lorry.
