SJW 1174K

**Estimate cost of repair to vehicle SJW1174K Kia Cerato EX Forte 1.6L A**

Insured:	-, Co. Reg. No.: -, Email: EMAIL@YAHOO.COM		
Main Claimant:	-		
Vehicle Reg. No.:	<b>SJW1174K</b>	Date of Loss:	22/03/2019 18:00 - :59 [108 Months and 19 Days From LTA Reg Date (Man Yr)]
Claim Type:	<b>TP / DMPC1900077H/JG</b>	Policy/Cover Note No.:	(Comprehensive)
Vehicle Reg. No. (Insured):	<b>SGN2052E</b>	Policy No. (Claimant):	
		Excess:	
Repairer:	<b>Quan De Motor Trading ()</b> BLK 1 KAKI BUKIT AVENUE 6 #01-67 AUTOBAY SINGAPORE 417883, 417883 Kaki Bukit - Tel:		
Handling Insurer:	<b>ECICS Limited (HQ)</b> - Tel: 63374779 /6303 0178 ... [Handled by <b>Janice Goh</b> - 6303 0182]		
Adjuster:	<b>LKK Auto Consultants Pte Ltd (HQ)</b> - Tel: 6256-3561 ... [Handled by <b>MARCUS CHUA</b> ] ... [Final Rpt due 03/04/2019]

## VEHICLE DAMAGE INSPECTION REPORT

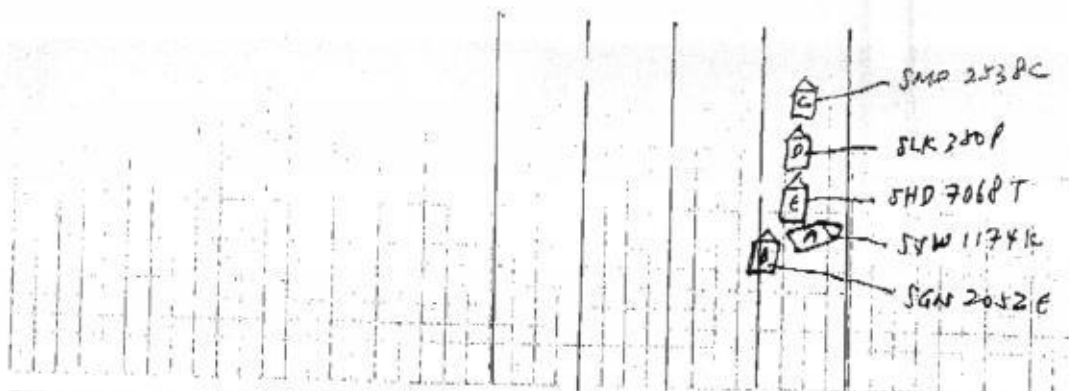
SKETCH PLAN

First car jammed brake suddenly due to a car in front of his car. Second car braked & followed by all the cars behind also jammed brake & I also managed to brake in time behind the 3rd vehicle (taxi) without hitting him. Suddenly, vehicle (B) - SGH 2052E travelled by high speed could not brake in time & hit onto the rear of my vehicle & the great impact caused my vehicle to lose control & hit onto the railing on the right & also hit onto the ~~front~~ right side of the taxi in front of me. It was a chain collision involving 5 vehicles.
