**Preliminary Advice**

| Insured Vehicle No | : FBG9104P | Accident Date | : 22/03/2019 |
| Make | : YAMAHA JUPITER LC135 | Est. Duration of Repair | : 4.00 |

**Point of Impact / General Description of Damages**

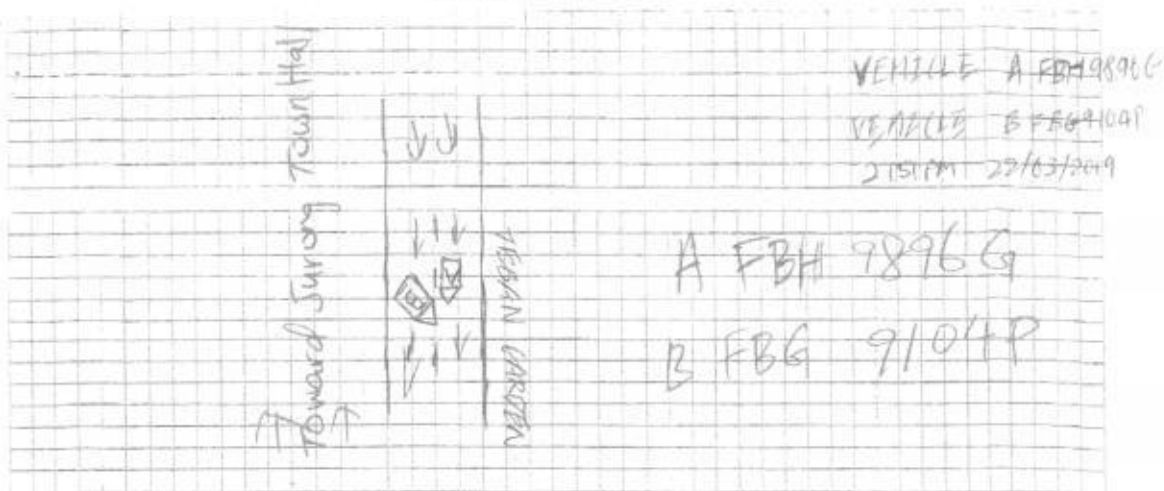
Sketch Plan #2 Pg. 1

ON THE ABOVE STATED DATE AND TIME, I WAS DRIVING ALONG TEBAN GARDENS ROAD. I WAS DRIVING IN MY OWN LANE. SUDDENLY VEHICLE B SWERVE TOWARDS MY LANE AND COLLIDED ONTO MY VEHICLE. I THEN FELL ON MY RIGHT, BOTH MY BIKE AND MY MOBILE PHONE WAS DAMAGED. THERE WAS AN EYE WITNESS NAMED LUKA, MOBILE NUMBER: 8809 8457.
