ACCIDENT DAMAGED VEHICLE INSPECTION REPORT

Date : 30 December 2018
Our Ref : WG/TP/2018-449

Registration No : SLL1994C
Make : TOYOTA
Model : VELLFIRE 3.5Z G-ELETRON A
Year : 2008

ADJUSTMENT ON REPAIR COST FOR VEHICLE NO. SLL 6954C

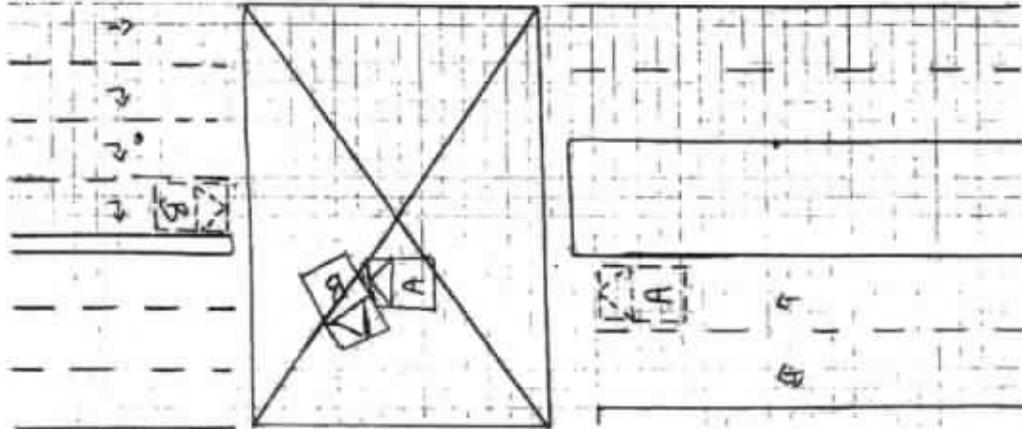
SKETCH PLAN

BAYFRONT AVE & CENTRAL BLVD JUNCTION
 VEH A: SLL 6954C
 VEH B: SKR 4596X

ON THE STATED DATE & TIME, I VEH A (SLL 6954C) WAS WAITING AT THE JUNCTION OF BAYFRONT AVE & CENTRAL BLVD FOR THE TRAFFIC LIGHT TO TURN GREEN & MOVE TOWARD MBS. AS THE TRAFFIC LIGHT TURN GREEN I MOVE OFF, JUST WHEN I MOVE OFF AT A VERY SLOW SPEED, AS I JUST PICK UP, VEH B (SKR 4596X) DID A RIGHT TURN ON THE OFF LANE INTO CENTRAL BLVD, AS VEH B DIDNT TURN ON GREEN ARROW, VEH B HIT ONTO MY FRONT & DAMAGE MY VEH WHOLE FRONT PORTION MAKING MY VEH UNABLE TO START PICS BADLY DAMAGE.

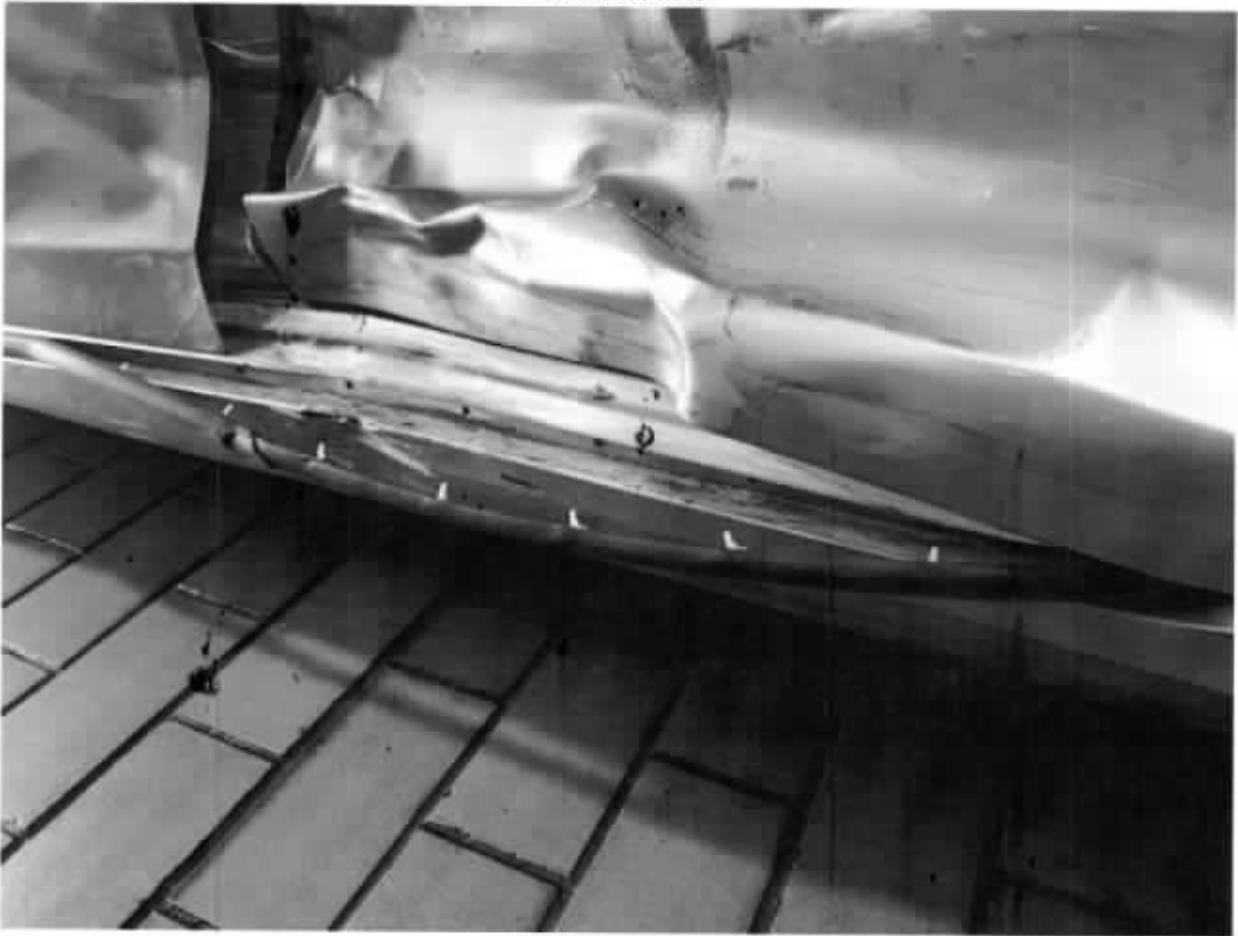
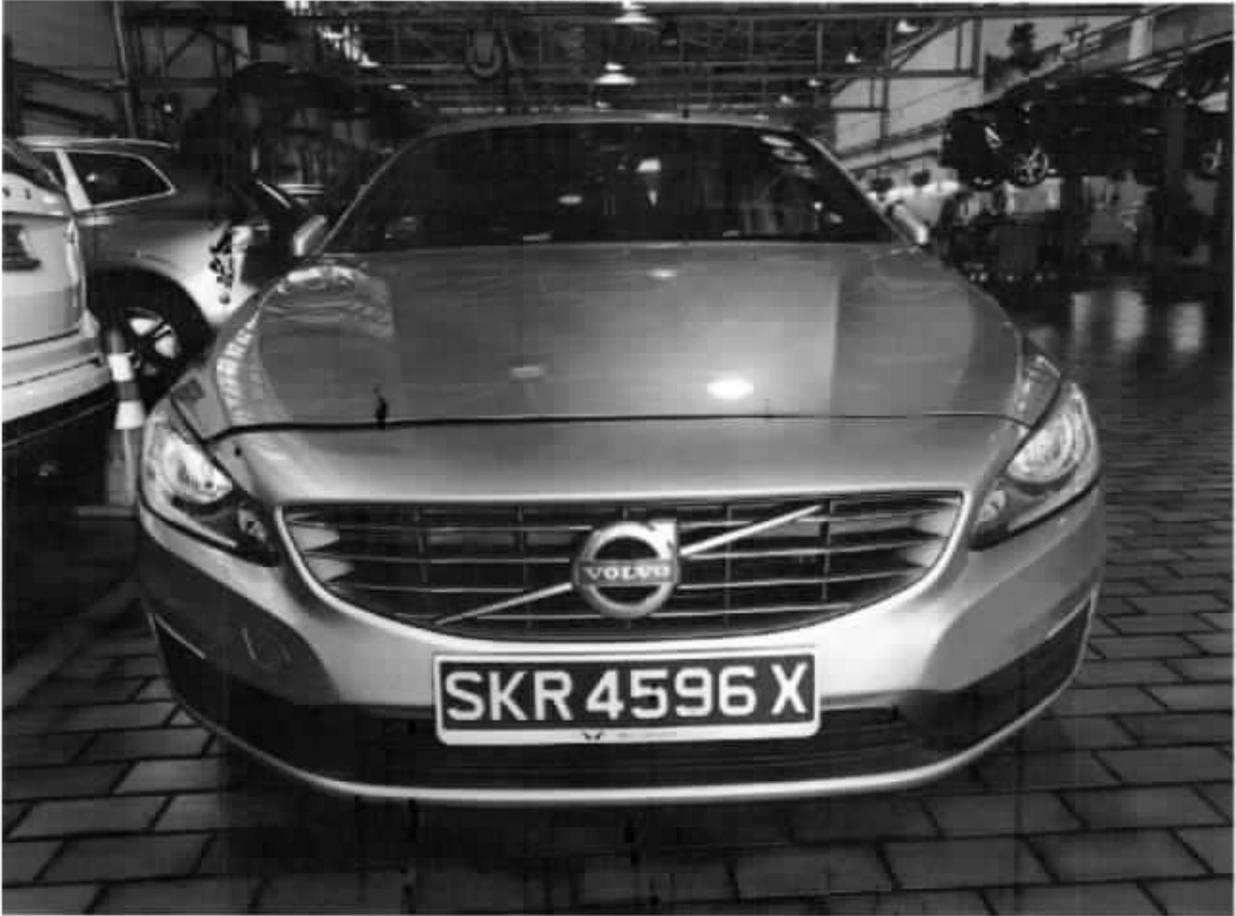
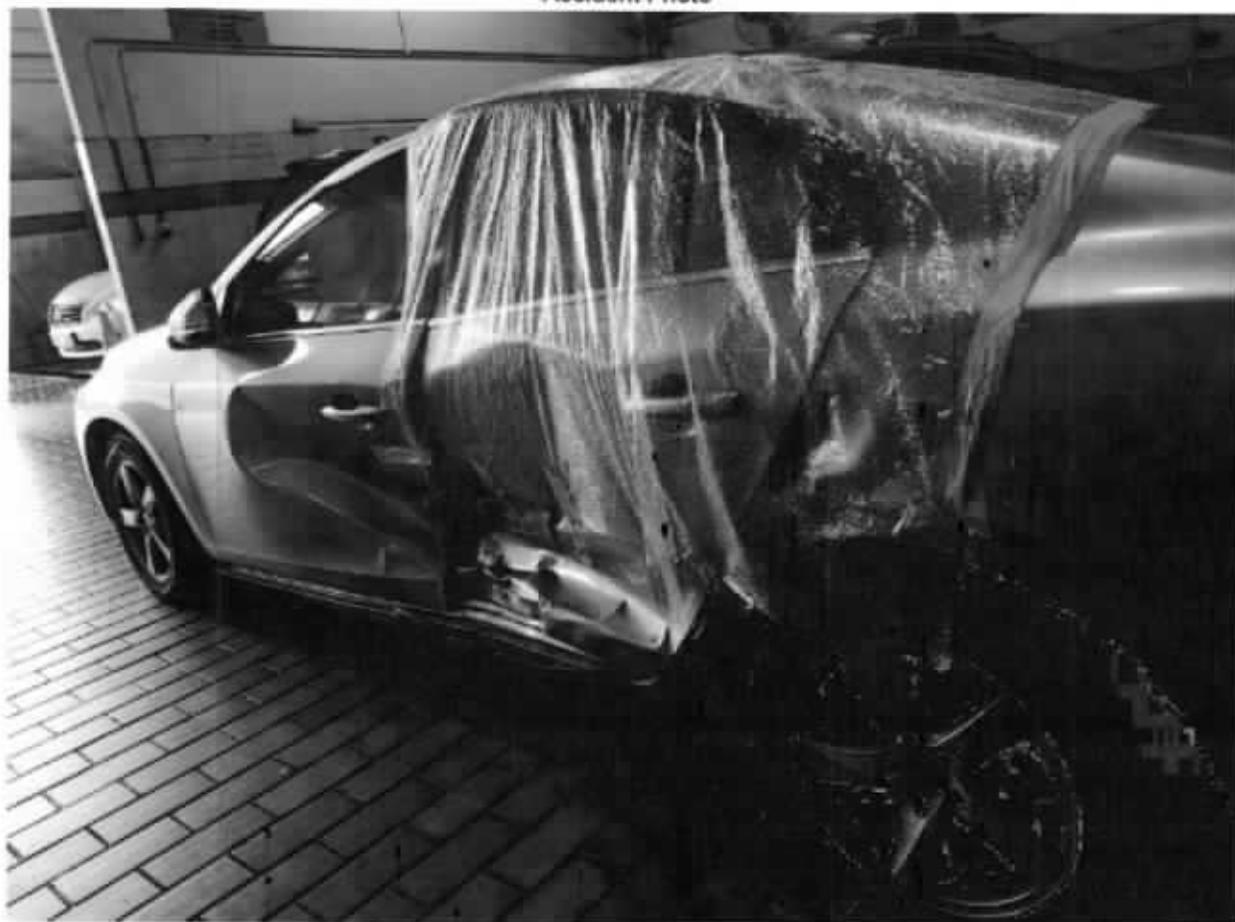
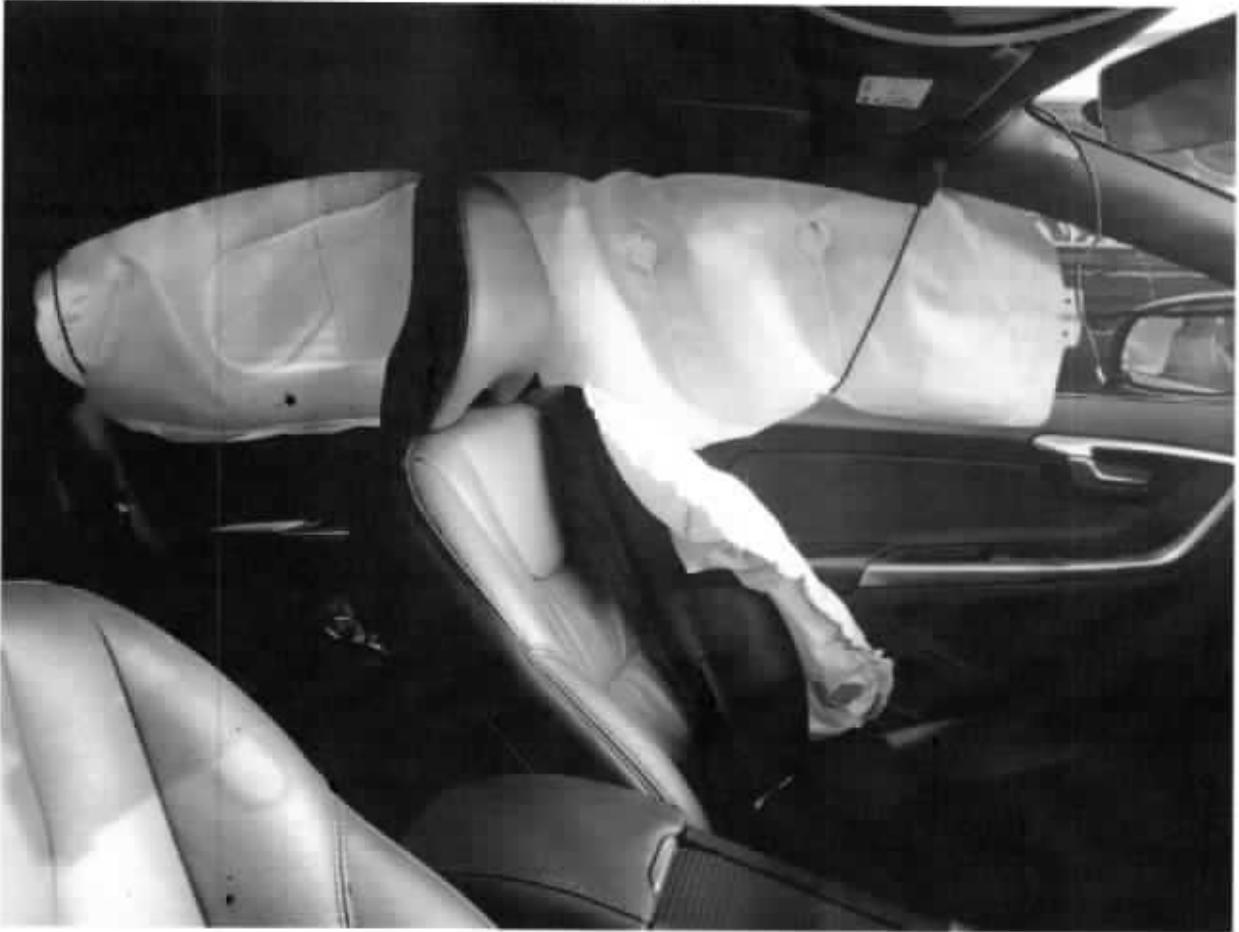
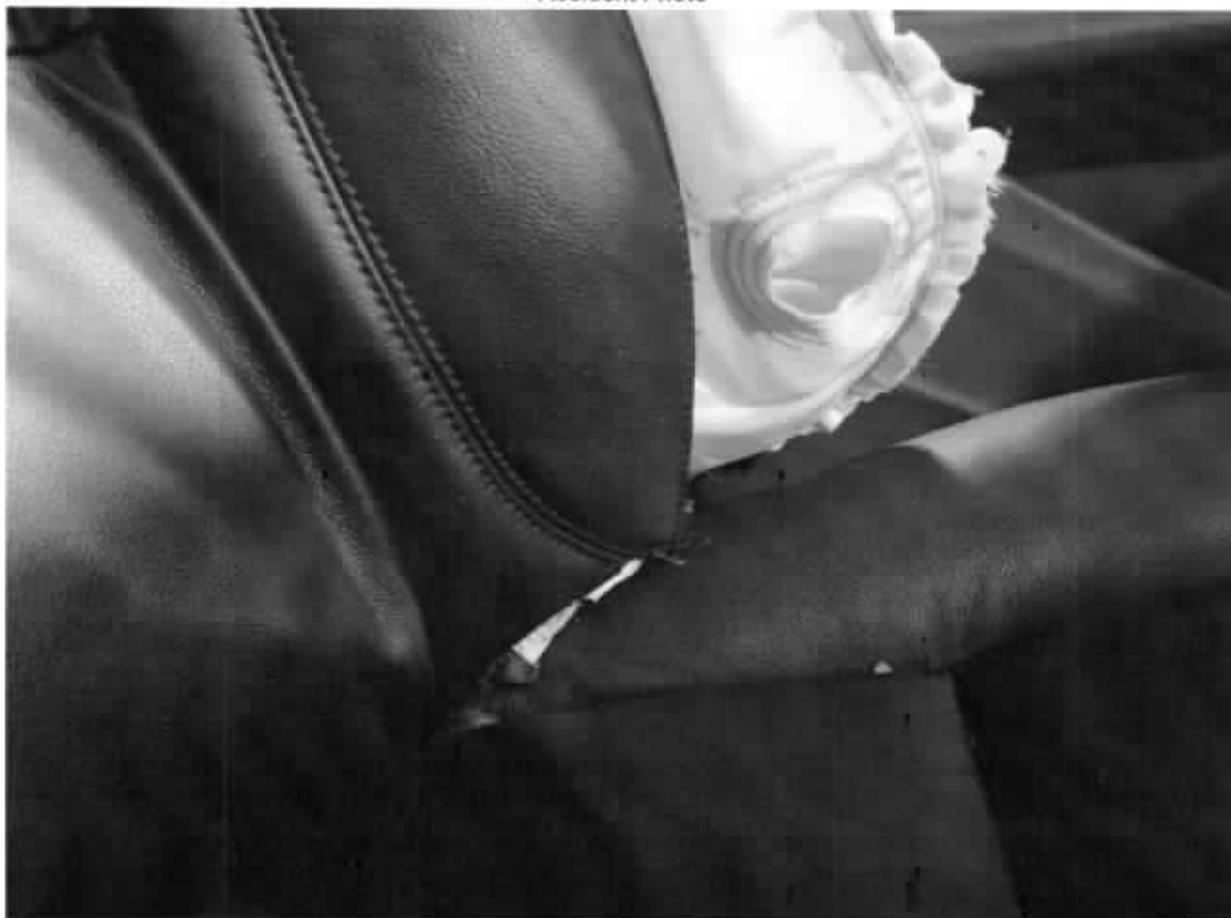
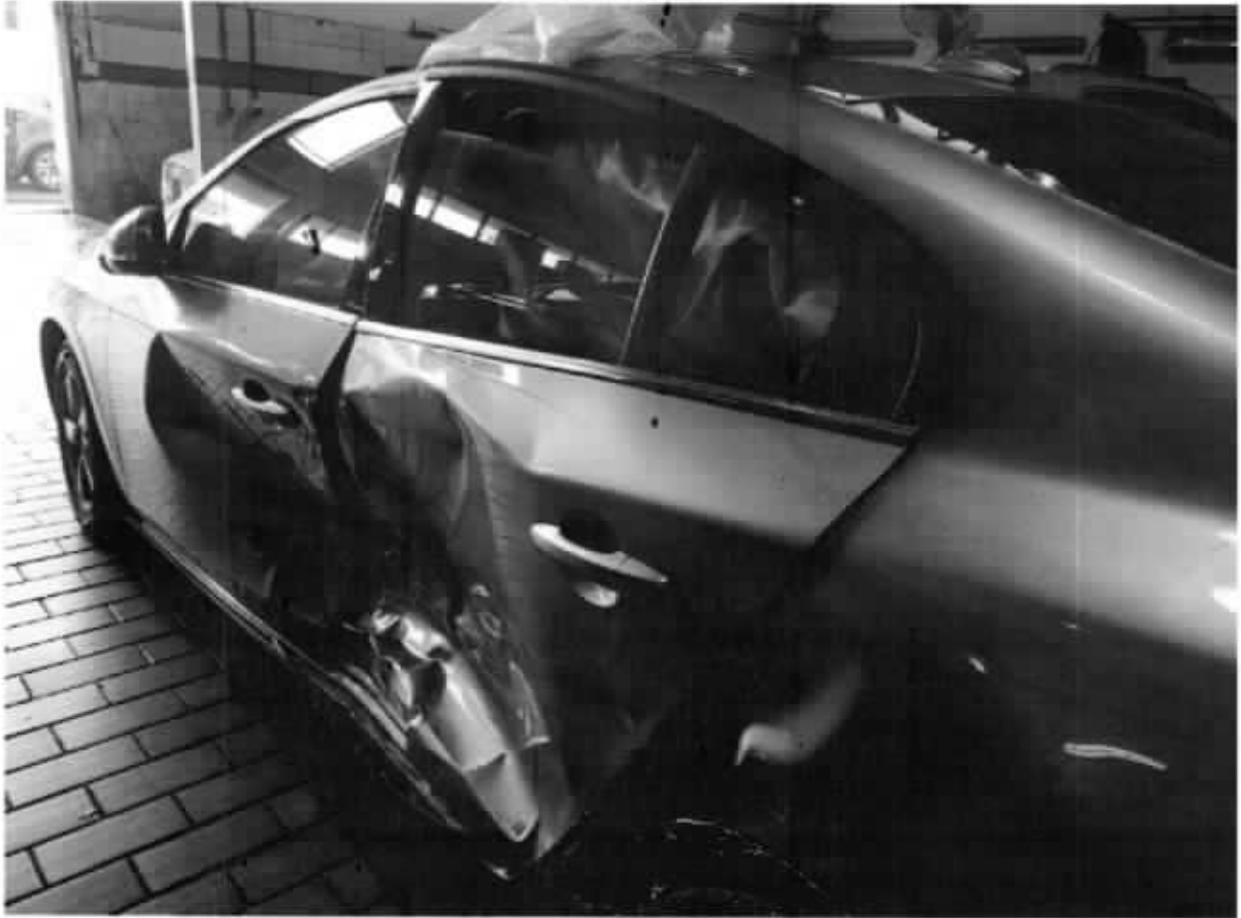
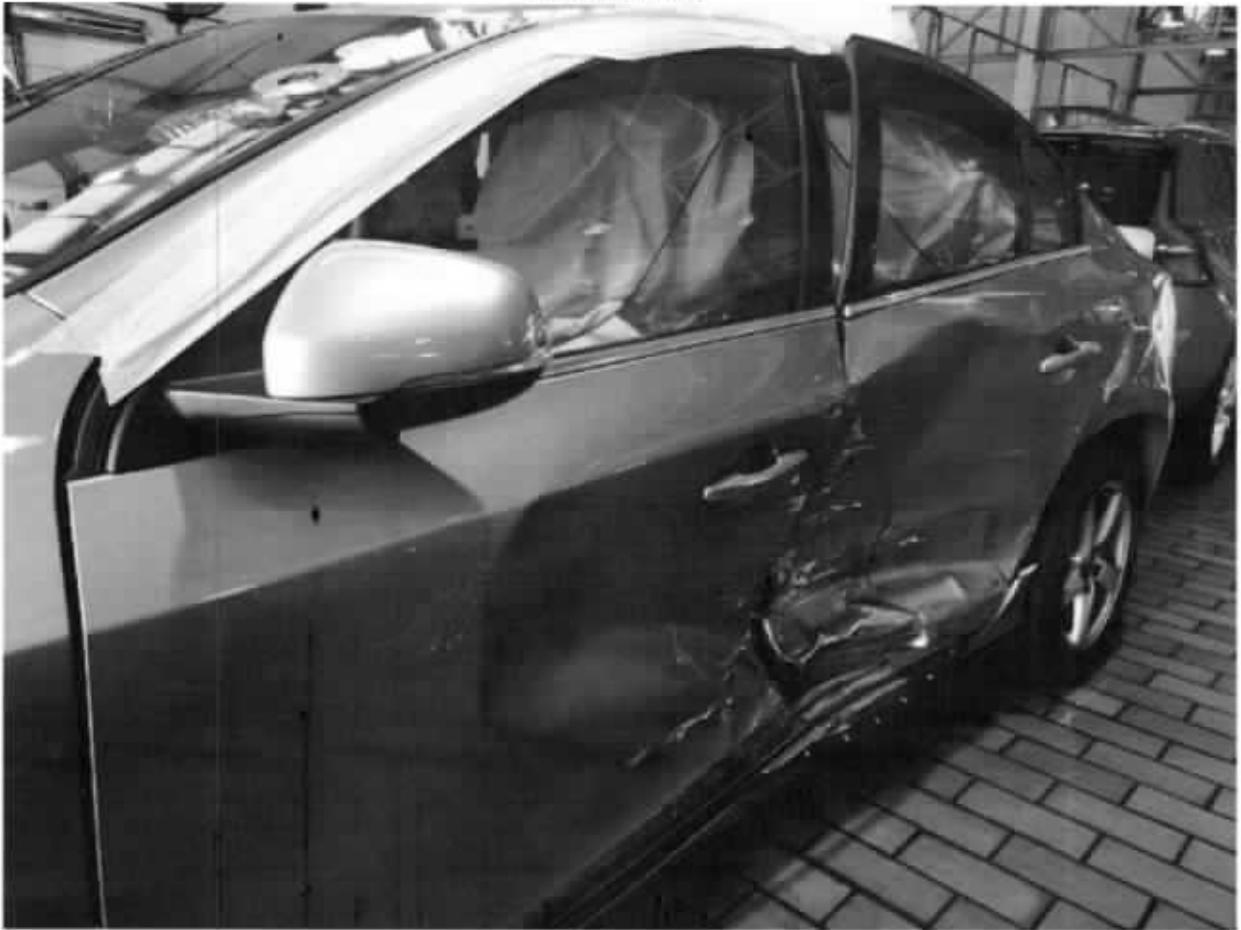
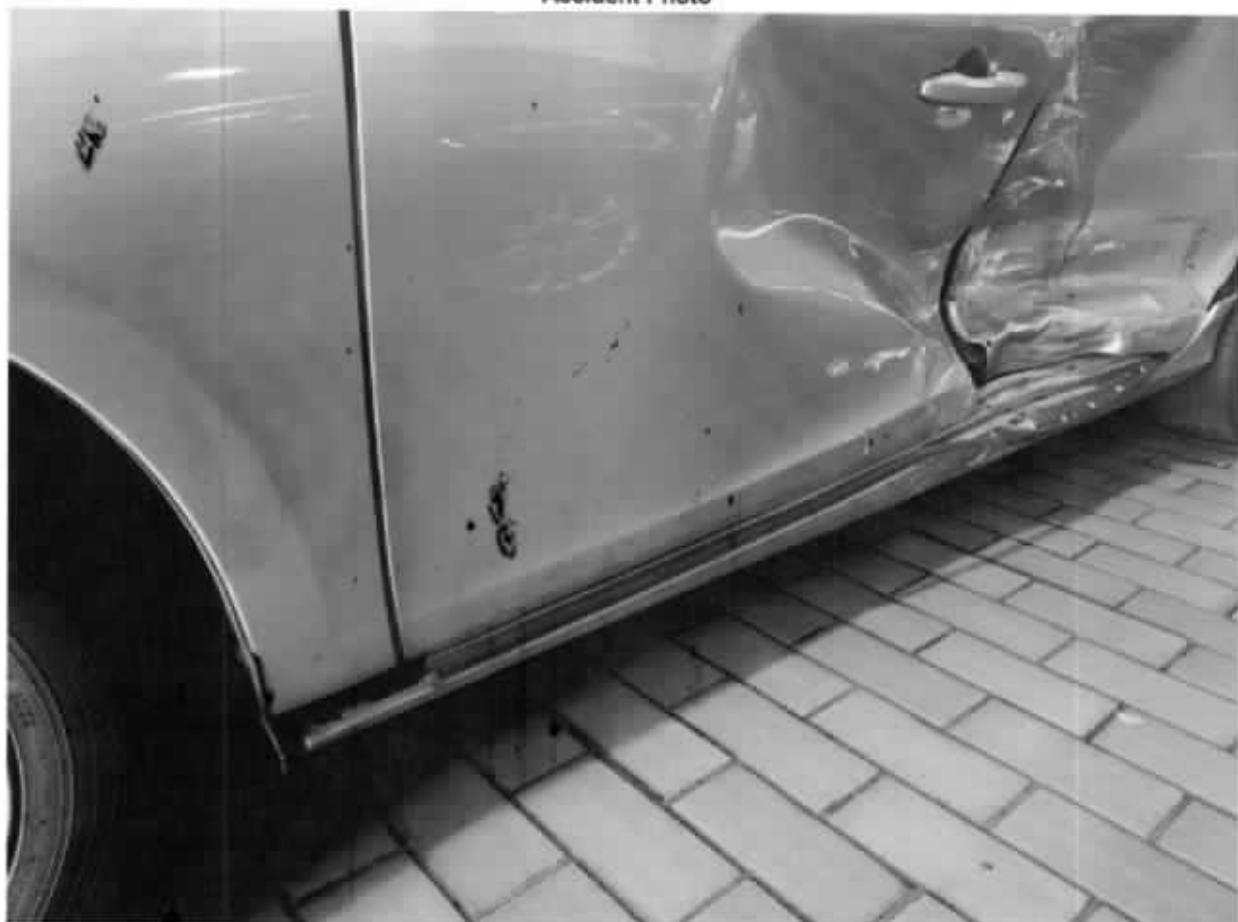
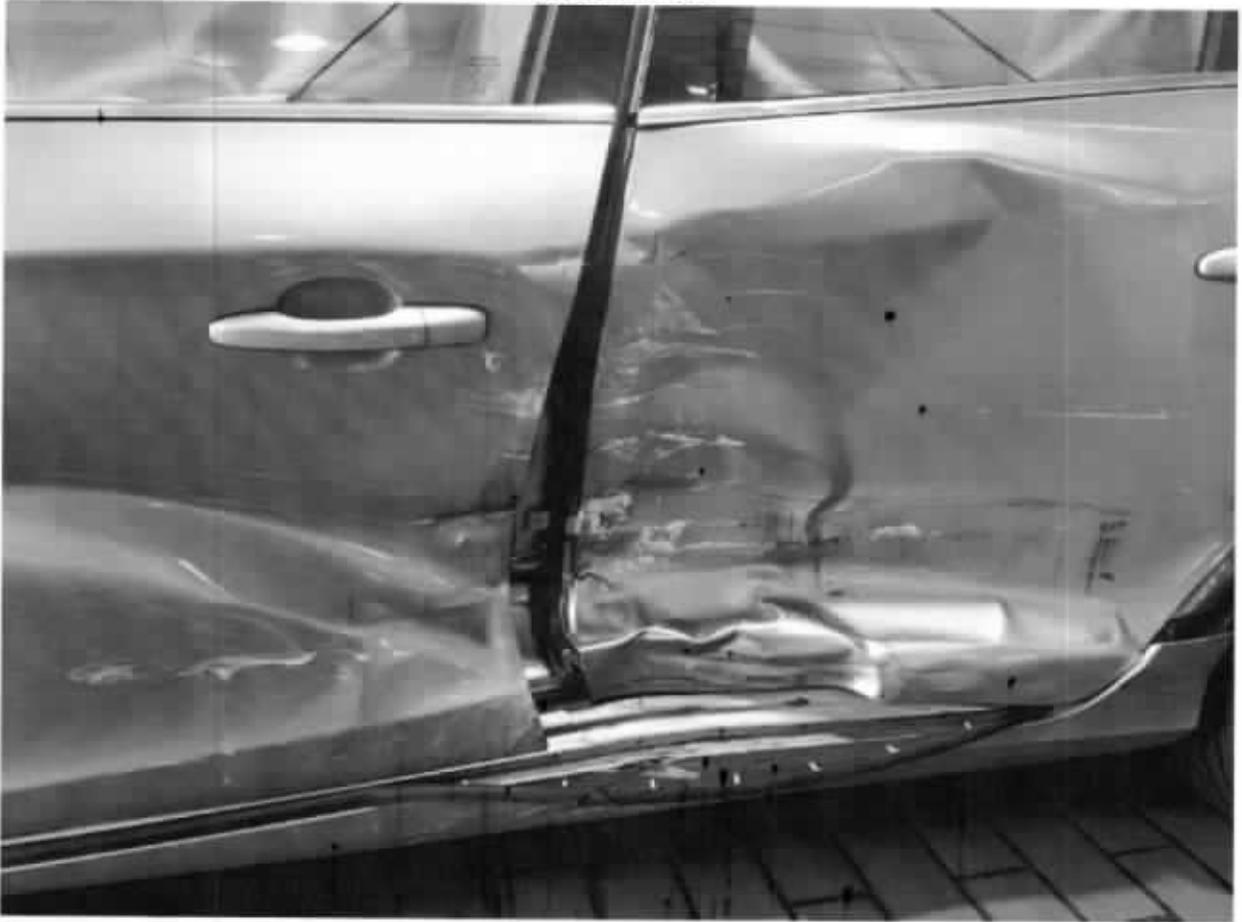
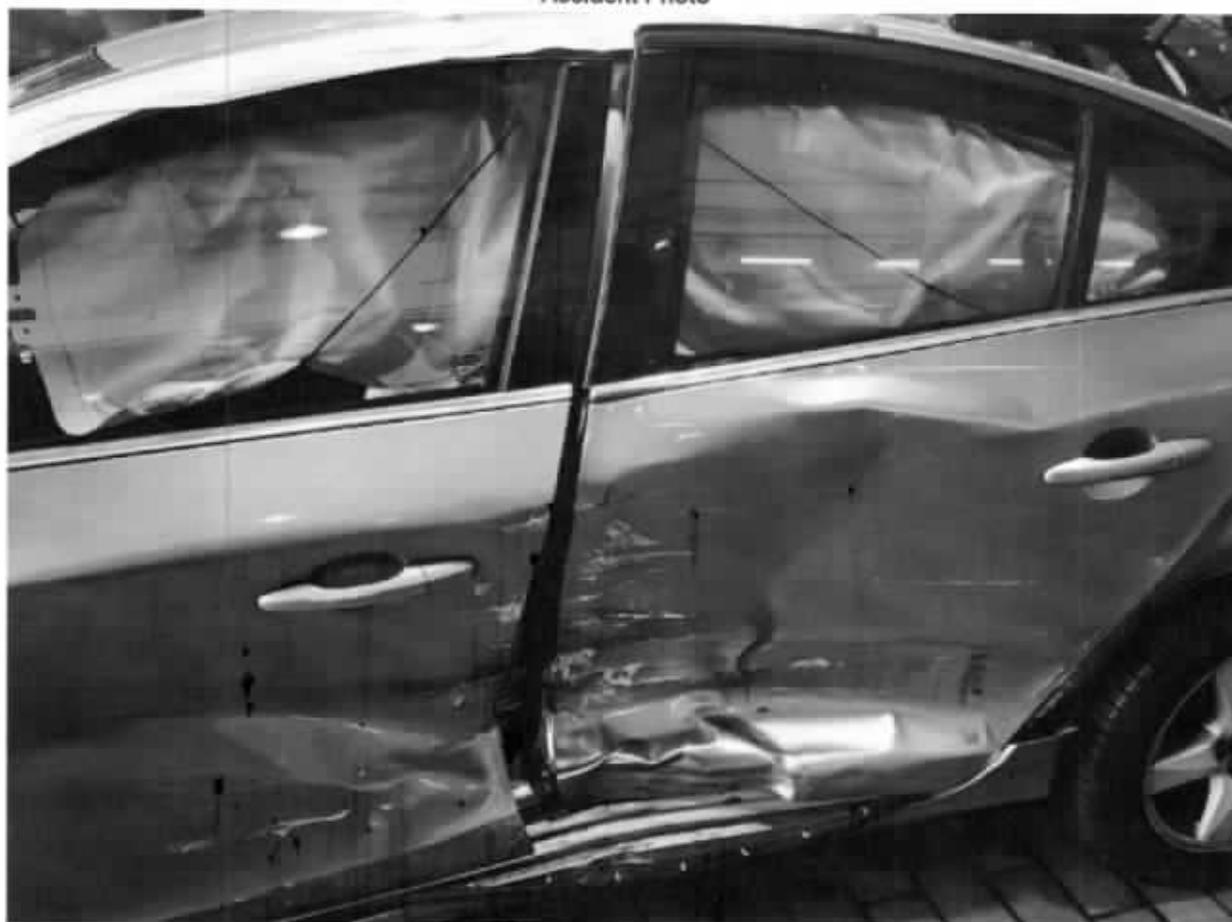
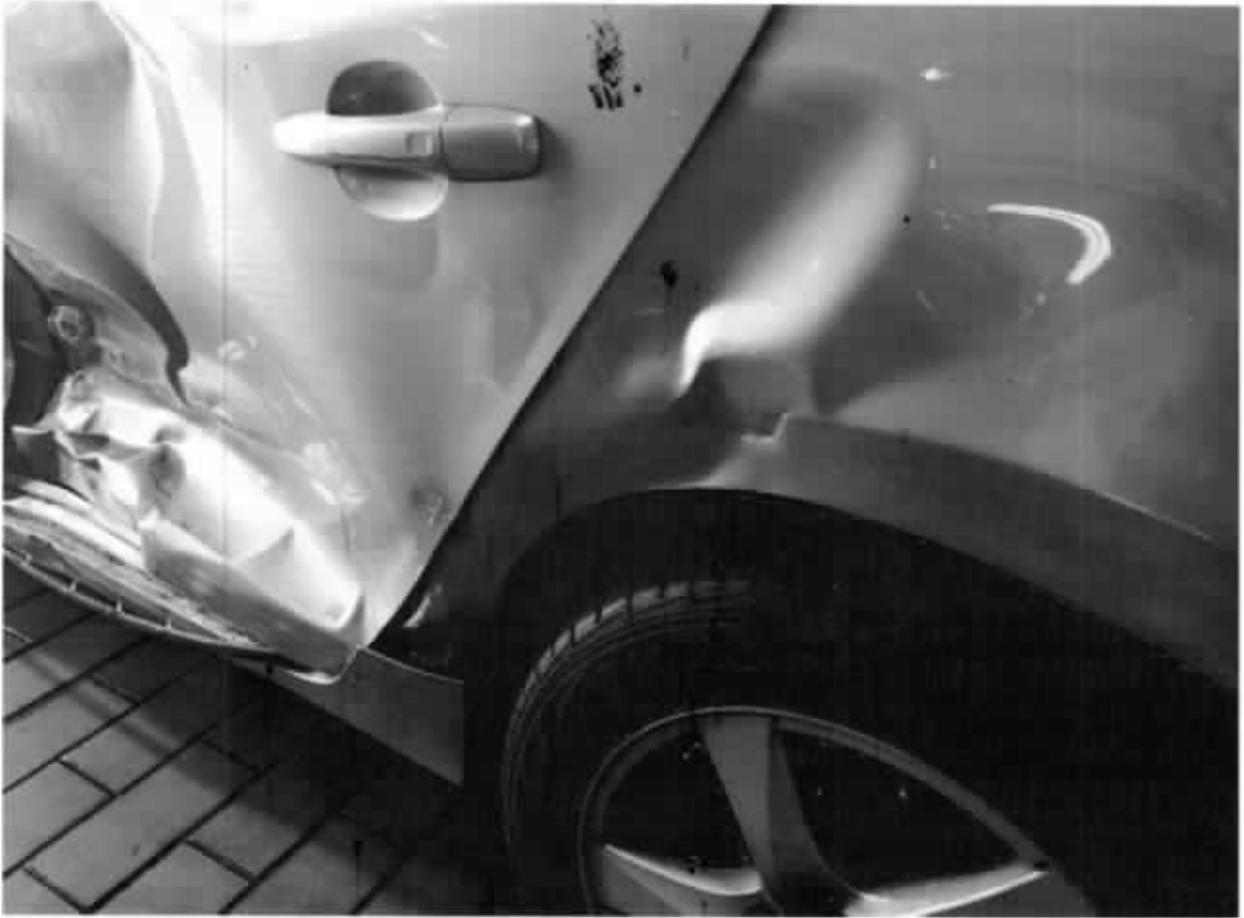
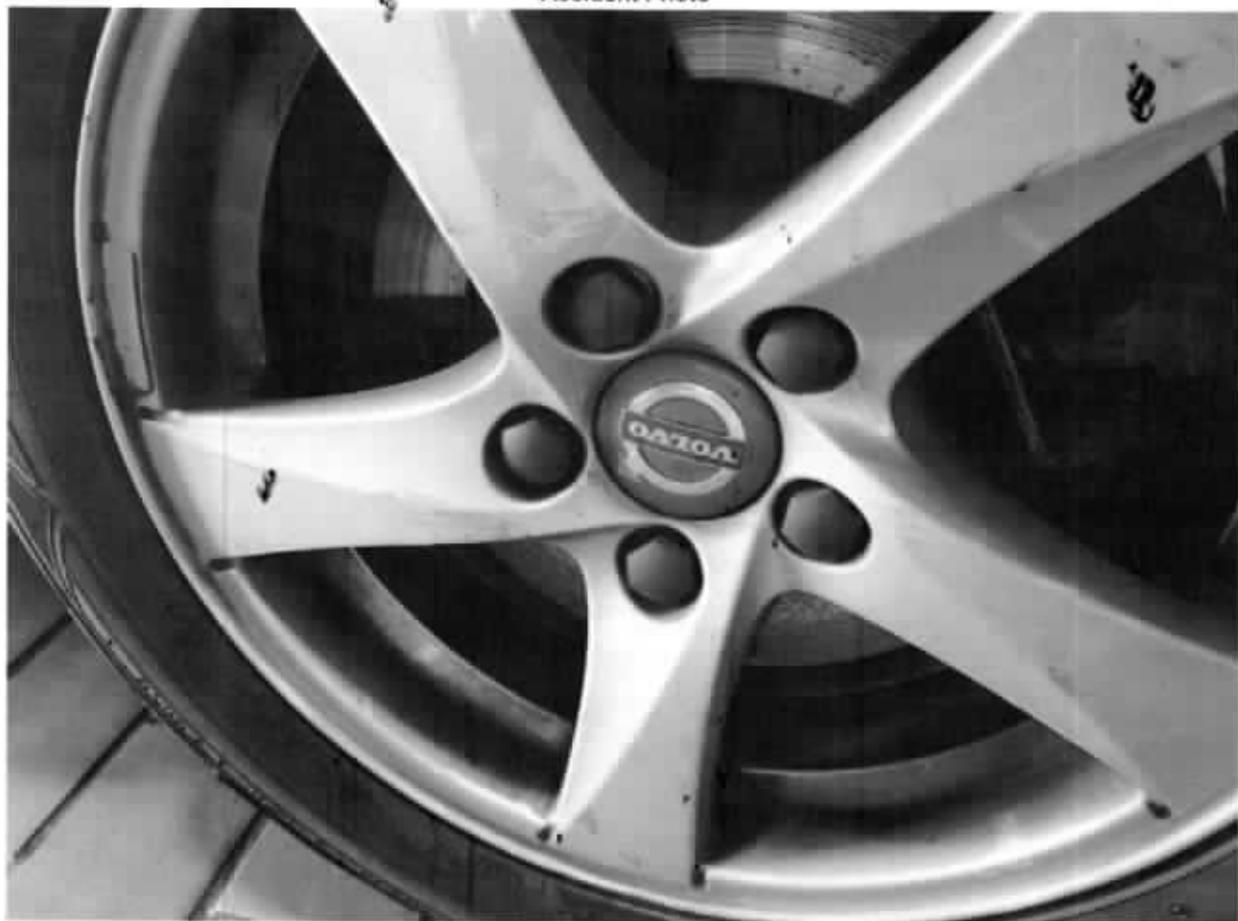
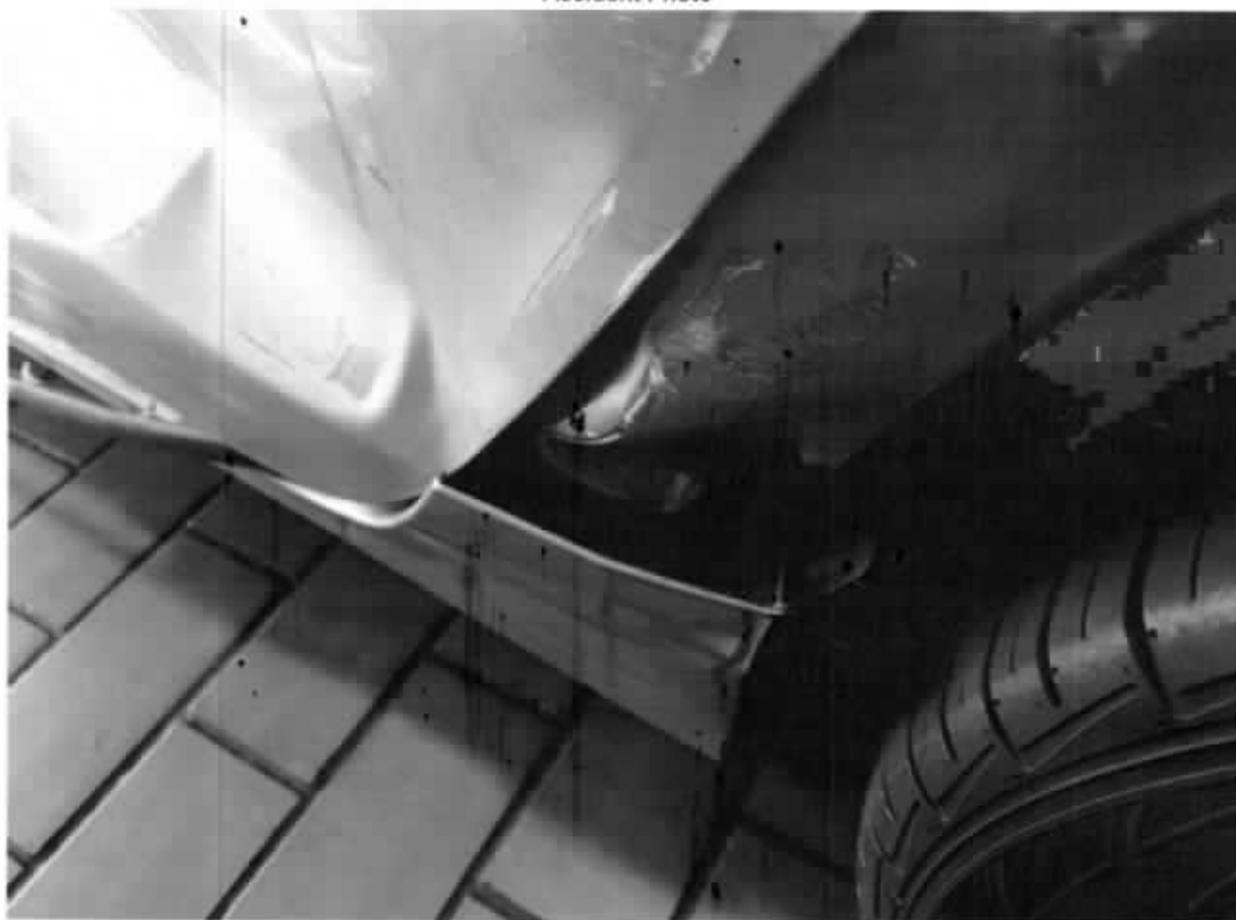
4. Description of Damages			
THE VEHICLE SUSTAINED DAMAGES AT THE FRONT PORTION. DAMAGES SEE DETAILS.			
5. General Information			
Accident Date	30/11/2018	Inspection Date	10/12/2018
Survey held at	AUTOWERKE AUTOMOTIVE PL 8 KAKI BUKIT AVENUE 4 #05-01 PREMIER @ KAKI BUKIT SINGAPORE 415875		
5a. Remarks			
A)THE INSPECTION WAS CONDUCTED ON A"WITHOUT PREJUDICE" BASIS. B)IN ACCORDANCE TO YOUR INSTRUCTIONS, WE HAVE NOT AUTHORISED REPAIRS.			
5b. Estimate Days of Repair			
ESTIMATED NORMAL PERIOD FOR REPAIR:		8 Working Days

Qty	Description of Parts	Condition	Estimate By Workshop (\$)	Our Adjusted (\$)
REPLACEMENT OF PARTS				
1	FRONT BONNET	DENTED	935.00	560.00
2	FRONT BONNET HINGE	BENT	156.00	156.00
2	FRONT BONNET DAMPER	NOT NECESSARY	143.00	-
1	FRONT GRILLE ASSY	CRACKED	755.00	755.00
1	FRONT GRILLE EMBLEM	NECESSARY	80.00	80.00
2	FRONT HEADLAMP	CRACKED	4,678.00	4,678.00
1	FRONT HEADLAMP CENTRE GRILLE LH	CRACKED	267.00	140.00
1	FRONT HEADLAMP CENTRE GRILLE RH	CRACKED	267.00	140.00
1	FRONT BUMPER	CRACKED	785.00	785.00
2	FRONT BUMPER RETAINER	NECESSARY	115.00	78.00
2	FRONT FOG LAMP	CRACKED	690.00	560.00
2	FRONT FOG LAMP COVER	CRACKED	334.00	334.00
1	TOW COVER	MISSING	35.00	35.00
1	FRONT LOWER GRILLE	CRACKED	309.00	278.00
1	SUPPORT PANEL	DENTED	1,417.00	985.20
1	FRONT LH CHASSIS	TO REPAIR SEE LABOUR	2,690.00	-
1	FRONT LH CHASSIS BRACKET	TO REPAIR SEE LABOUR	225.00	-
1	FRONT LH WHEEL HOUSE	TO REPAIR SEE LABOUR	900.00	-
1	FRONT LH FENDER	DENTED	1,050.00	670.00

RECOMMENDED COST OF LUMP SUM REPAIRS (TO ITS PRE-ACCIDENT CONDITION)			12,600.00
---	--	--	-----------
