ACCIDENT INVOLVING SKN 1831 H AND YN 8266 C ON 18 JANUARY 2019 ALONG THOMSON ROAD BALESTIER HILL SHOPPING CENTRE CARPARK

Pre-Repair Inspection Date : 24/01/2019 at M/s Bak Heng Motor Repairing Co, Block 5032, Ang Mo Kio Industrial Park II, #01-291, Singapore 509535.

ADJUSTMENT ON REPAIR COST FOR VEHICLE NO. SKN 1831H

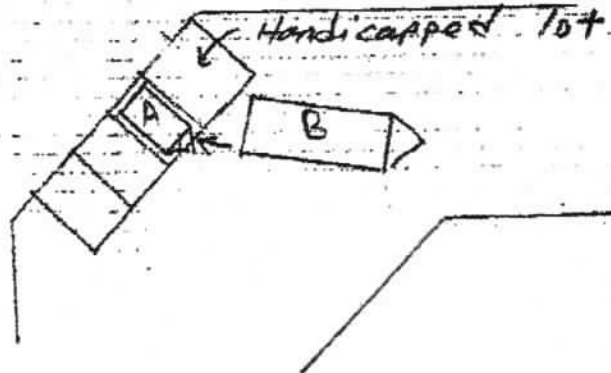
SKETCH PLAN

Date of Accident: 18/1/2019 Time: 2.20-2.30 Location: Balestier Hill shopping Centre Carpark
 My Vehicle A: SKN1F31H Vehicle B: YN8266L Vehicle C/Others: _____

Refer to police report T/20190119/219
