**Preliminary Advice**

Vehicle No	: WC4641K	Accident Date	: 19/03/2019
Make	: ISUZU CYH52S	Policy No.	: B29088496MKF
Assignment Date	: 29/03/2019	Excess	: S\$1,500.00
Date of Inspection	: 01/04/2019	Est. Duration of Repair	: 14.00
Inspection At	: YEW TEE AUTOMOBILE TECH PTE LTD (HQ) BLK 6 WOODLANDS ROAD 399F,, YEW TEE IND ESTATE SINGAPORE 678006

## VEHICLE DAMAGE INSPECTION REPORT

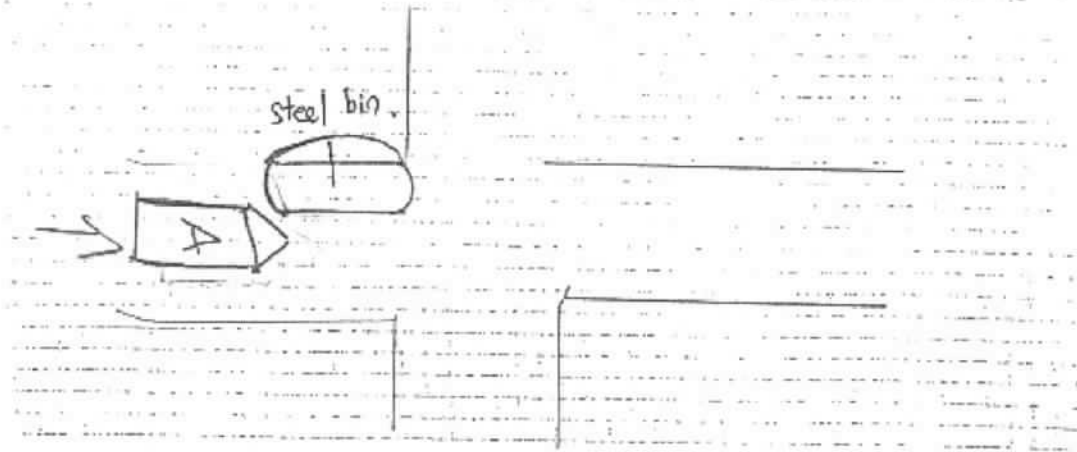
### SKETCH PLAN

While I was driving vehicle WC 4641K along  
maina glene, dog ran out on the ~~maina~~ road  
and I ~~was~~ lost control and bang on the steel bin.  
That is all from me.
