VEHICLE DAMAGE INSPECTION REPORT

Our File No: CS/CT119005618/R1TD3N2

Handling Insurer:	China Taiping Insurance (Singapore) Pte. Ltd.	Policy No:	DMPCSN1507131803	
Claimant Vehicle No :	SLR9771L	Insured Vehicle No :	SJP7815S	
Date of Loss:	24/03/2019	Nature of Claim:	TP	Claim No: SNM19D201336C02

Reg No:	SLR9771L	Engine No:	1NZR519665
Make & Model:	TOYOTA SIENTA, 1.5 HYBRID (A)	Chassis No:	NHP1707089839
Reg. Date:	31/08/2017 (Man. Year: 2017)	Odometer:	26959 km
Colour:	Blue		
Engine Capacity:	1496 cc		
Market Value/New Car Price:	N/A		
Sum Insured (\$\$):	Market Value/New Car Price

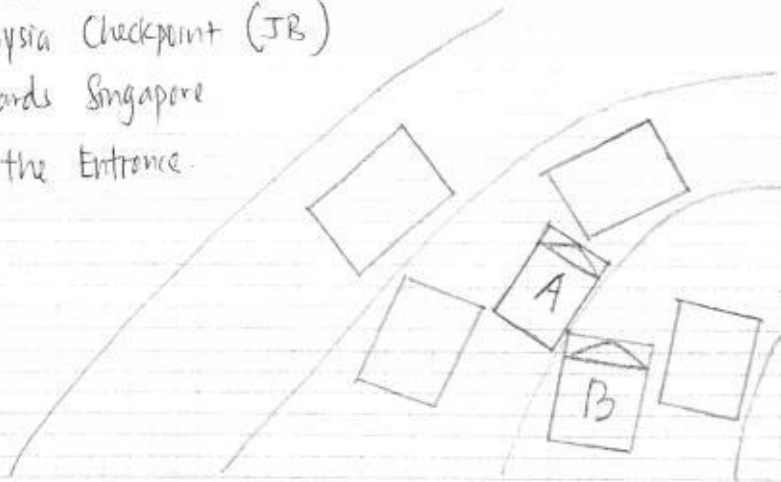
SKETCH PLAN

Malaysia Checkpoint (JB)
Towards Singapore
At the Entrance.

A: SLR 9771 L
B: STP 7815 S

- 1) 24 March 2019 around 10:55 pm
- 2) Malaysia checkpoint towards Singapore.
- 3) Car A travelling at centre lanes, merging ~~to~~ accordingly.
- 4) Car B on the right lane, ^{signal &} moving towards left. At Car A's blind spot.
- 5) While Car A concentrating on the merging traffic at the front, a screeching sound was heard. Car B ~~scared~~ front bumper scratched Car A right rear.
