SINGAPORE ACCIDENT STATEMENT

Automobile Inspection Report

**EVALUATION REPORT (PAPER SURVEY) OF ACCIDENT VEHICLE NO: SJM 1845K
INSURED VEHICLE: SHD 9538R ACCIDENT DATE: 27/02/2018**

ADJUSTMENT ON REPAIR COST FOR VEHICLE NO. SJM 1845K

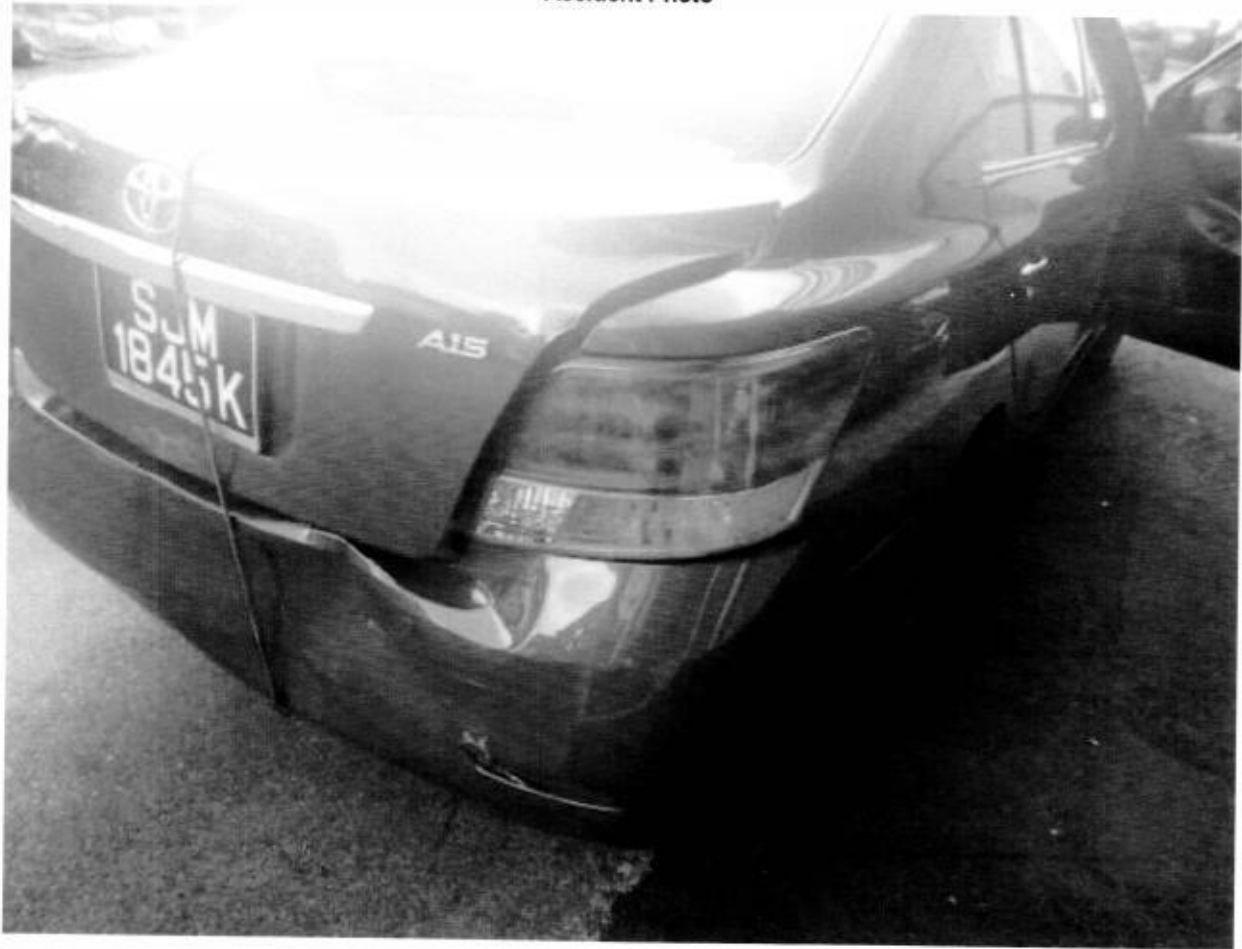
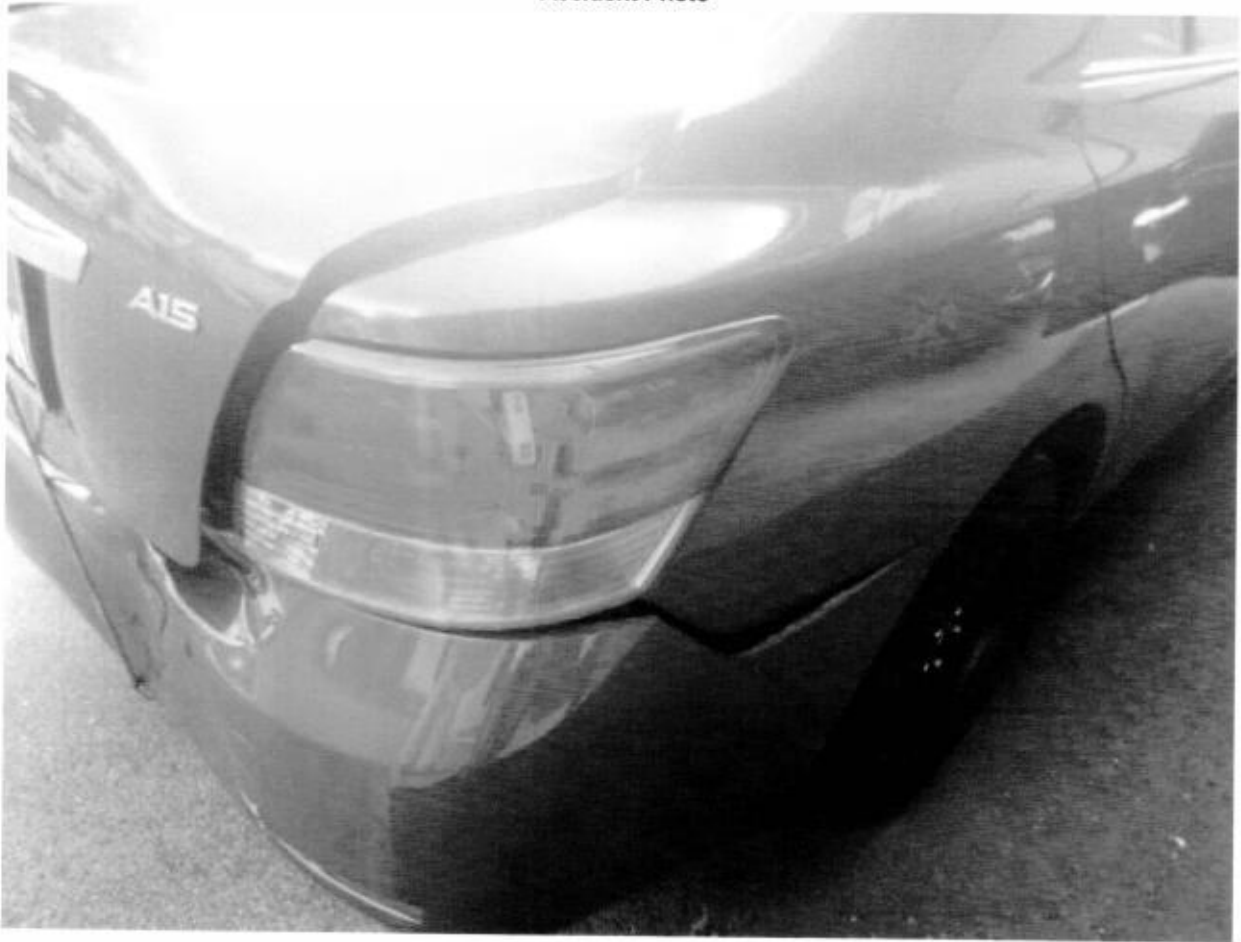
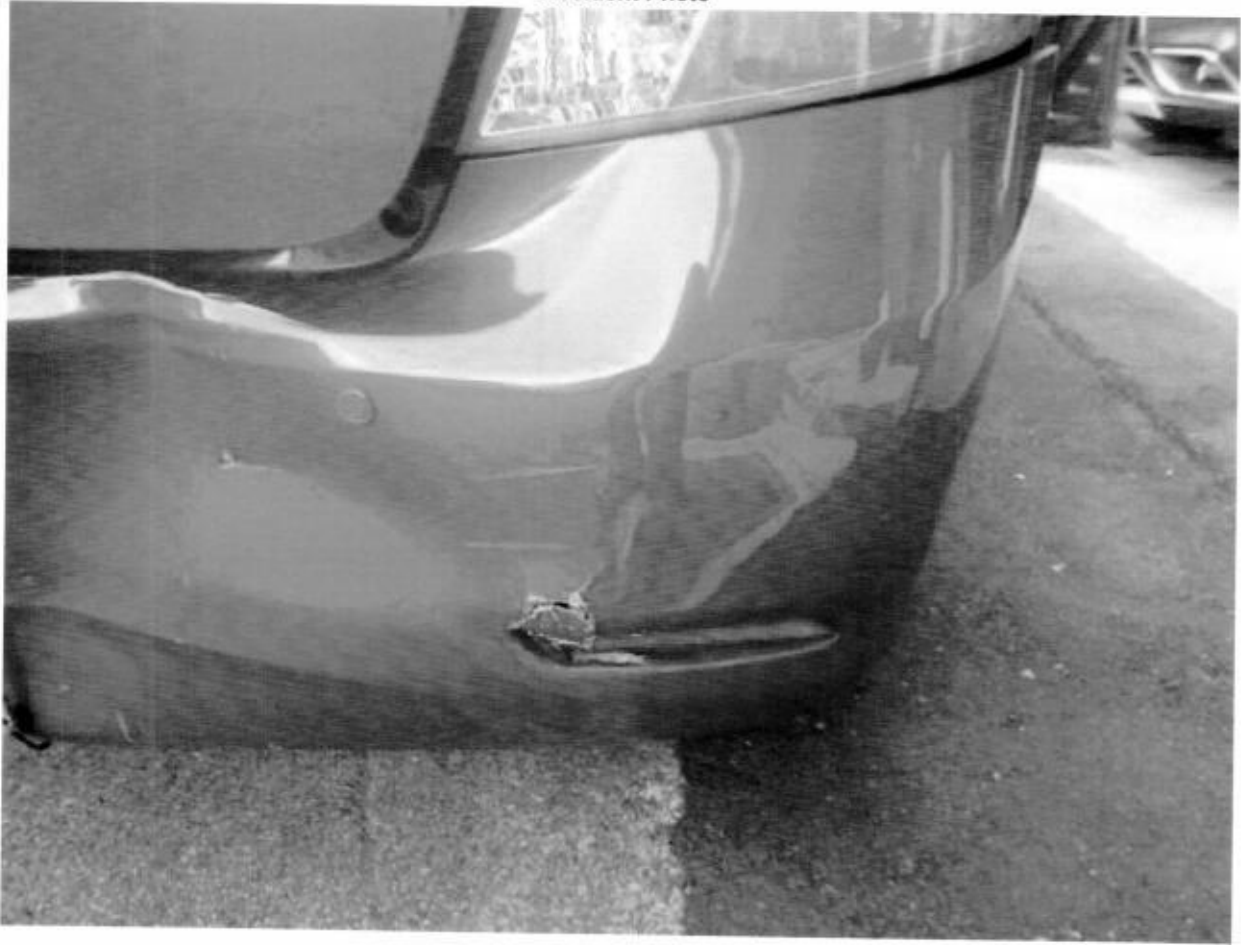
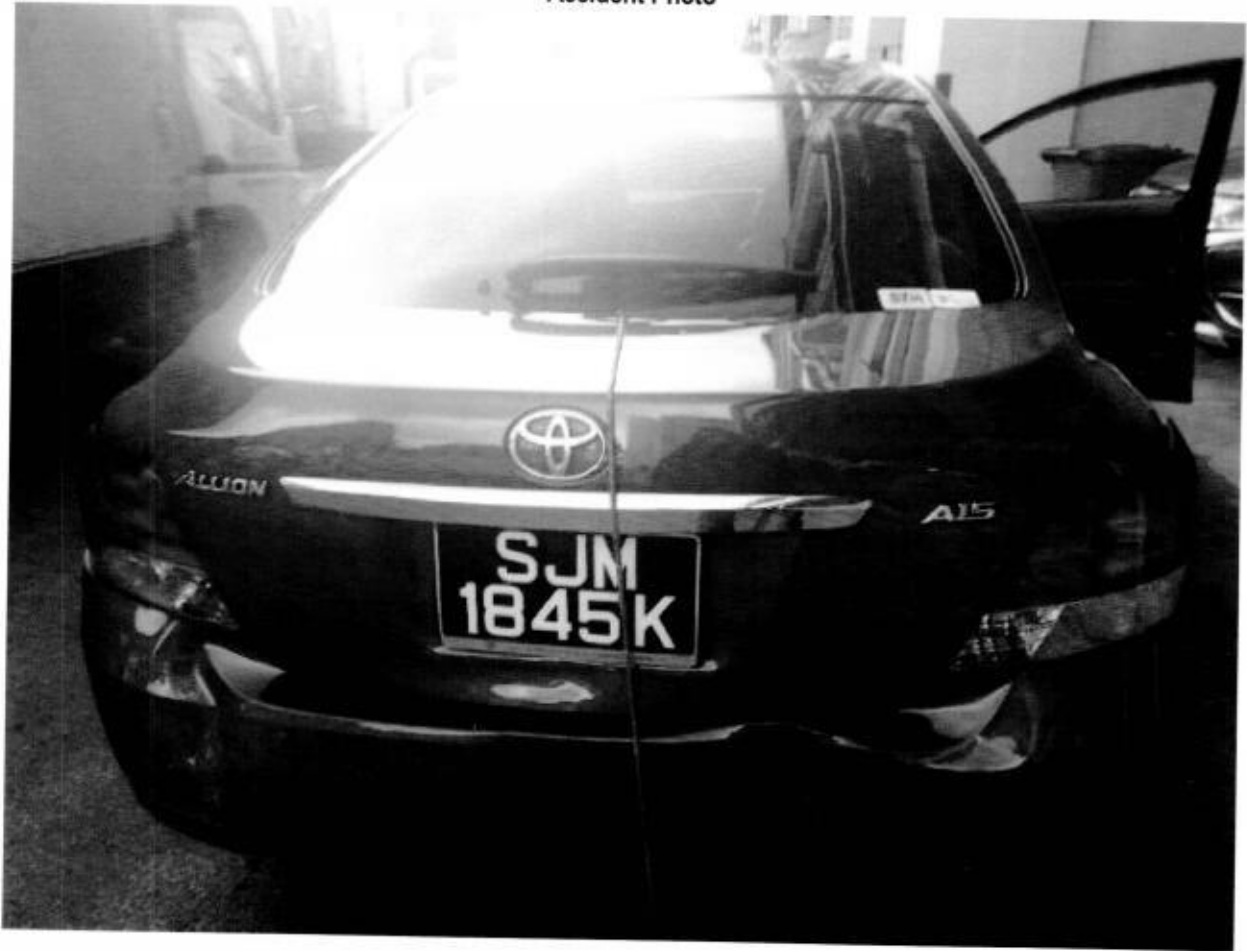
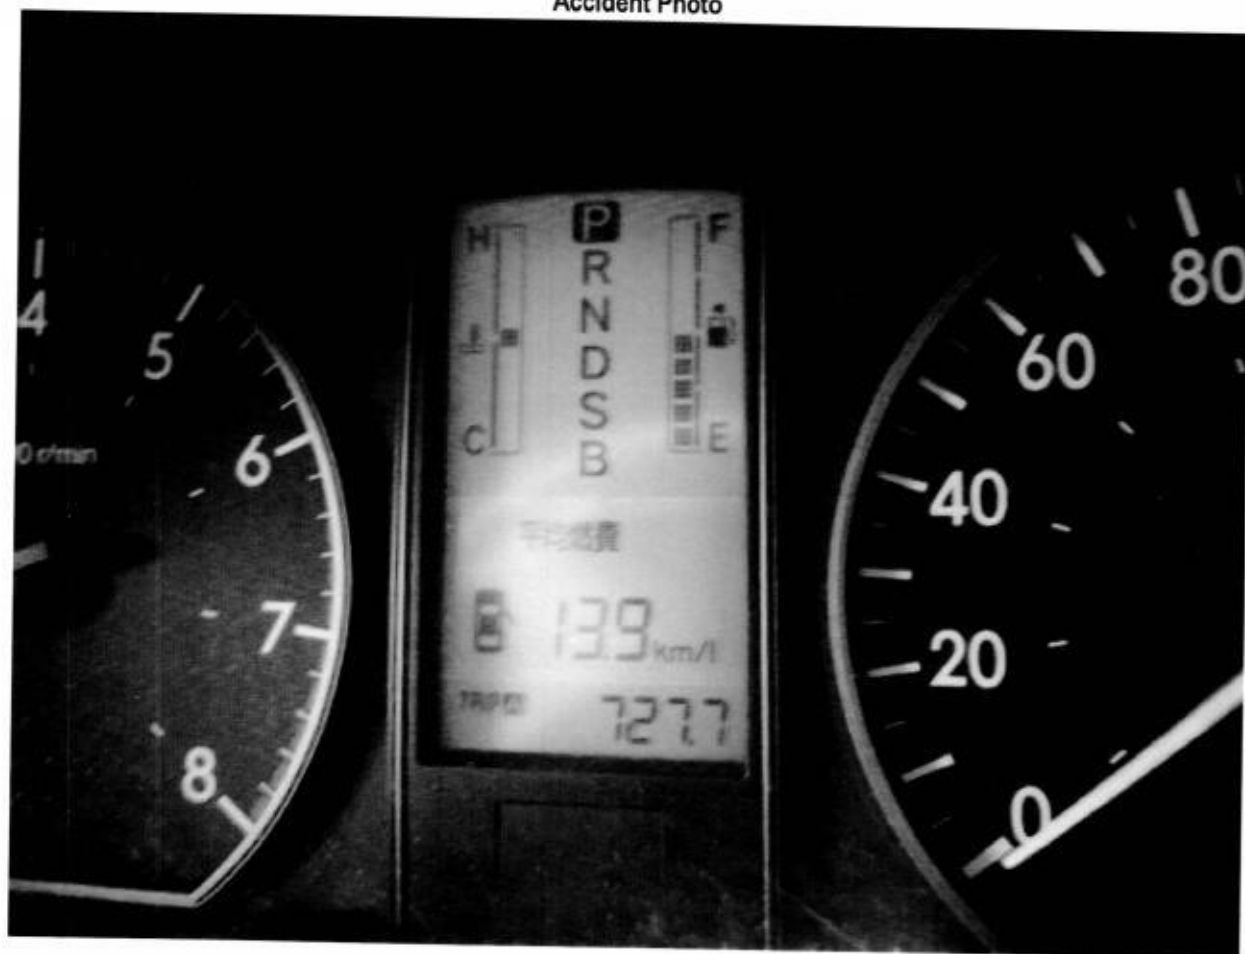
Accident Photo

On 27.02.2018 at about 2210hours, I was travelling straight on the extreme right lane along CTE towards Ang Mo Kio Avenue 1 when Vehicle B (SJM1845K) in front of me E-brake. I immediately apply brake to avoid collision but to no avail my taxi had hit onto Vehicle B's rear portion.
