**1. Policy Particulars :- THIRD PARTY CLAIM**

**4. Description of Damages**

THE VEHICLE SUSTAINED DAMAGES AT THE REAR PORTION. DAMAGES SEE DETAILS.
--

## ADJUSTMENT ON REPAIR COST FOR VEHICLE NO. SKD 2516P

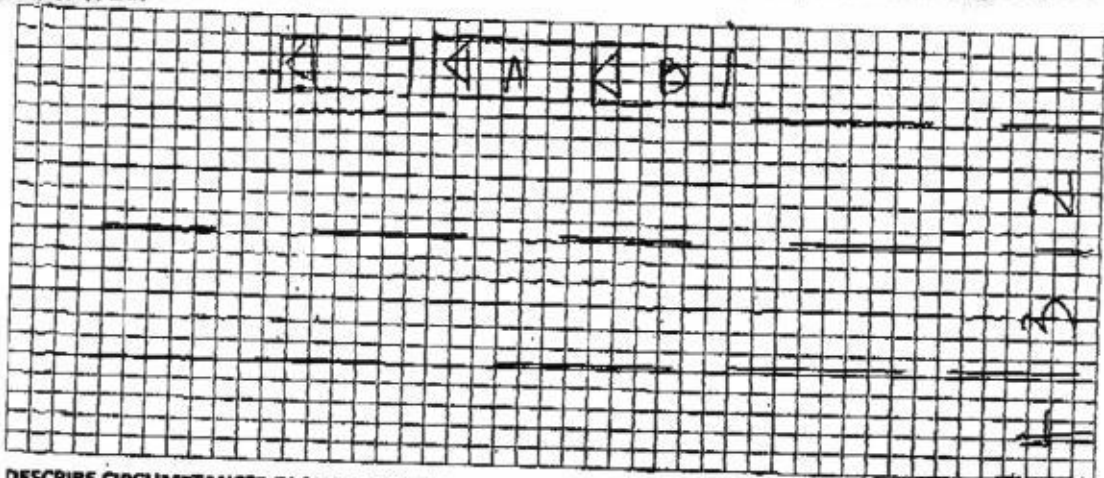
## SKETCH PLAN

On 27/3/19 at about 3:16pm, I was driving along PIE on the 1st lane. Vehicle in front of me came to a stop so I followed. Suddenly Car B cannot stop in time and hit the rear of my car.
