REF: NS/INC19005789/NSd3s2
INC

NTUC INCOME INSURANCE CO-OPERATIVE LTD Ref: NS/INC19005789/Nsd3s2	
73 BRAS BASAH ROAD #05-01 NTUC TRADE UNION HOUSESINGAPORE 189556	Date: 12-04-2019
	Code: INC4

THE VEHICLE SUSTAINED DAMAGES AT THE N/S FRONT PORTION. DAMAGES SEE DETAILS.

ADJUSTMENT ON REPAIR COST FOR VEHICLE NO. SH 6453U

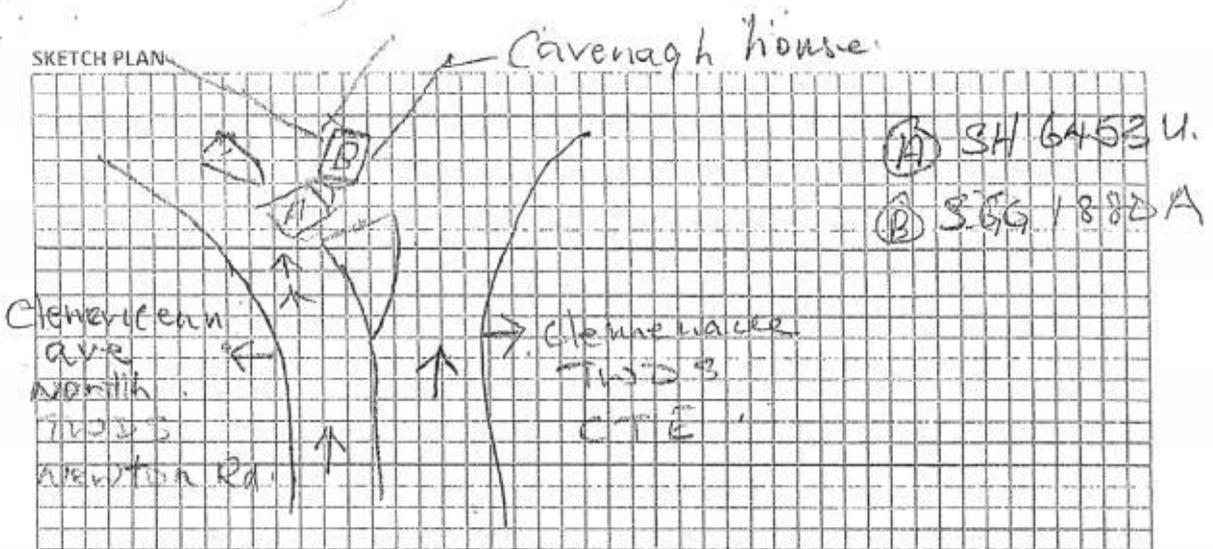
Sketch Plan Pg. 2

On 29/3/2019 at about 2215 hrs, I vehicle A was driving my taxi along Clemenceau North making a U turn. Vehicle B didn't stop at the stop line and he dash out from Cavenagh house collided onto vehicle A left front portion. No one was injured at that time.

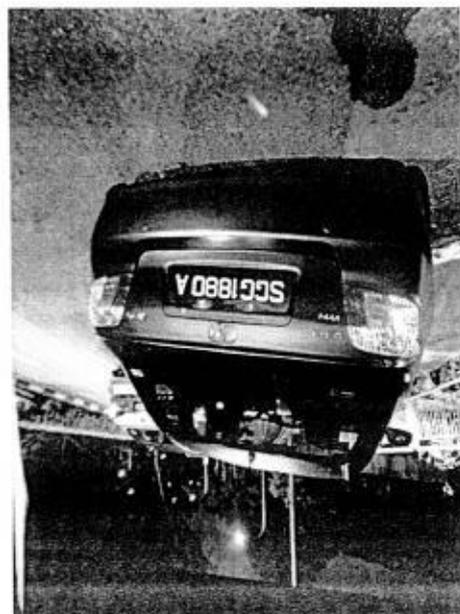
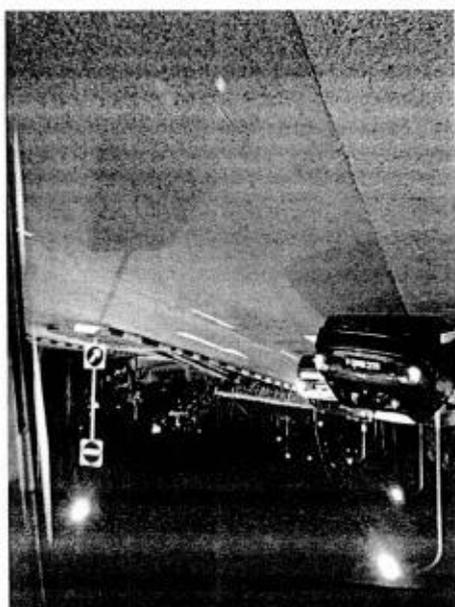
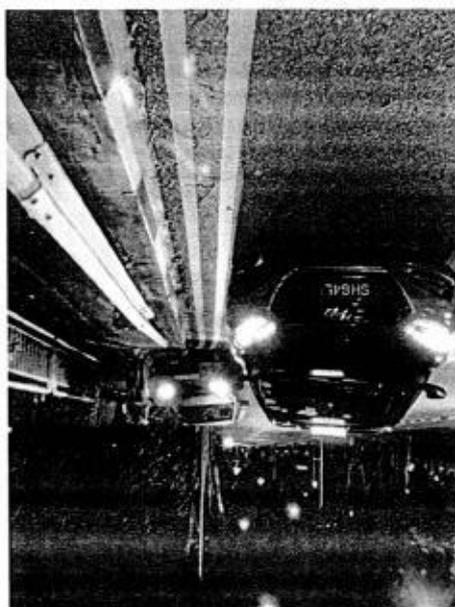
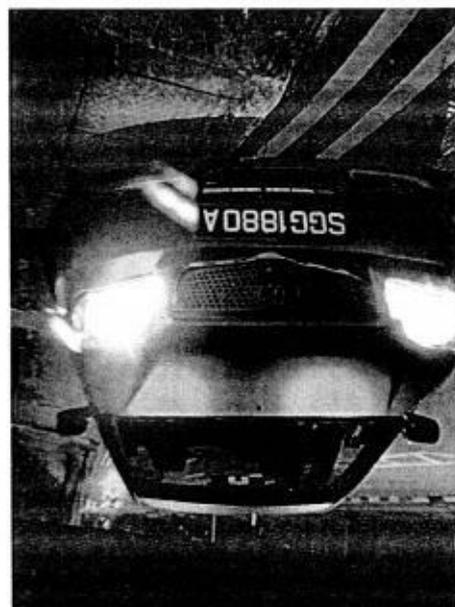
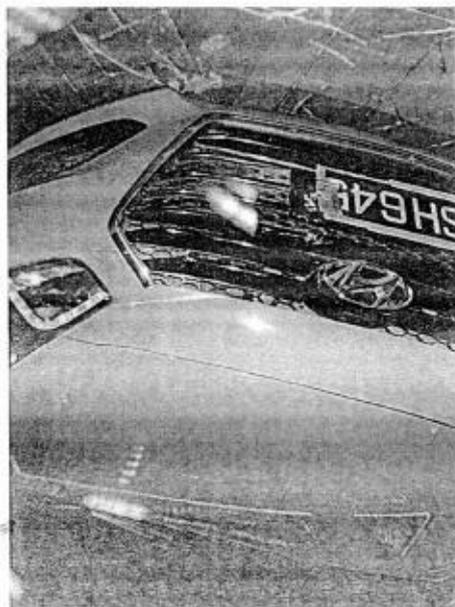
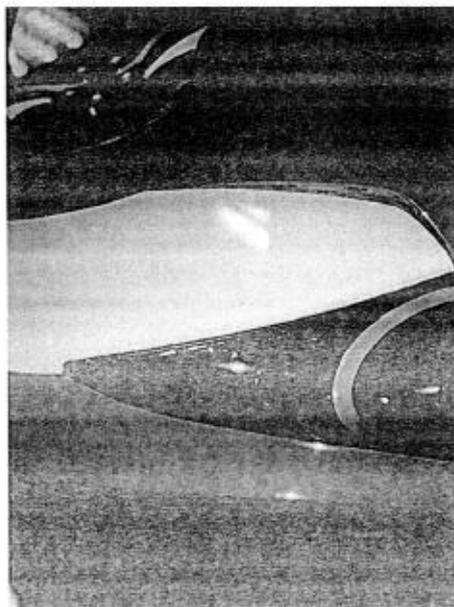
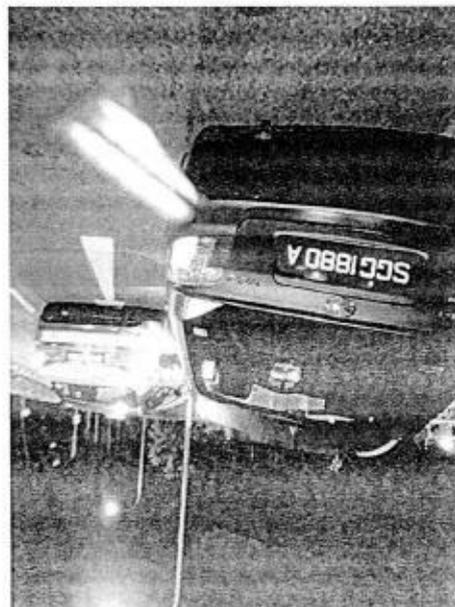
Qty	Description of Parts	Condition	Estimate By Workshop (\$)	Our Adjusted (\$)
<u>REPLACEMENT OF PARTS</u>				
1	RADIATOR GRILLE	CRACKED	1,110.10	1,110.10
1	FRONT BUMPER COVER	CRACKED	1,052.20	1,052.20
1	FRONT BUMPER SPONGE	SERVICEABLE	99.20	-
1	FRONT BUMPER REINFORCEMENT	SERVICEABLE	402.10	-
2	FRONT BUMPER BRACKET TOP (LH/RH) @ \$22.40	SERVICEABLE	44.80	-
2	FRONT BUMPER BRACKET (LH/RH) @ \$24.60	SERVICEABLE	49.20	-
1	HEADLAMP SUPPORT PANEL ASSY	SERVICEABLE	907.40	-
1	HEADLAMP (LH)	CRACKED	1,388.00	1,388.00
1	FRONT FENDER (LH)	DEFORMED	566.30	566.30
	LESS 20% DISCOUNT		-1,123.86	-823.32
			4,495.44	3,293.28
<u>NETT ITEMS</u>				
1	FRONT NUMBER PLATE (N)	MISSING	25.00	25.00
1	FRONT NO. PLATE TRIM COVER (N)	CRACKED	30.00	30.00
	LESS 10% DISCOUNT		-	-5.50

RECOMMENDED COST OF LUMP SUM REPAIRS (TO ITS PRE-ACCIDENT CONDITION) (CONFIRMED)			3,700.00
--	--	--	----------
