From: Veron Chen (LKKAuto)
Sent: Friday, 5 April 2019 10:23 AM
To: SUR; motorclaims@tokiomarine.com.sg
Subject: DIRECT SURVEY INSPECTION ON WORKSHOP -COMFORTDELGRO ENGINEERING PTE LTD, DOA: 3/4/2019, SHD 3358H (TP VEHICLE), YN 7339H (OI VEHICLE)

VEHICLE DAMAGE INSPECTION REPORT

Our File No: CC3/TMI19006010/K1VD3N2

Handling Insurer:	Tokio Marine Insurance Singapore Ltd	Policy No:	MG001256
Claimant Vehicle No :	SHD3358H	Insured Vehicle No :	YN7339H
Date of Loss:	03/04/2019	Nature of Claim:	TP
		Claim No:	M1902297

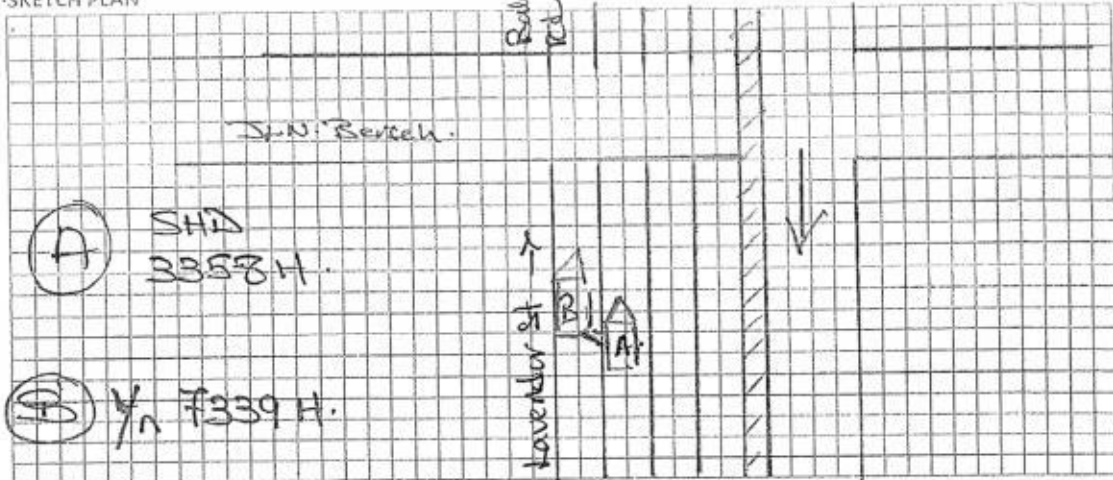
SKETCH PLAN

ON 3 April 2019 ^{1930hr} I Vett A stop
at the 3rd lane B4 Traffic Light.
Suddenly Vett B was on 4th lane.
the movement Vett B pass Vett A,
Vett B truck Cabin Rear Right Door
was unlock and open and hit Vett A
left wing mirror. at the point
of accident Vett A ferry 2 pax wat.
Injured.

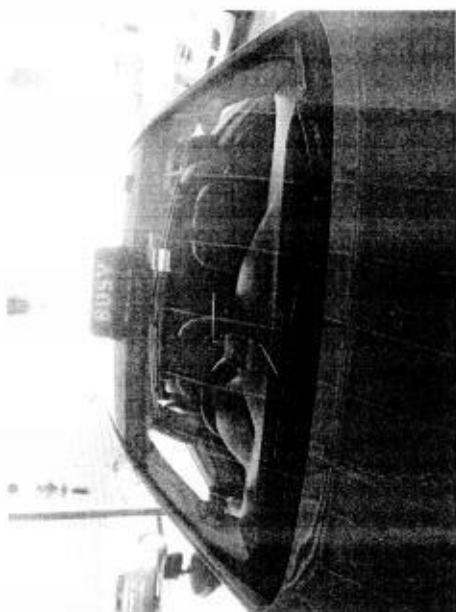
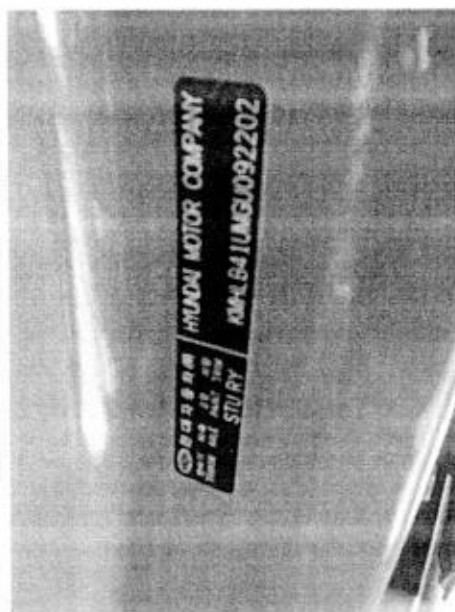
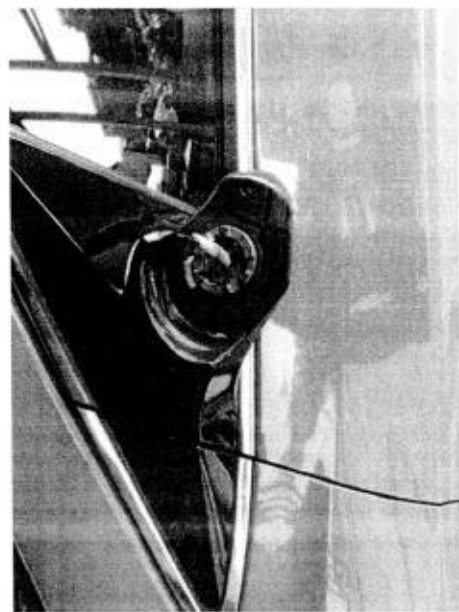
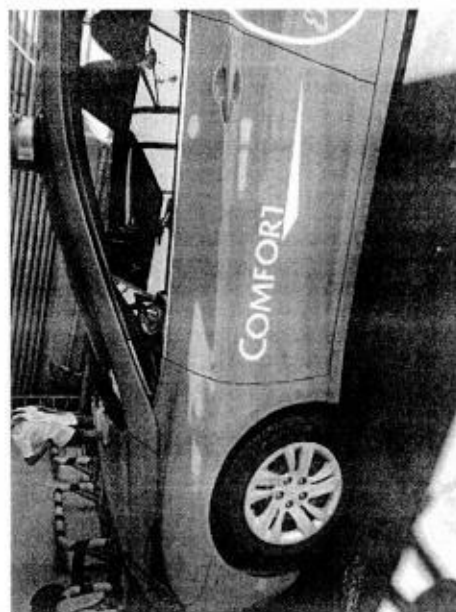
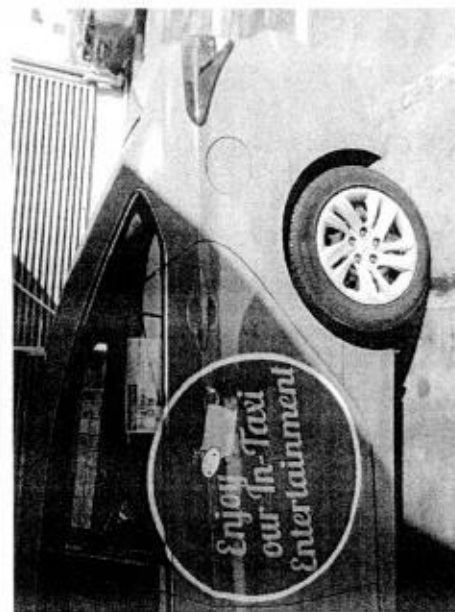
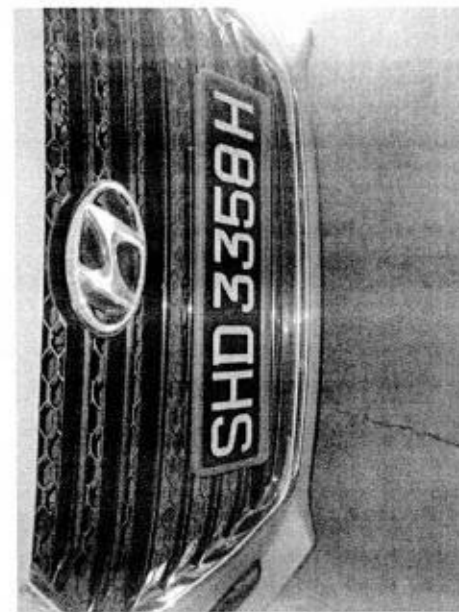
Veh No: SHD 3358H Yr Regn: 21/4, 2016
 Type: M/Car / M/Cycle / Bus / Van / Lorry / T/ / Prime Mover /
 Truck / Trailer or
 Make: Vauxhall Z40 cc: 1685
 Colour: Blue A/C: Insured / Std / Nil / NA
 Sp. Reading: 348454 T/Radio: Insured / Std / Nil / NA
 Eng/No: _____
 C/No: KMHLBx1m640 92202
 Gen. Cond: Good / Fair / Poor / Burnt
 Steering: In order / Jammed / Leaked / Burnt or
 Brake: In order / Jammed / Leaked / Burnt or
 Modi: Nil / S/Rim / STD / R/Rim or
 Tyre Size: F: 205 / 60 R16
 R: _____
 BS / DUN / EXNOVA / GY / FS / LIZA / MIC / OHTSU / PIR / SUMI /
 TOYO / YOKO or Camper
 Front: _____ Rear: _____
 R/Bal. 6 mm R/Bal. 6 mm
 L/Bal. 6 mm L/Bal. 6 mm
 D.O.A. 3/4/19 D.O.I. 4/4/19
 Survey held at CDHE (Loyang)
 Des. of Damages: Frt / Rear / O/S / N/S / U/C / Roof/Top or
1/3 wing mmr
 The U/C & Chassis frame / Body Structure affected due to collision.

No.	Qty	Part No.	Particulars	%Disc	%Depr	Amount
1	1		*SIDE MIRROR - LH <i>Broken</i>	20.00	0.00	*670.00 FL
						<i>Front LH window pillar repair</i>
						Sub Total (\$\$)
						670.00
						- List Item Discount on L Items (\$\$)
						134.00
						Total Parts (\$\$)
						536.00

No.	Qty	Part No.	Particulars	Condition	Repairer's	Amount
1	1		*SIDE MIRROR - LH	Broken	670.00 FL	*670.00 FL
2	1		*FRONT LH WINDSCREEN PILLAR (NPA)	Repair	-	*- FL
F=Franchise part. L=ListItemDisc.						
Sub Total (S\$)					670.00	670.00
- List Item Discount on L Items 20.00/20.00% (S\$)					134.00	134.00
Total Parts (S\$)					536.00	536.00

No	Particulars	Lab.Type	Repairer's	Amount
<u>Labour Items</u>				
1	LABOUR	New	100.00	100.00
2	SPRAY PAINTING	New	100.00	50.00
3	WIRING CHARGE	New	30.00	20.00
<u>Supplementary #1</u>				
<u>Labour Items</u>				
4	PANEL BEATING - REPAIR FRT WINDSCREEN PILLAR - LH	New	200.00	100.00
5	SPRAY PAINTING FRT WINDSCREEN PILLAR - LH	New	200.00	200.00
Gross Labour Cost (S\$)			630.00	470.00
