**REPORT OF A TRAFFIC ACCIDENT**

### VEHICLE INSPECTION REPORT

Registration Number	: GW 6046 A	Odometer Reading	: 432 660 Km
Make/Model	: Toyota Dyna 150D	Radio/Cassette/CD	: Fitted
Year of Manuf/Reg	: 2003	Air Conditioner	: Fitted
Engine Number	: 5L5358379	View Mirrors	: Fitted -C/S & n/s
Chassis Frame Number	: JTFUF34Y403001563	Seat Belts	: Fitted -Front only
Class/Type	: Lorry ( Metal Body )	Other Accessories	: (Specify)
Colour	: Metallic Silver

**EVALUATION REPORT (PAPER SURVEY) OF ACCIDENT VEHICLE NO:  
GW 6046A INSURED VEHICLE: SGF 3898S ACCIDENT DATE: 31/07/2018**

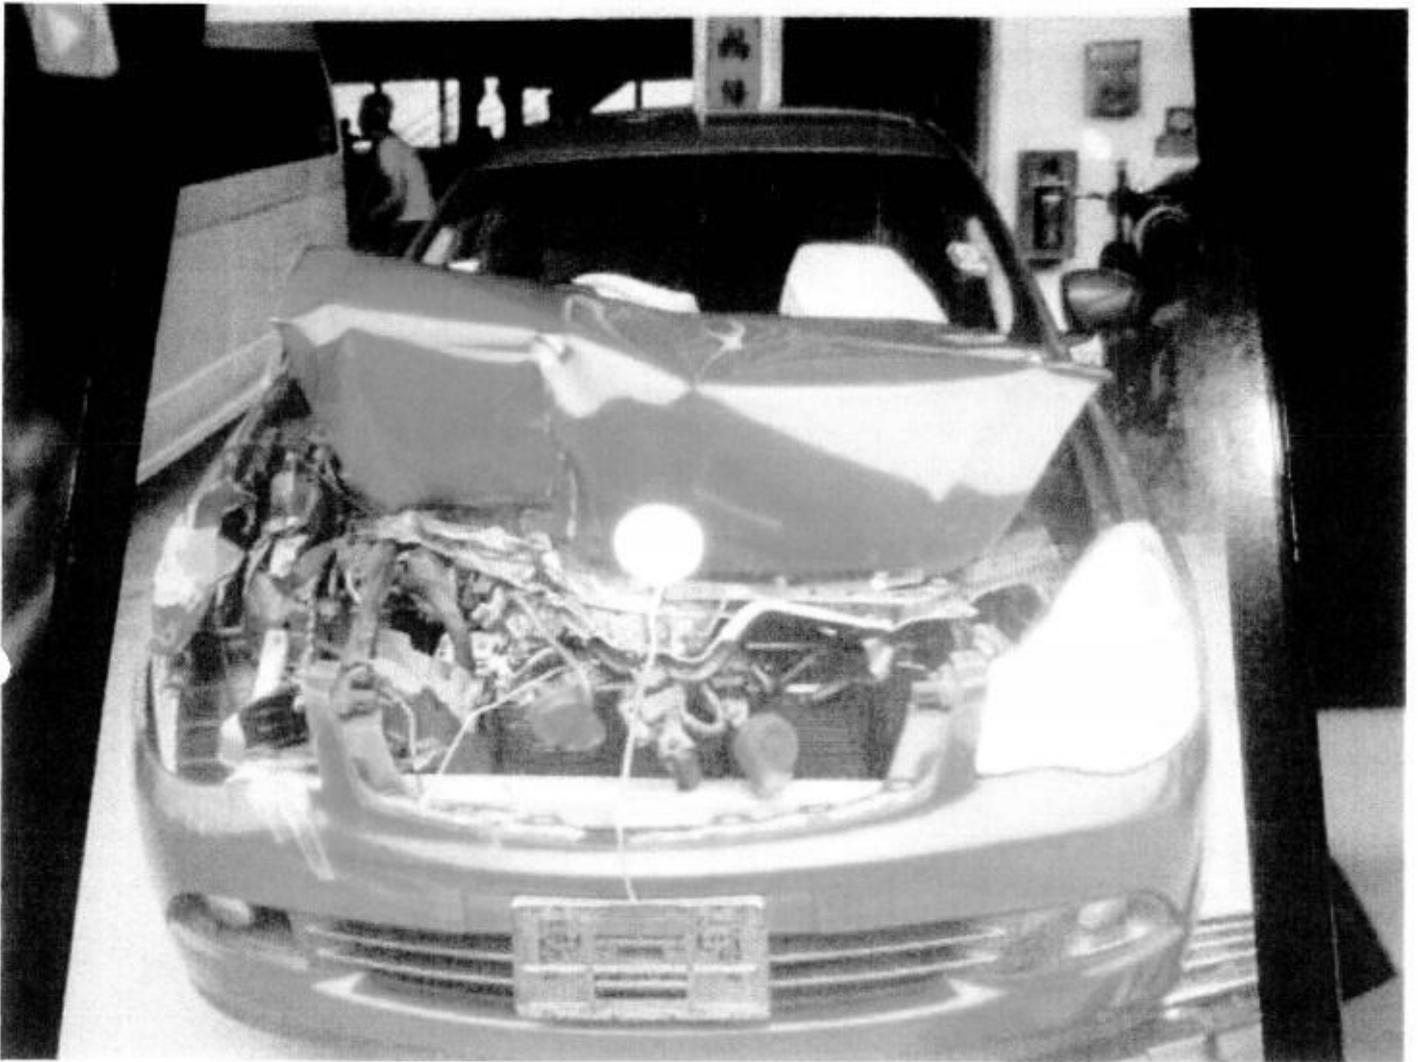
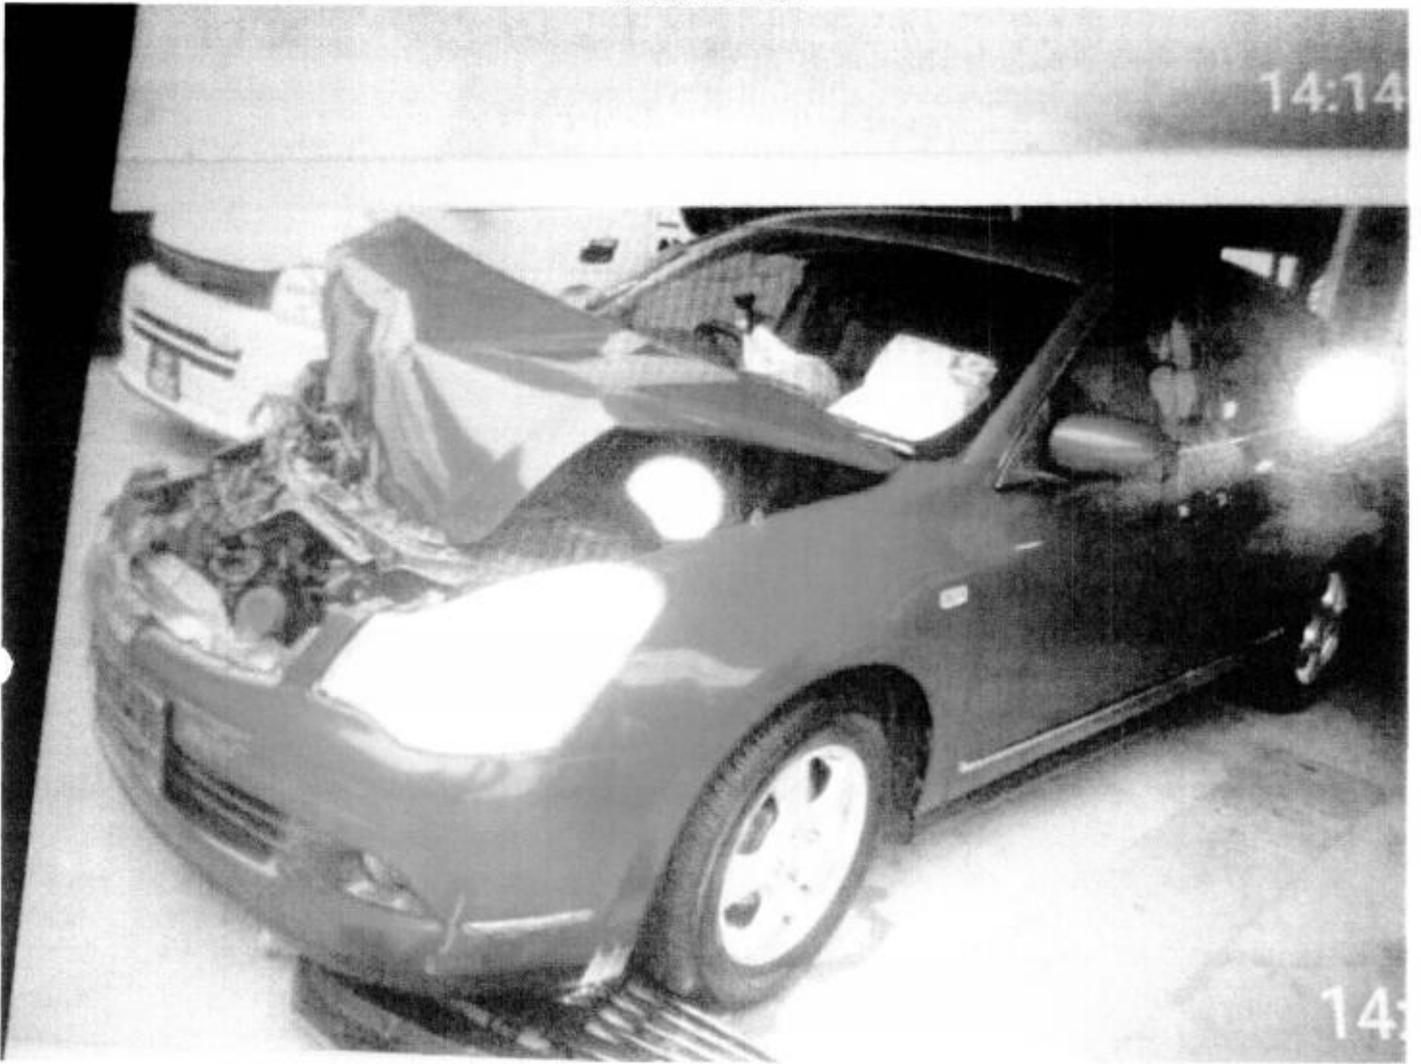
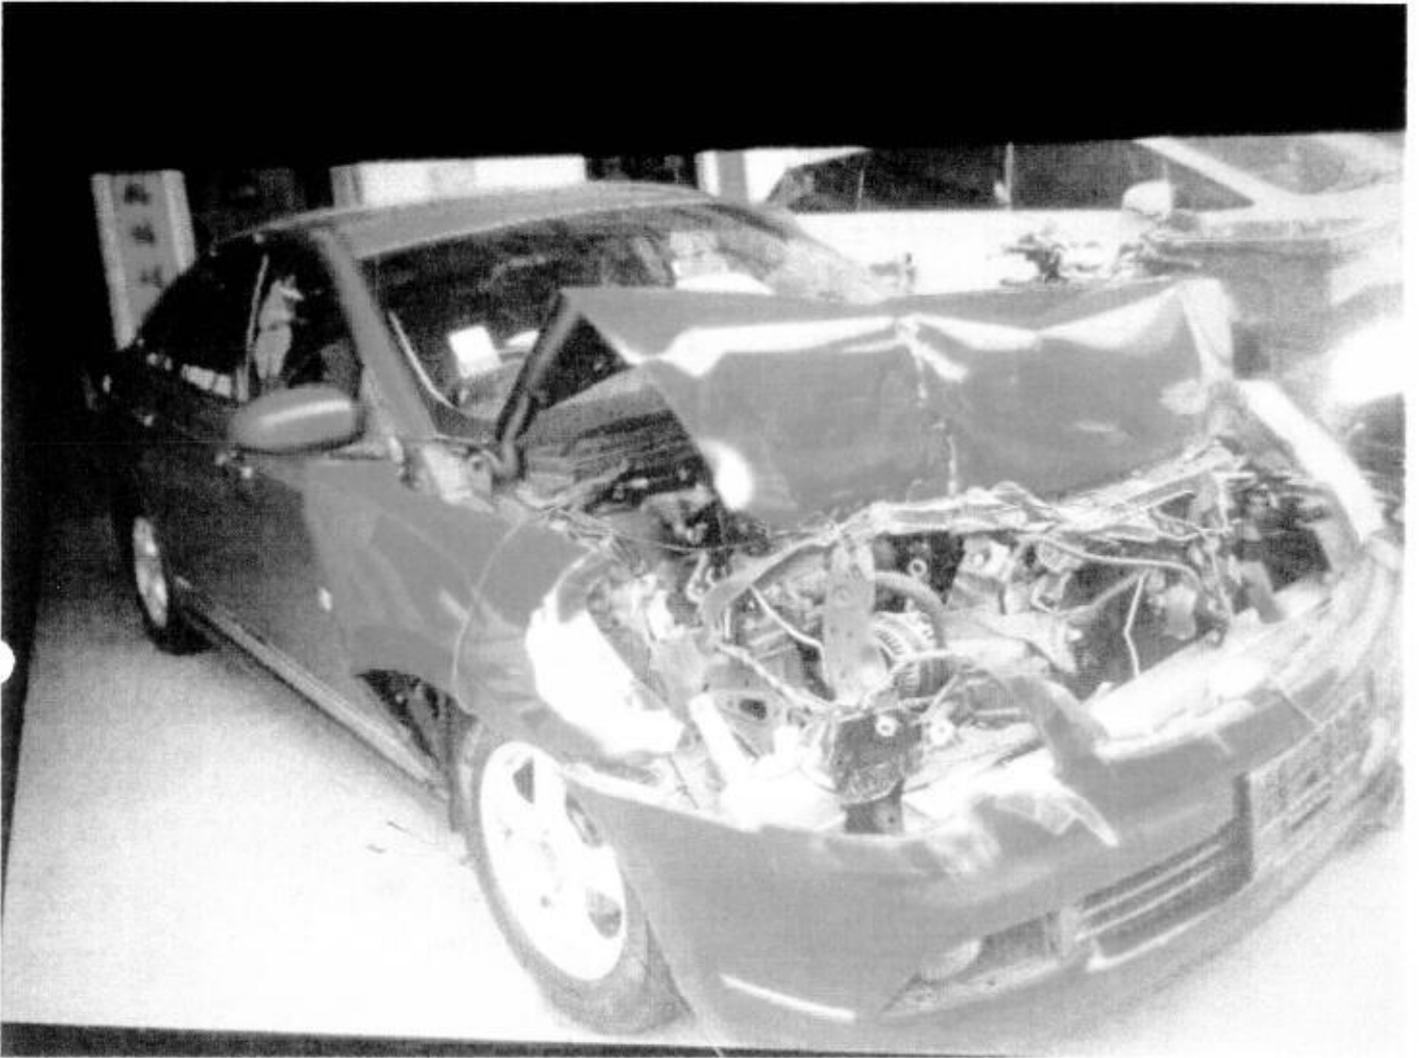
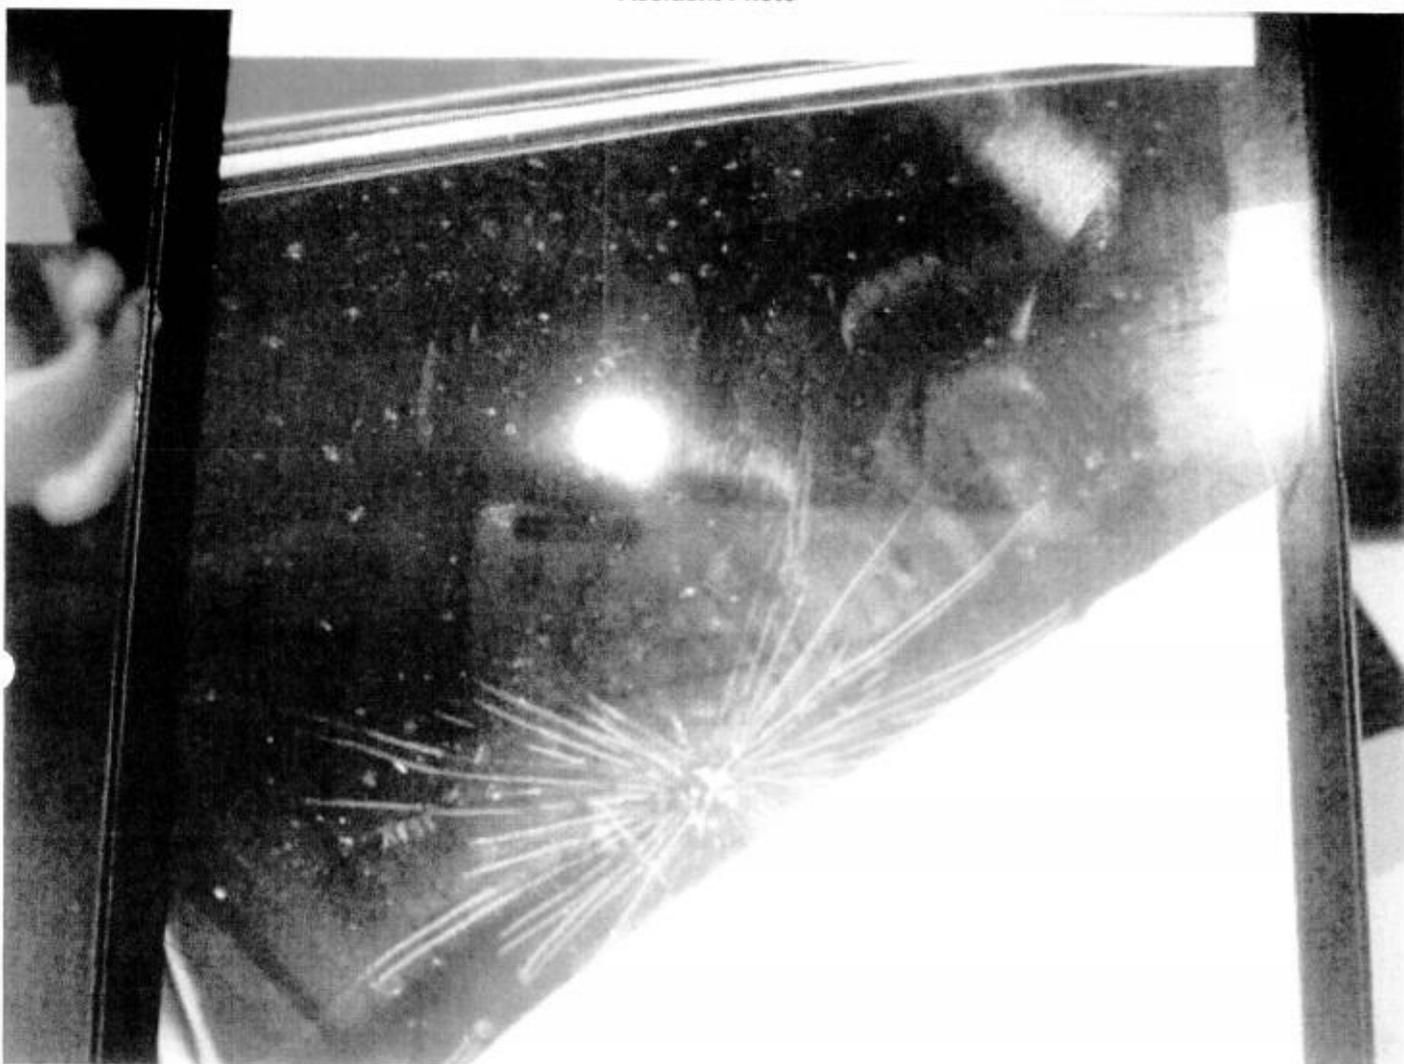
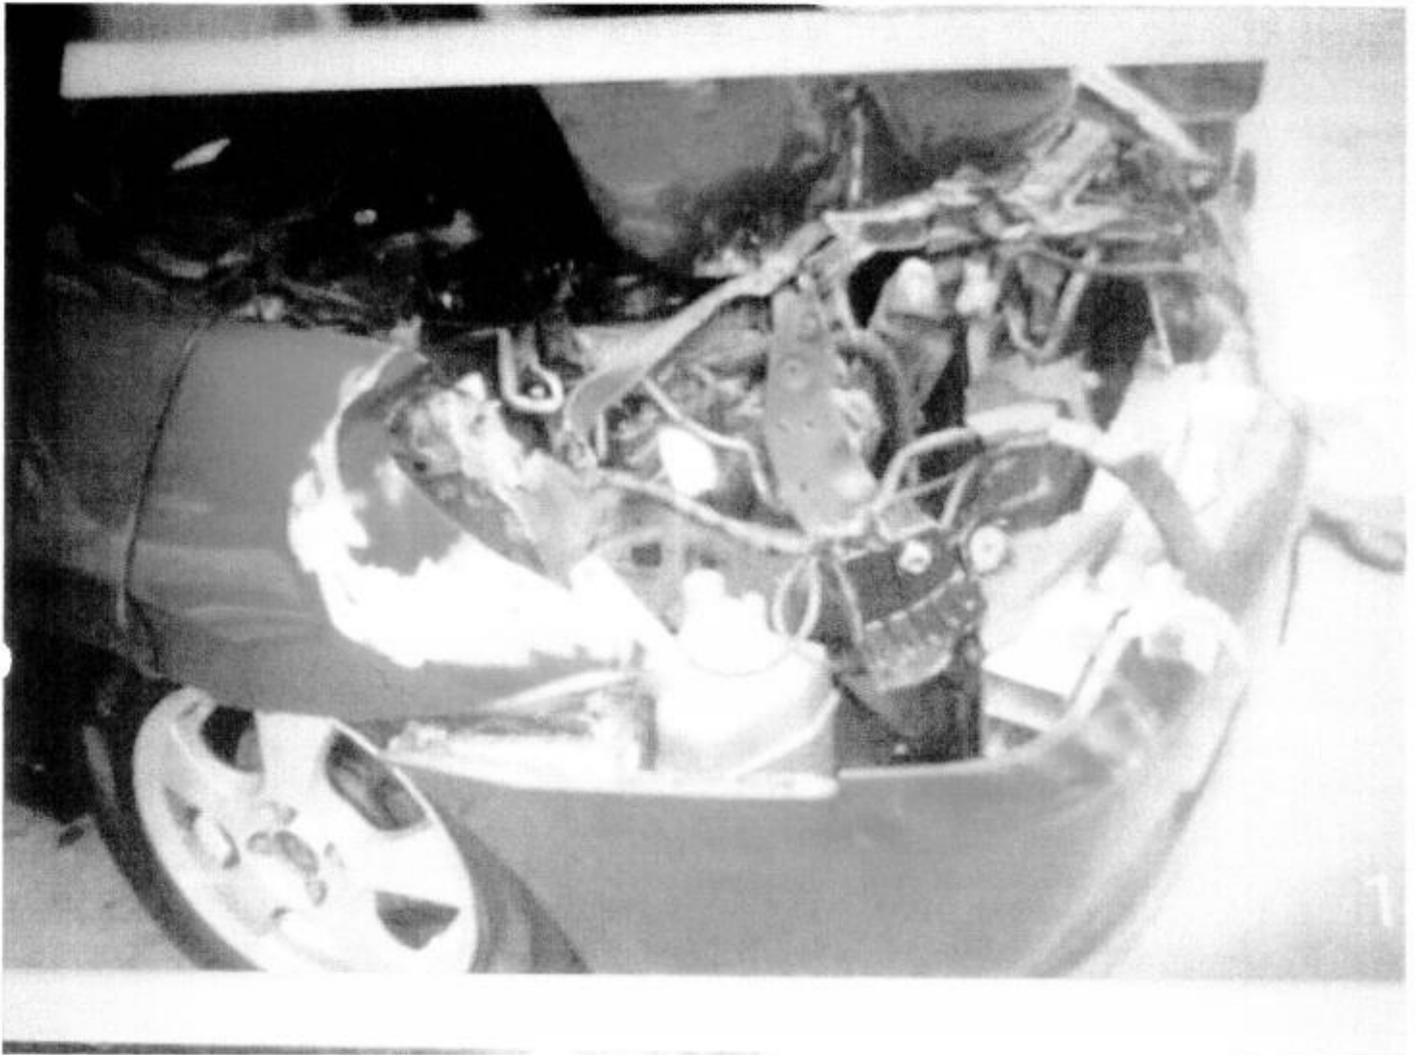
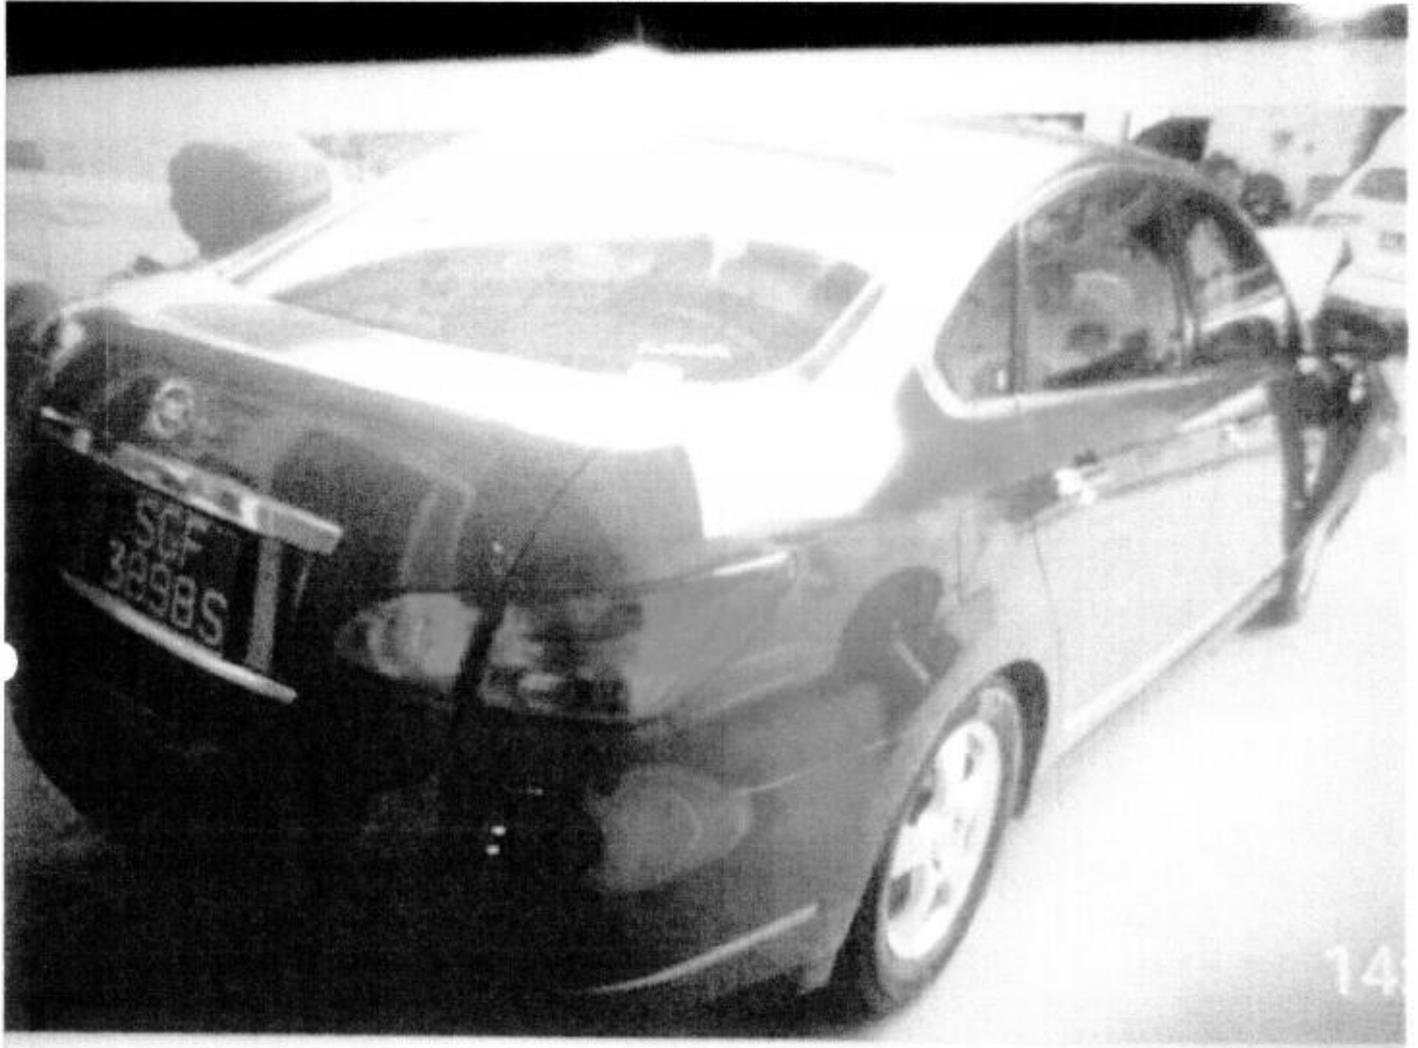
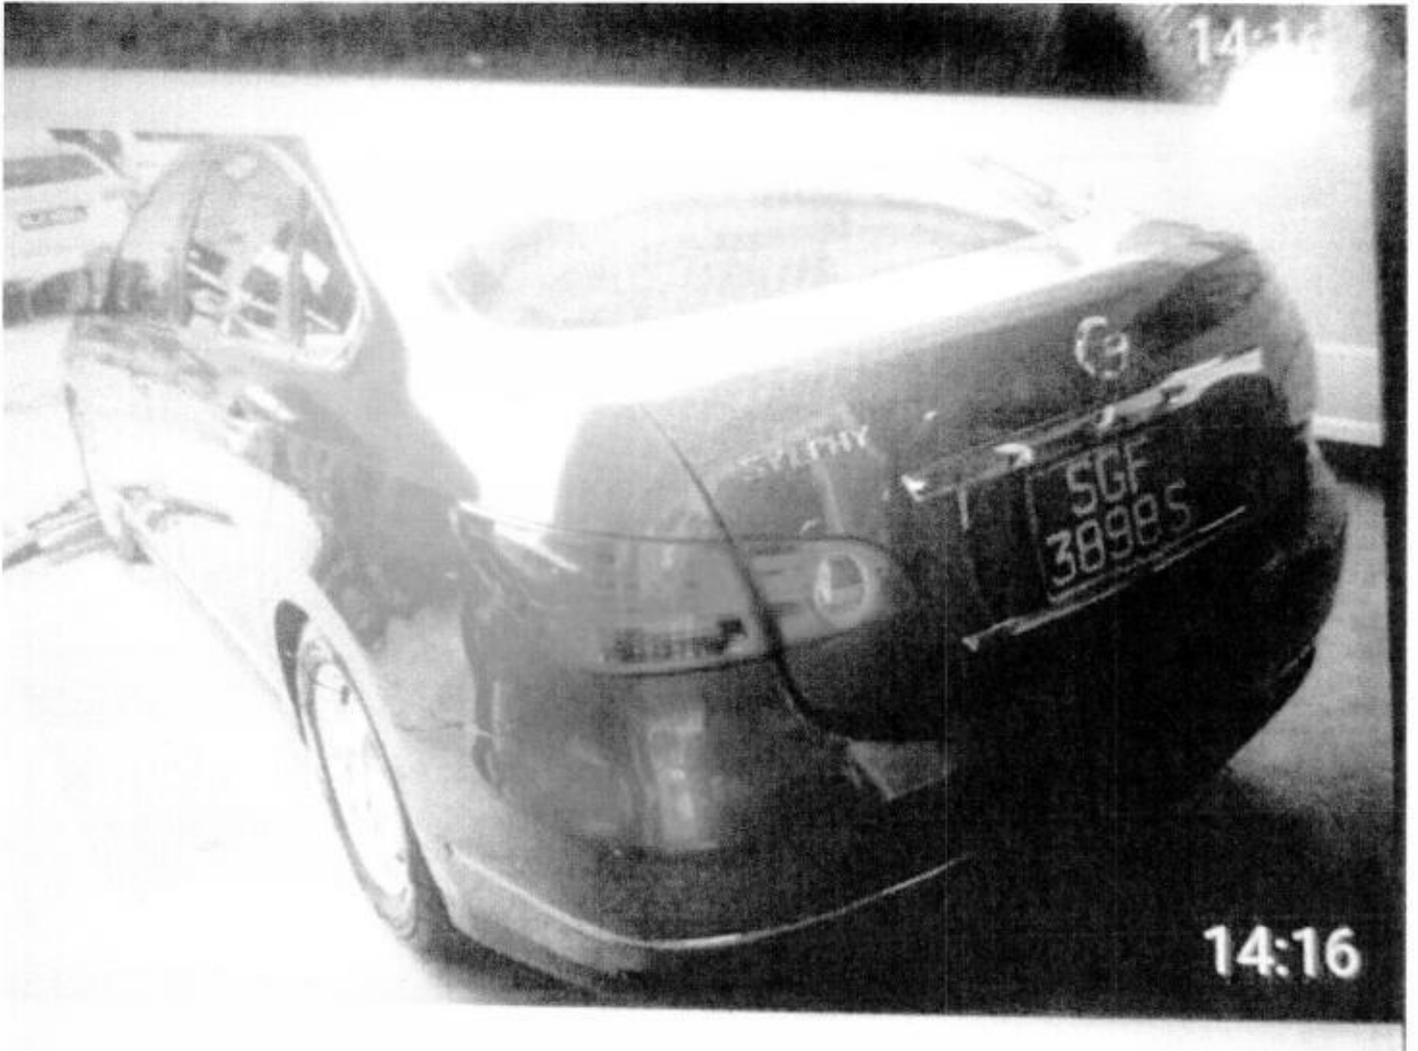
Accident Photo

On 31/07/2018 between 1200-1230hrs along Sungei Kadut Avenue heading towards Choa Chu Kang Way, I was driving my car (SGF3898S) and following behind a lorry (GW6046A). As the Lorry driver did not signal and show his intention that he is going to make a right turn into one of the compound (Thong Huat Bros) 4 Sungei Kadut Avenue, S729641. I am unable to stop in time and knocked onto the lorry rear.

My car front bonnet is badly damaged.

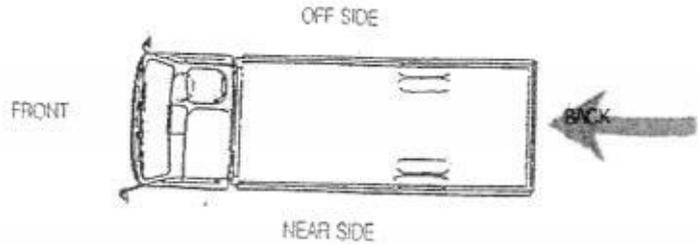
### IMPACT OF VEHICLE

Direction of Impact (←→)

Damages sustained were consistent with the subject vehicle being involved in a collision with another vehicle and the impact was delivered onto the rear n/s portion of the vehicle.
