**Preliminary Advice**

**Point of Impact / General Description of Damages**

## REPAIR ESTIMATE FOR SLL3222B MINI COPPER S HATCHBACK

## VEHICLE DAMAGE INSPECTION REPORT

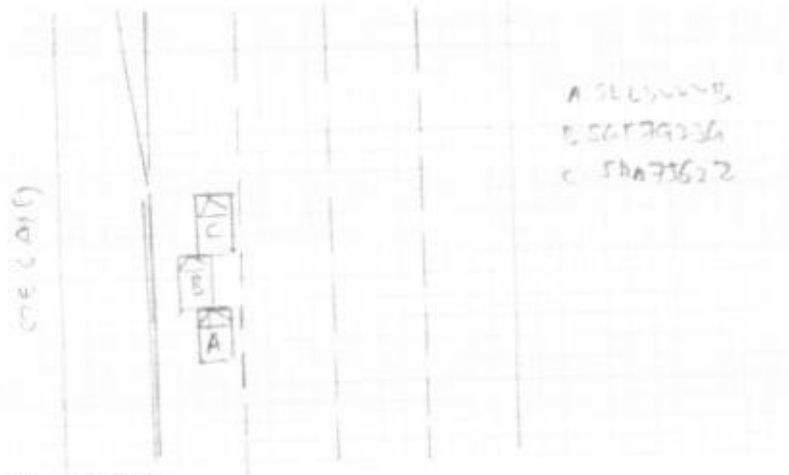
## SKETCH PLAN

ON STATED DATE AND TIME, I WAS TRAVELLING ALONG THE STATED VENUE. SUDDENLY VEHICLE B JAMMED BRAKE, I COULDN'T BRAKE MY VEHICLE IN TIME AND HIT ONTO VEHICLE B REAR PORTION.
