PRE-REPAIR INSPECTION REQUEST – SFT8199G vs SLT2187J (OI) on D.O.A.: 03/04/2019

## VEHICLE DAMAGE INSPECTION REPORT

Our File No: CS/AIG19006156/KVD3N2

Handling Insurer: AIG Asia Pacific Insurance Pte. Ltd. Policy No:  
 Claimant Vehicle No: SFT8199G Insured Vehicle No: SLT2187J  
 Date of Loss: 03/04/2019 Nature of Claim: TP Claim No: 1302474942SG

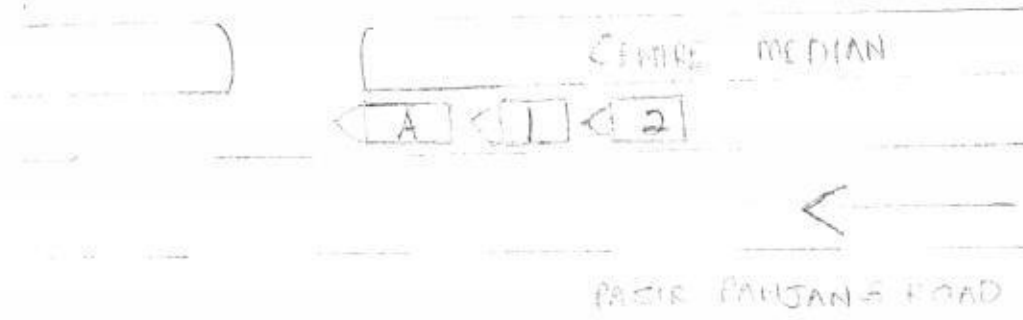
## SKETCH PLAN

A - SET 8199G  
I - SET 2877  
2 - SPWA 4623R

At about 10:45am on 3/4/19, while I was driving SET 8199G along Pasir Panjang Road by the Pagar on lane 1, vehicle number SET 2877 hit my car from multiple impact. It takes a while for me to get out from my car because of the hard impact and shocked. Some time from my car I noticed it was a chain collision involving 3 vehicles (As shown in the sketch plan). Eventually, police and ambulance came and the police call made by the driver of SET 2877.
