## ASSIGNMENT

To Inspect Vehicle No: Ru 6828Mat Workshop m/s MPH

## 1. Policy Particulars :- THIRD PARTY CLAIM

## ADJUSTMENT ON REPAIR COST FOR VEHICLE NO. RU 6829M

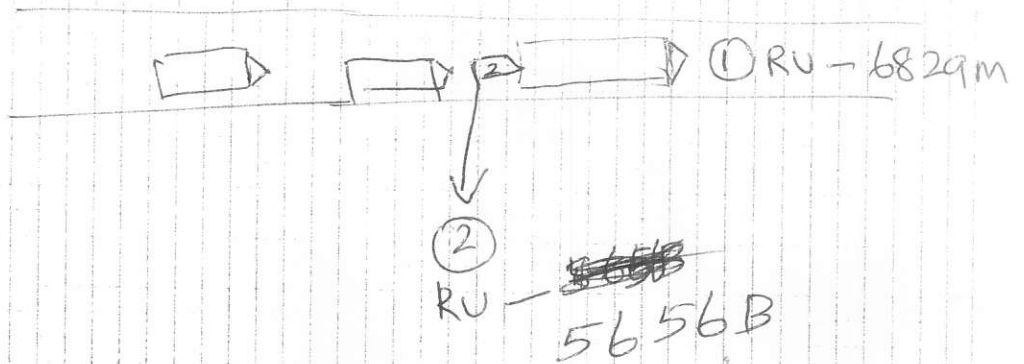
Changir Airport.

DESCRIBE CIRCUMSTANCES OF THE ACCIDENT

When I am going to pick up passenger from AI to A5 Area That time Sats van RU 5656B hit my RU Van 6829m Back side, was damage
