RE: ACCIDENT INVOLVING VEHICLE NO: SKS 6915 R
VEHICLE MODEL: Audi A6 C7 2.0
LOCATION: TAMPINES ROAD
DOA: 7TH APRIL 2019

Preliminary Advice

Vehicle No	: SKS6915R	Accident Date	: 07/04/2019
Make	: AUDI A6	Policy No.	: 2100411170-03
Assignment Date	: 10/04/2019	Excess	: S\$0.00
Date of Inspection	: 09/04/2019	Est. Duration of Repair	: -
Inspection At	: Premium Automobiles Pte Ltd (UBI) 55 Ubi Road 1 Singapore 408699

VEHICLE DAMAGE INSPECTION REPORT

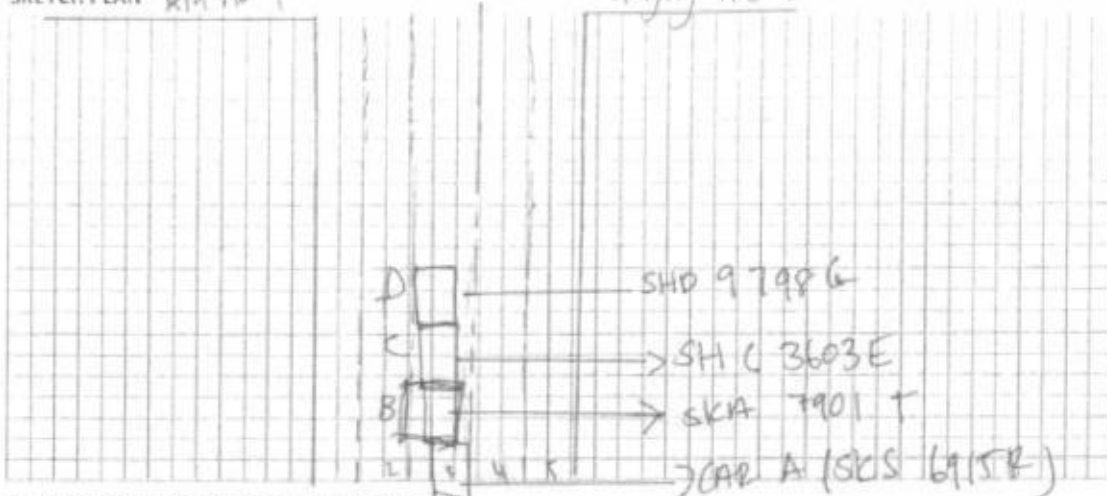
SKETCH PLAN *Depth Ave 1*

On 07/04/2019 at about 1645hrs, I was driving my car SKS6915R along Tampines Road. While driving, I dozed off without realizing. Suddenly I felt an impact and my airbags were activated. Until the car came to a stop, I went out to check. I had collided onto a car SKA7901T. The impact caused that car to hit onto 2 other taxis SHC3603E and SHD9798G.

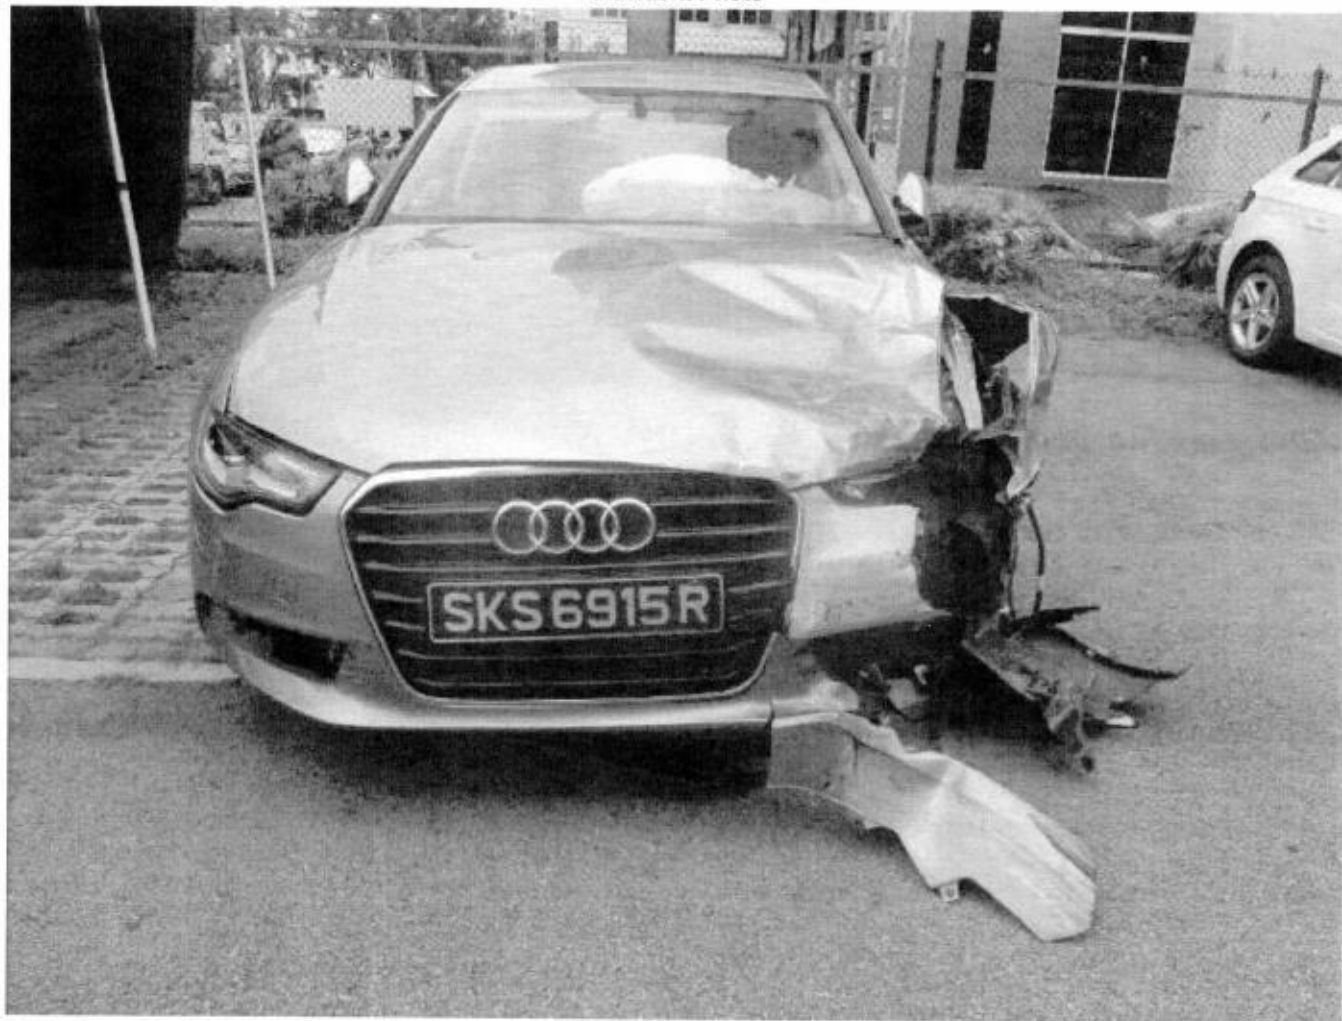
Accident Photo

The accident has caused structural damages including unconfirmed items. The damages incur onto the whole frontal portion, front windscreen, suspension system, and air bag system which estimated to be \$85,894.00.00 for parts.

The vehicle sustained impact / damages front portion and parts claimed are consistent to the accident.

In view of the above, the vehicle is uneconomical to be repaired, you are advised to invite tender
for the wreck.
