**-PRE-REPAIR INSPECTION - ACCIDENT INVOLVING OUR INSURE...**

**THIRD PARTY SURVEY  
ACCIDENT HAPPENED ON 9 Apr 2019**

As per your instruction dated **11 Apr 2019** with regard to the above matter. We have carried out a physical inspection on the said vehicle **SKK 1248 H**. We enclosed herewith our report and findings as follows:

## VEHICLE DAMAGE INSPECTION REPORT

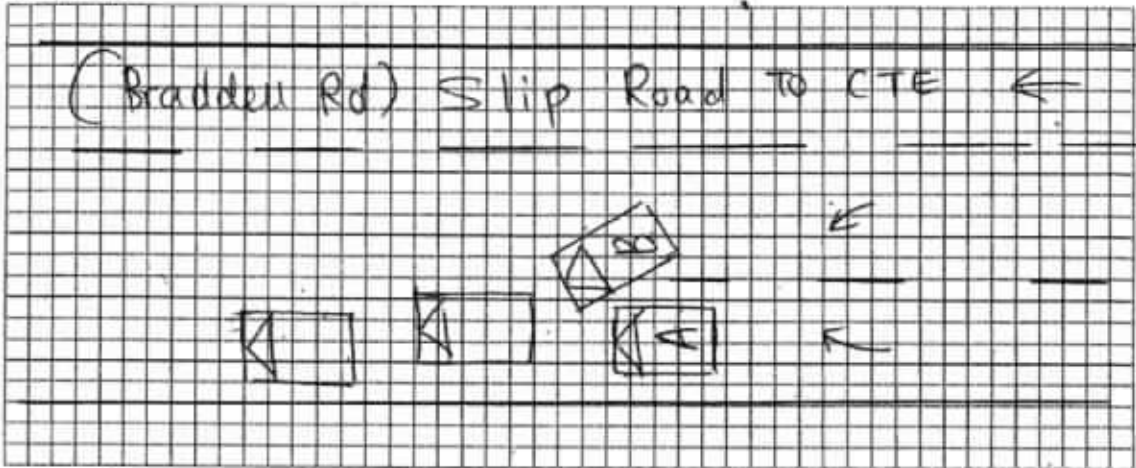
SKETCH PLAN

On 09/10/19 at about 6pm, I was driving along the slip road. Traffic volume was quite heavy and vehicles were moving slowly. Car B which was on my right cut into my lane and it hit the front right side of my car (A). My in-car camera has captured the accident.

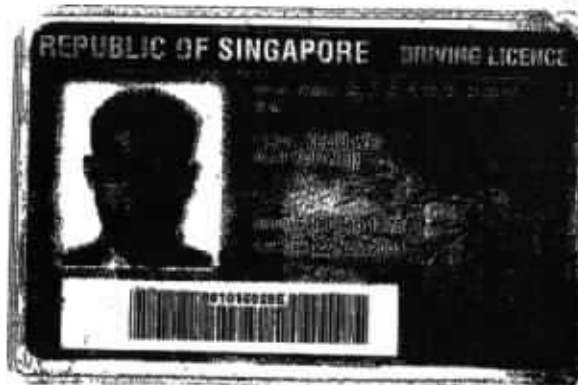
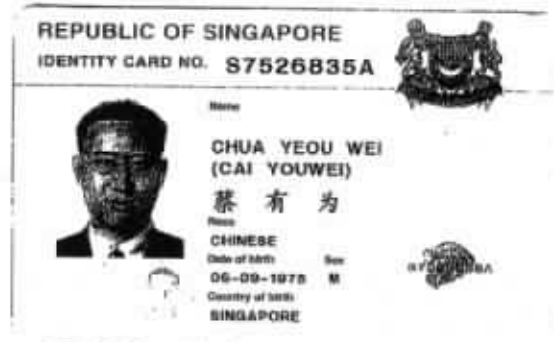
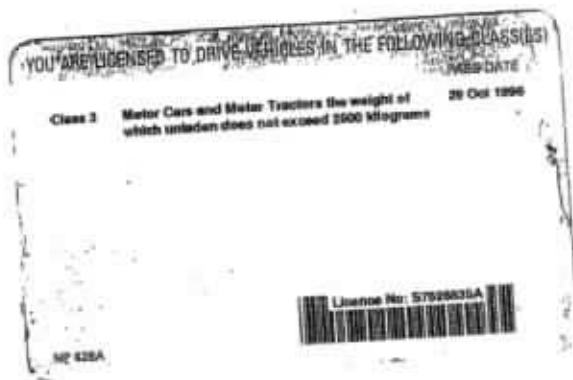
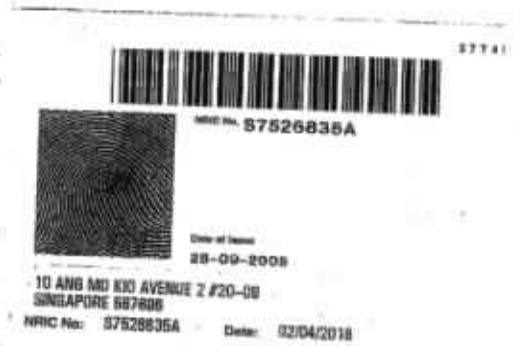
| Qty | Parts Description | Condition | Workshop's Estimation | Our Revised Estimation |
|---|--|---|---|---|
| 1 | Front headlamp | Damage | \$ 2490.00 | \$ 2490.00 |
| 1 | Front bumper | Damage | \$ 1485.00 | \$ 1485.00 |
| 1 | Front bumper fog lamp | Damage | \$ 505.00 | \$ 505.00 |
| 1 | Front fender | Damage | \$ 660.00 | \$ 660.00 |

| S/No | Job Descriptions | Workshop's Estimation | Our Revised Estimation |
|---|---|---|---|
| 1 | To remove and refit damage parts, test for proper functioning and focus of headlamps. | \$ 60.00 | \$ 40.00 30 |
| 2 | To remove and replace the above damaged parts, straighten, knock out, realign and repair including cut and weld body panels. To re-adjust to the original position using power tools. | \$ 800.00 | \$ 500.00 200 |
| 3 | To spray paint on the replaced and repaired parts, prepare spray such as masking tape the unaffected areas with paper, cleaning and sanding of surfaces, final polishing and waxing are also available. | \$ 1000.00 | \$ 800.00 400 |

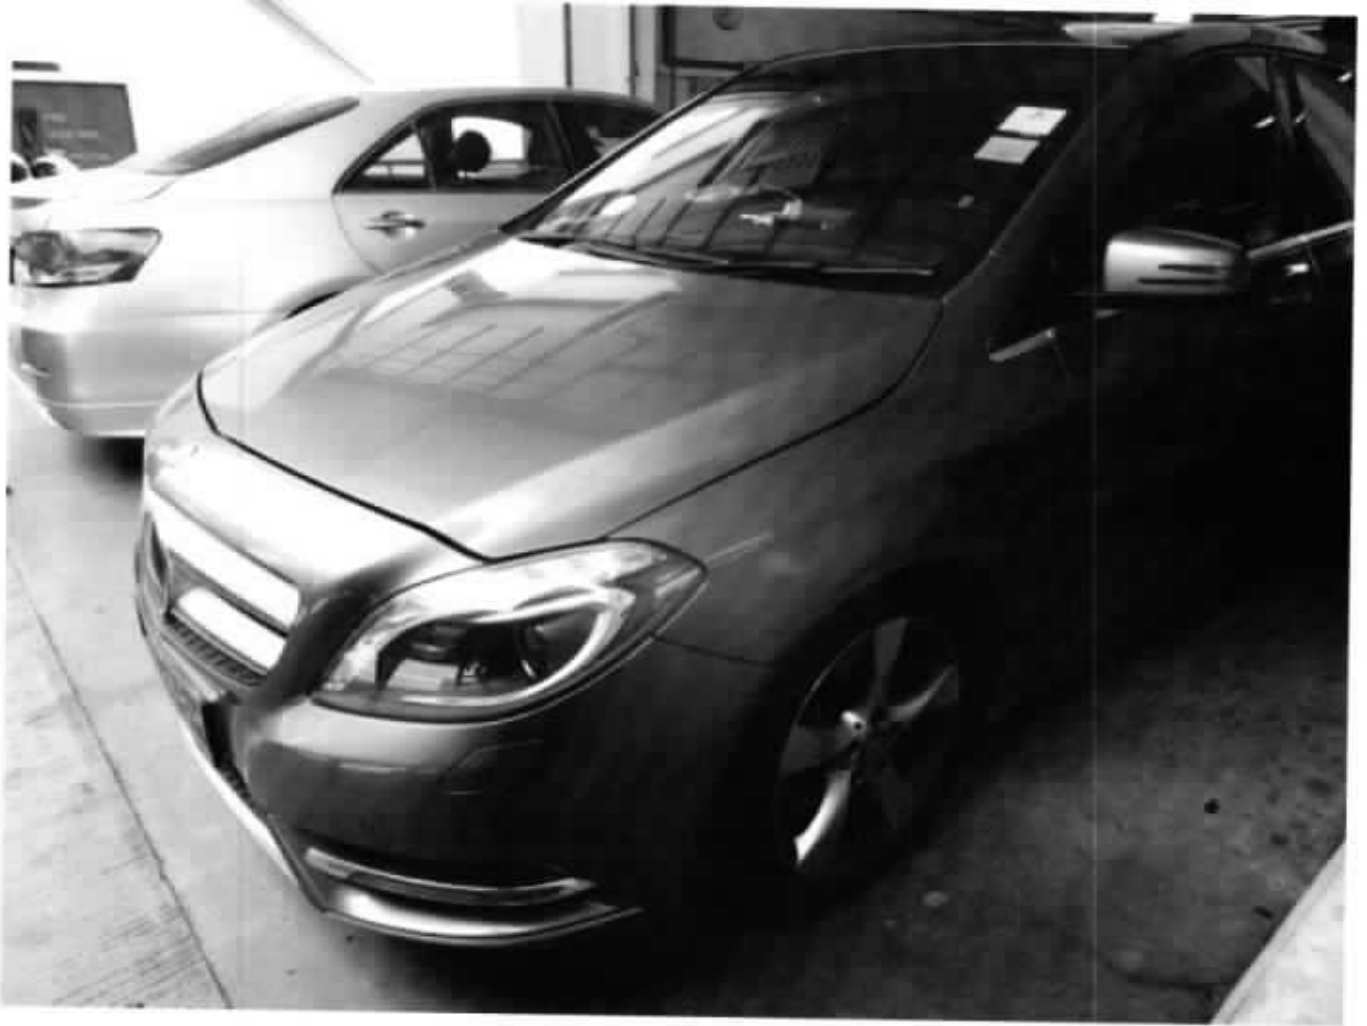
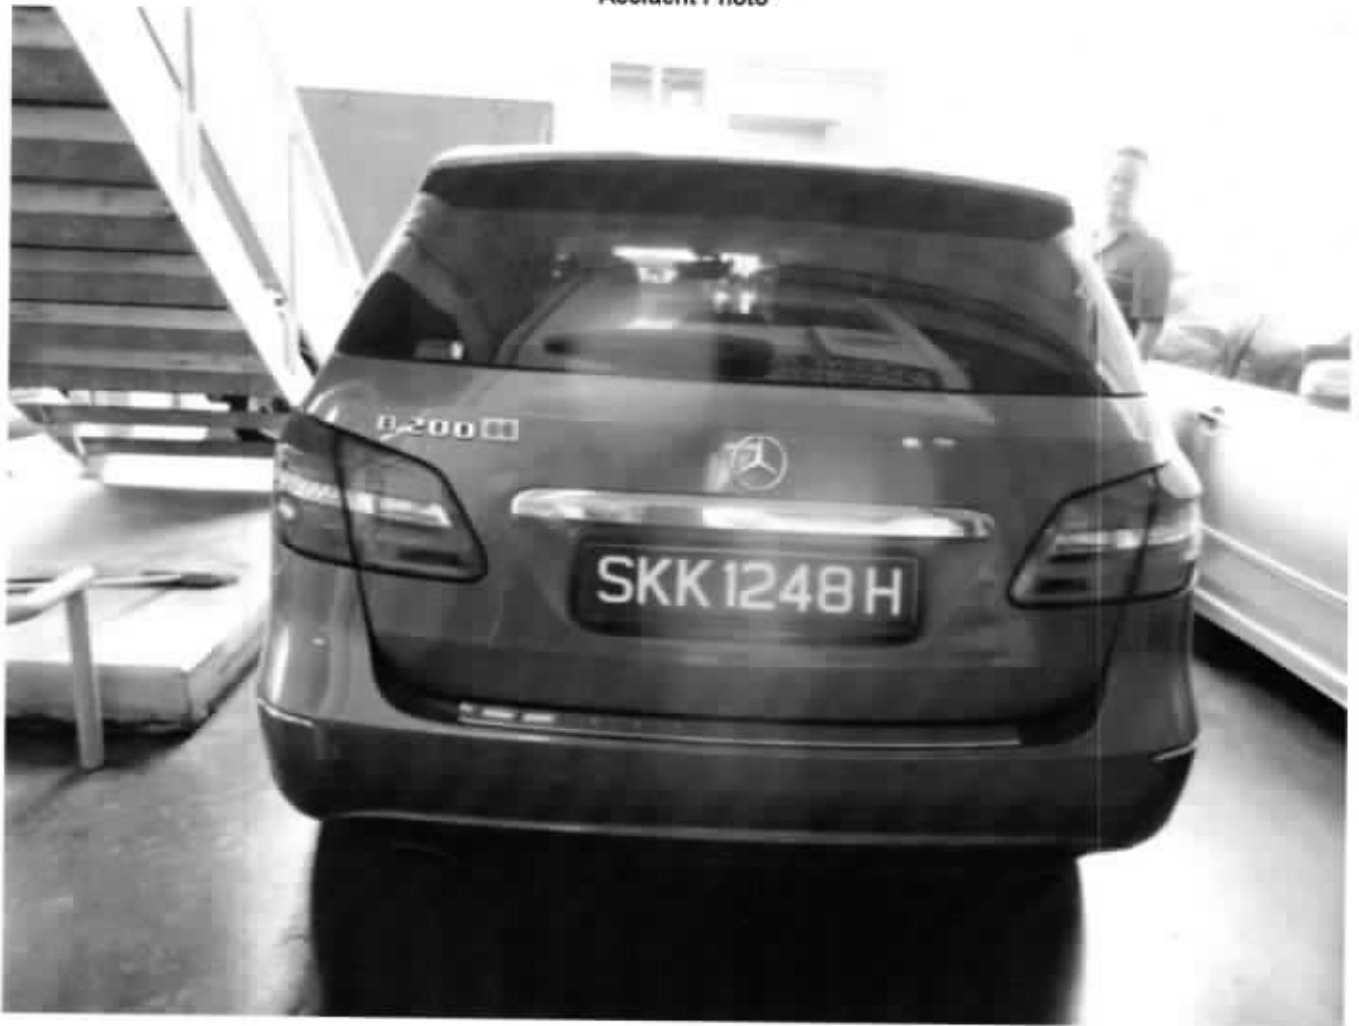
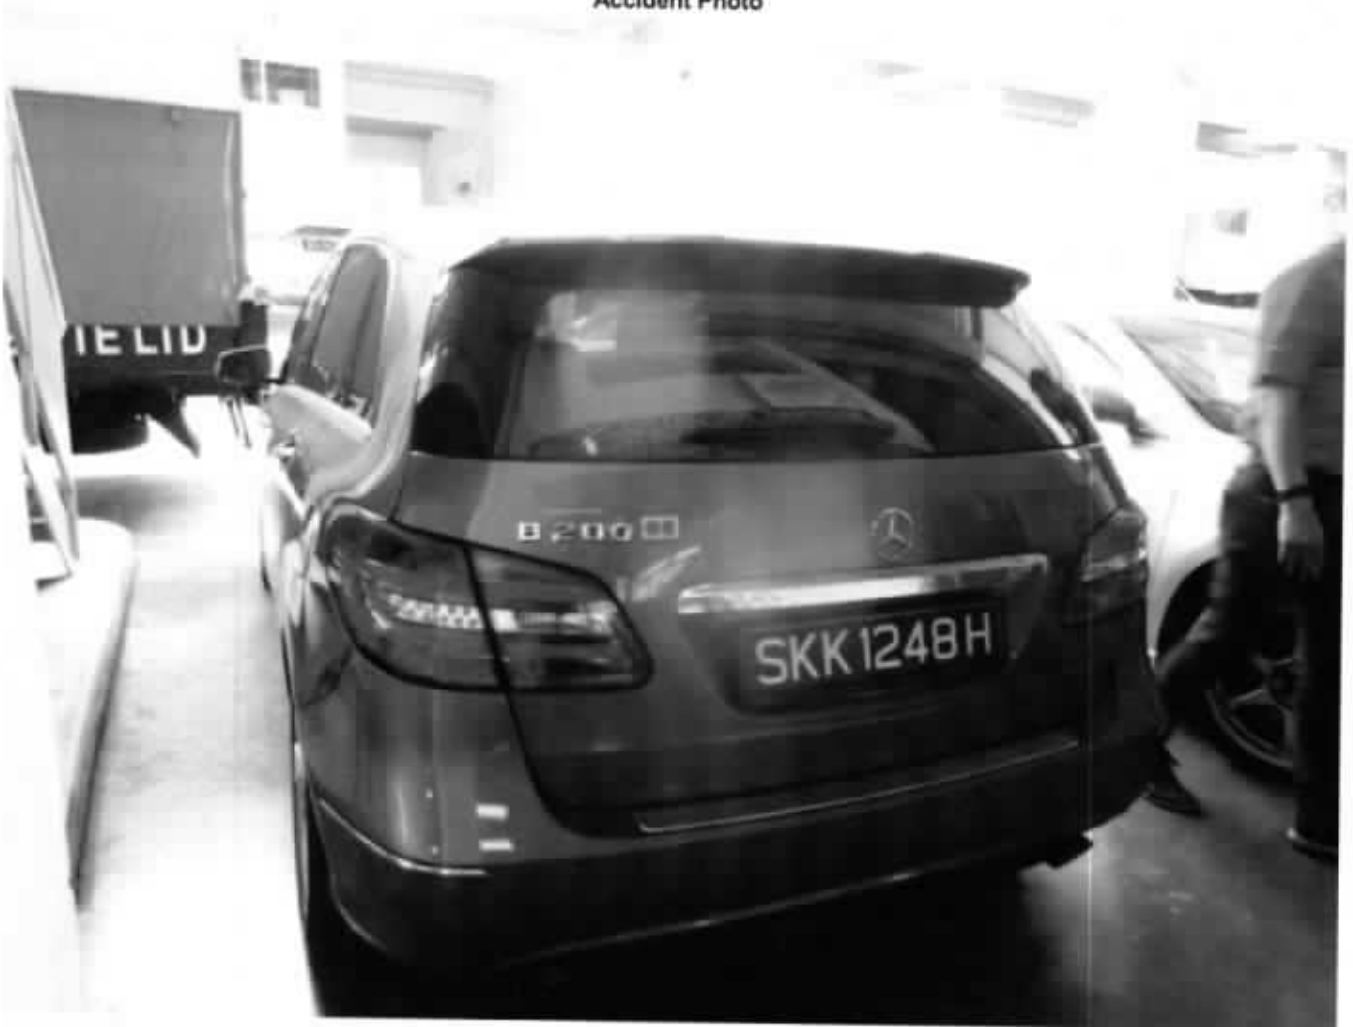
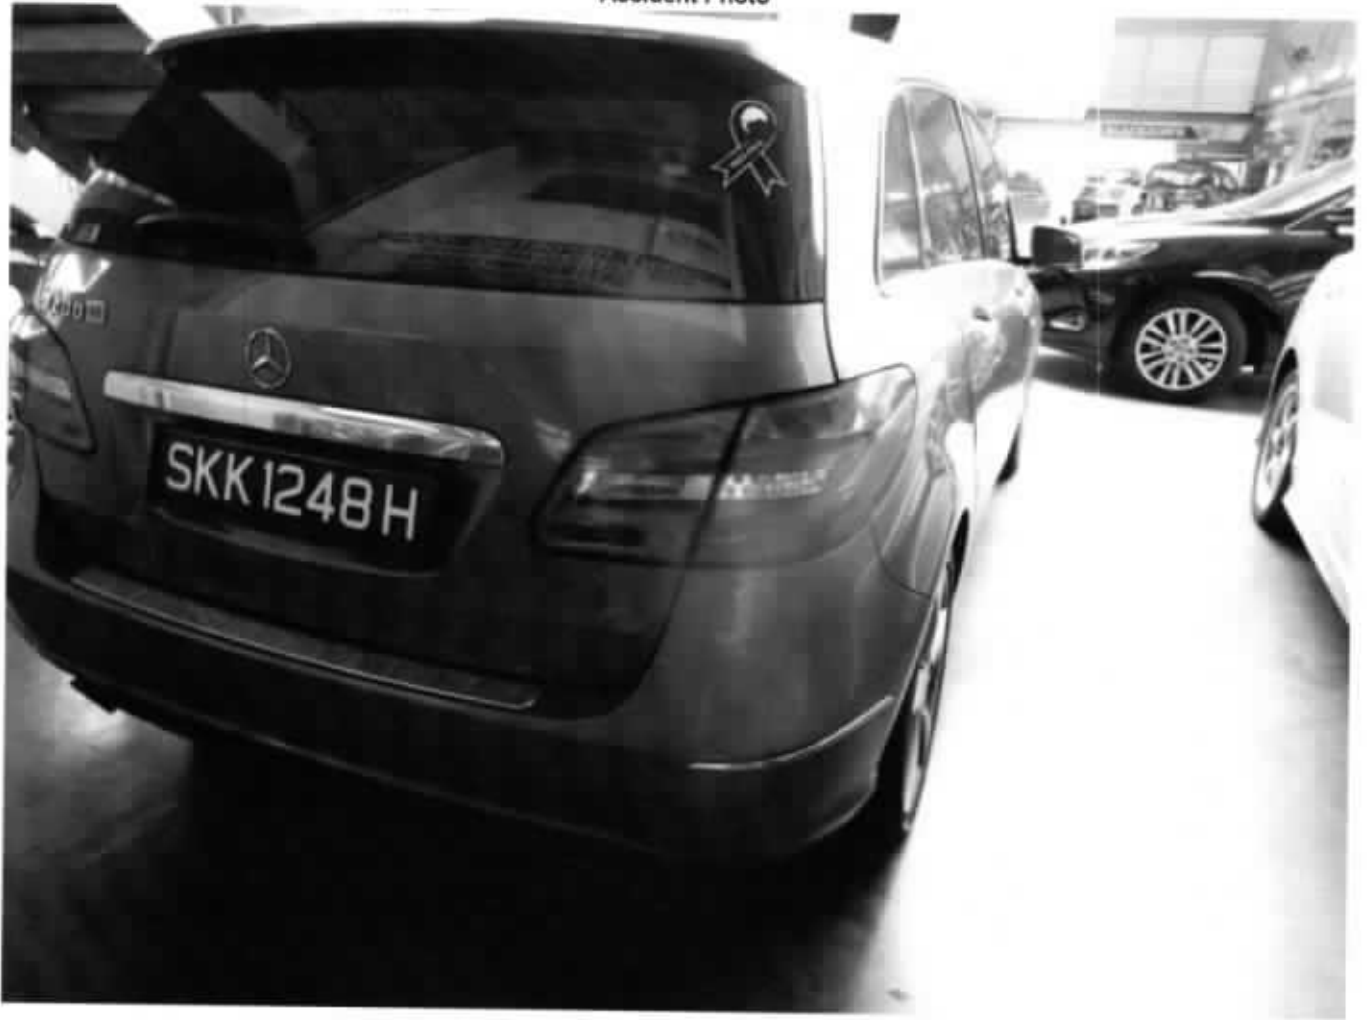
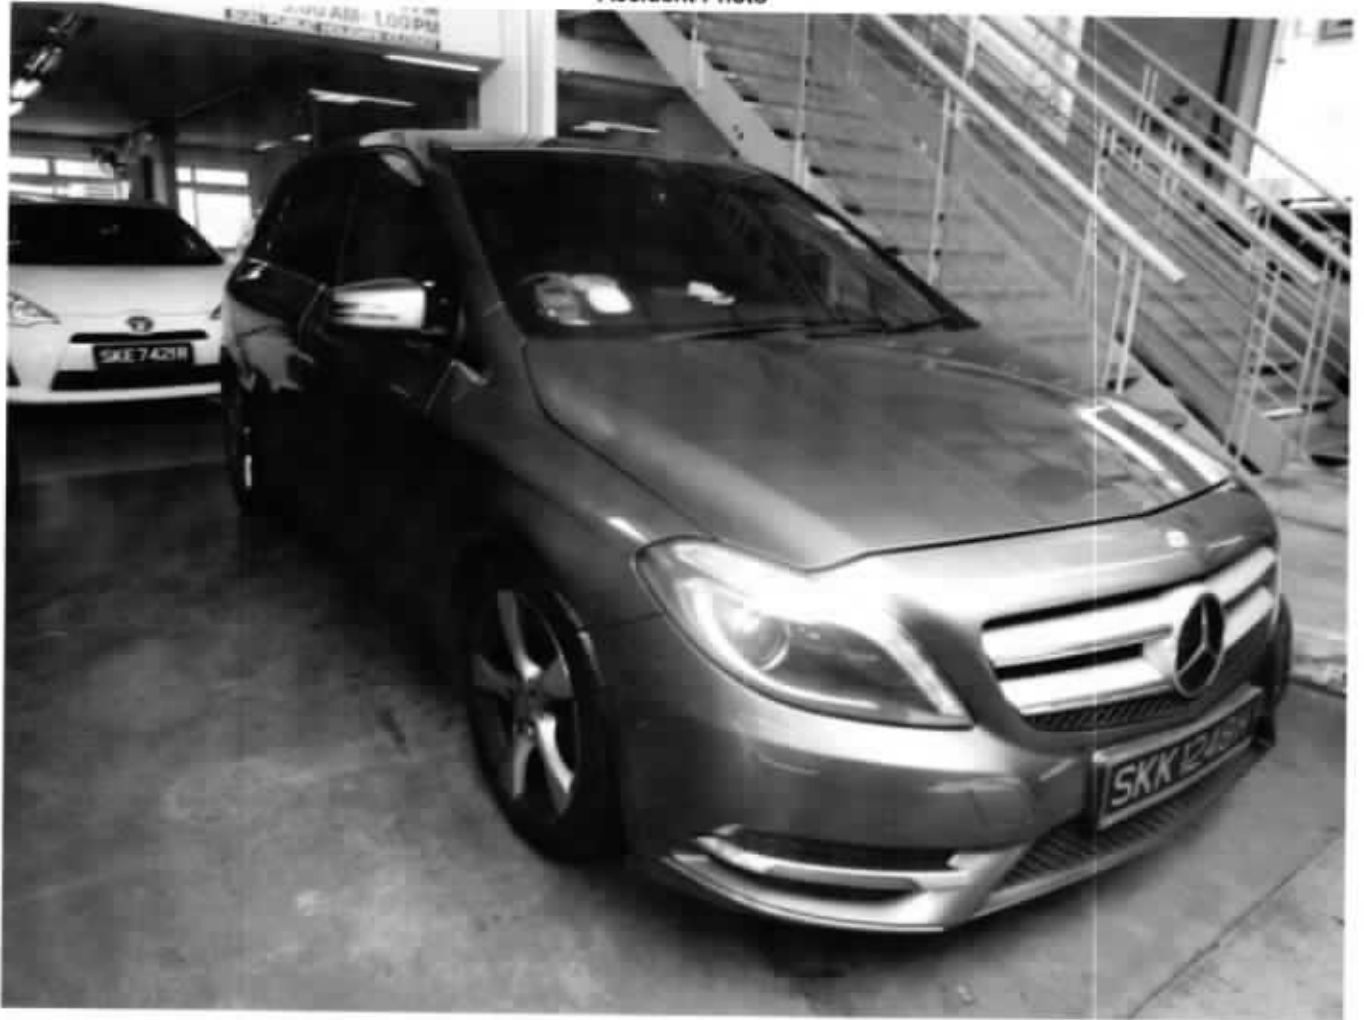
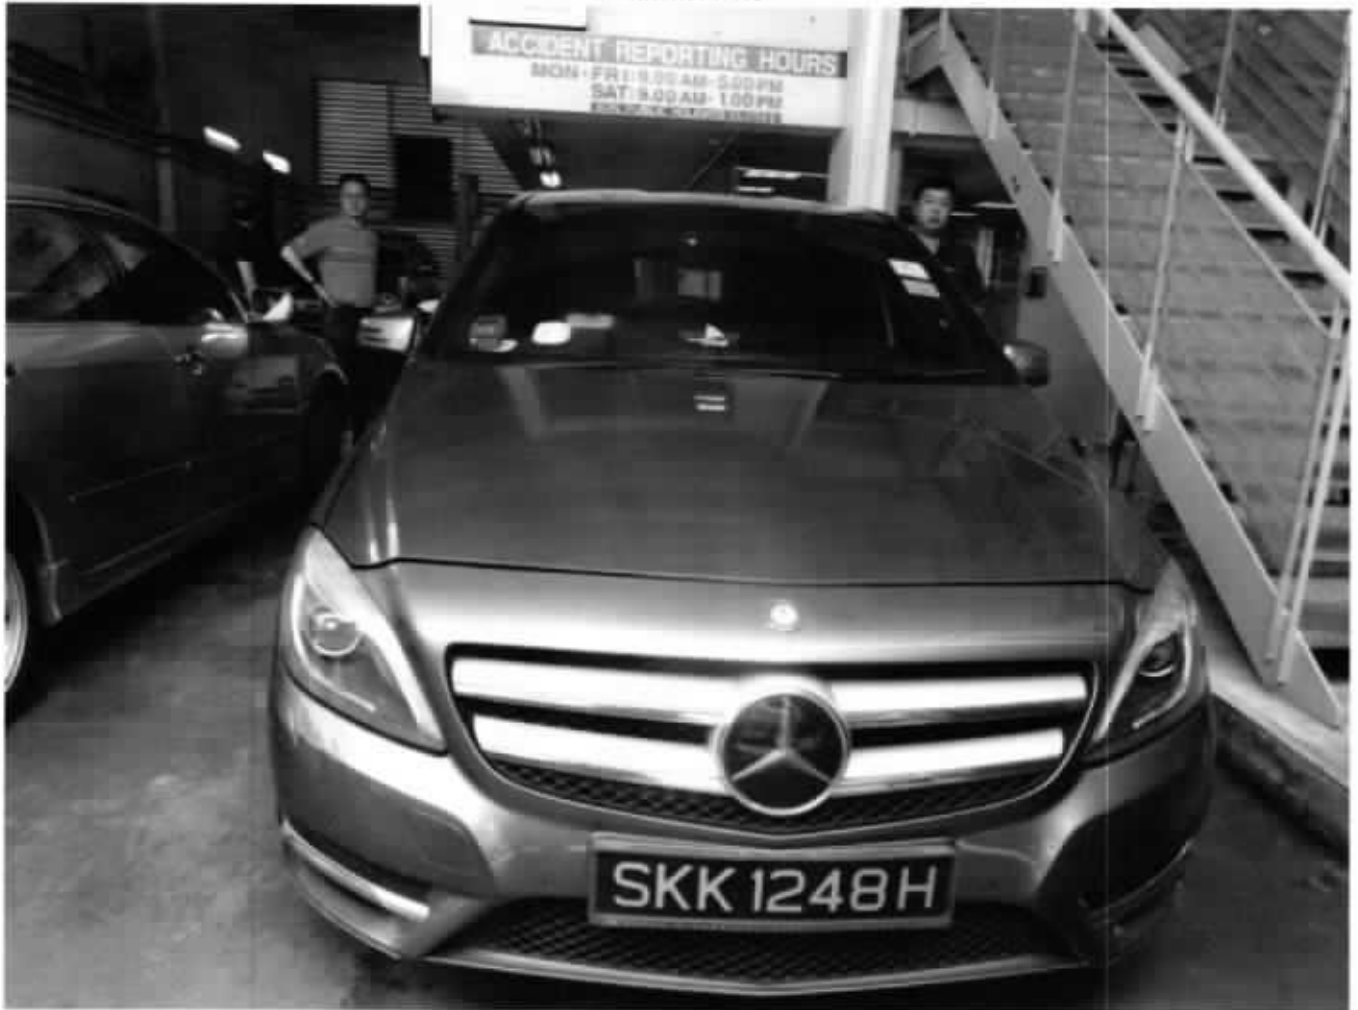
Accident Photo

At the time of inspection, we noted that the vehicle has sustained an impact damages on the o/s front portion(s). For more detail of the damages, please see photograph attached.
