Estimate Cost Repair Bill To Toyota Corolla SJN 6201 E & SJQ 9914 X on 09/04/2019@10:30:00

VEHICLE DAMAGE INSPECTION REPORT

Claimant Vehicle No : SJN6201E

Make & Model: TOYOTA COROLLA ALTIS, 1.6 (A)

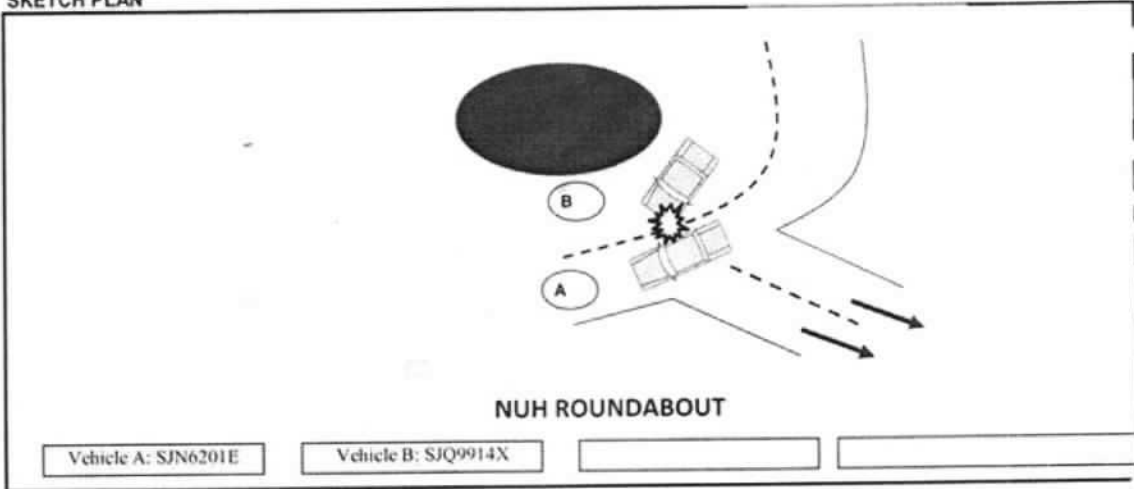
SKETCH PLAN

MY VEHICLE WAS DRIVING ALONG THE LEFT LANE OF NUH ROUNDABOUT. VEHICLE B WAS ON THE RIGHT LANE. I WAS GOING STRAIGHT, SUDDENLY I FELT AN IMPACT ON MY RIGHT PORTION. VEHICLE B HAD TRIED TO EXIT OUT AND HIT ONTO MY VEHICLE. NO ONE WAS INJURED.
