VEHICLE DAMAGE INSPECTION REPORT

Our File No: CS3/MSG19006640/ECD3E2
Date: 07/05/2019

Handling Insurer: MSIG Insurance (Singapore) Pte. Ltd.	Policy No:	80442288QMY
Claimant Vehicle No : SBA555L	Insured Vehicle No :	SKV7672T
Date of Loss: 08/04/2019	Nature of Claim:	TP
		Claim No: 590368

Reg No:	SBA555L	Engine No:	A955I623N46B20BZ
Make & Model:	BMW 318I, 2.0 L (A)	Chassis No:	WBAPF72000A793570
Reg. Date:	26/02/2010 (Man. Year: 2009)	Odometer:	170604 km
Colour:	Silver		
Engine Capacity:	1995 cc		
Market Value/New Car Price:	N/A		
Sum Insured (S\$):	Market Value/New Car Price

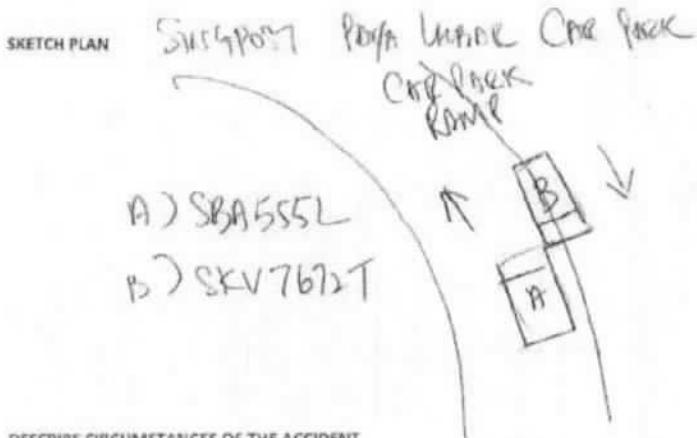
Accident Sketch Plan

On the 8th of April about 2.02 pm I was driving out of a car park at Singpost Paya Lebar. While I was carrying at the car park ramp suddenly a car BMW SKV7672T drove into my lane and hit my right front bumper.
