DAMAGE ASSESSMENT REPORT

Insured Veh.	SKA 5008K	Veh. Inspected	SLM 4505Z
Policy No.		Coverage (\$)	0.00
Claim No.	MT/1034482-002	Excess (\$)	0.00
Assign From	ANNIE KOH	Assign Date	16/04/2019

ADJUSTMENT ON REPAIR COST FOR VEHICLE NO. SLM 4505Z

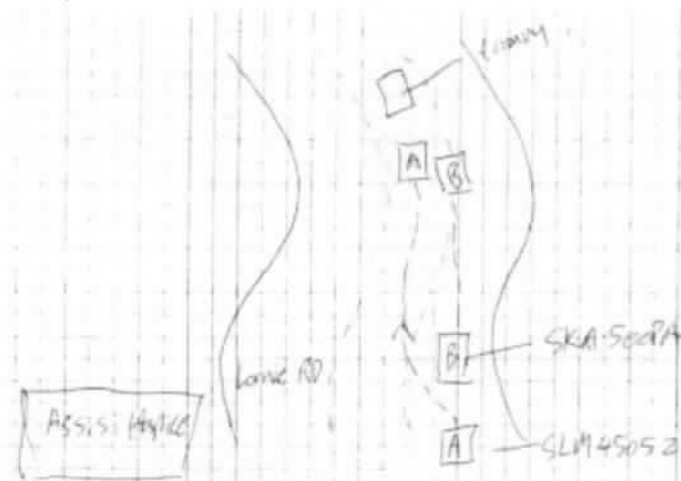
SKETCH PLAN

I was driving on Lone Rd Lane 1. ~~When I moved off~~ I changed lane from 1 to 2 as I am heading towards Thames Rd. Upon completing my lane change, about 5 secs later I was hit by Driver of SKA 5002A from the right side. As I turned into Thames Rd properly to ~~stop~~ stop so that we can exchange particulars, the driver of SKA 5002A kept to the extreme right line and did not have intention to stop. As there was a traffic light ahead, I managed to inform her that ~~it is~~ instead run is an offence. We both turned into SLC Complex to exchange details.

It should also be noted that prior to the accident, the Driver of SKA 5002A ~~changed~~ moved from lane 1 on upper Thames Road ~~and~~ ~~at~~ ~~to~~ ~~lane~~ ~~4~~ to lane 4 to take the exit to Lone Road abruptly. This abrupt moving is captured on the video.
