Vehicle No	: SJJ2522B	Accident Date	: 10/04/2019
Make	: MAZDA RX-8	Policy No.	: Z18VP05020042
Assignment Date	: 22/04/2019	Excess	: S\$1,500.00
Date of Inspection	: 17/04/2019	Est. Duration of Repair	: 9.00
Inspection At	: WAH HONG MOTORS & CREDIT PTE LTD (HQ) 38 TOH GUAN ROAD EAST, #01-57, ENTERPRISE HUB SINGAPORE 608581

PRELIMINARY ADVICE OF VEHICLE NO. SJJ 2522B

VEHICLE DAMAGE INSPECTION REPORT

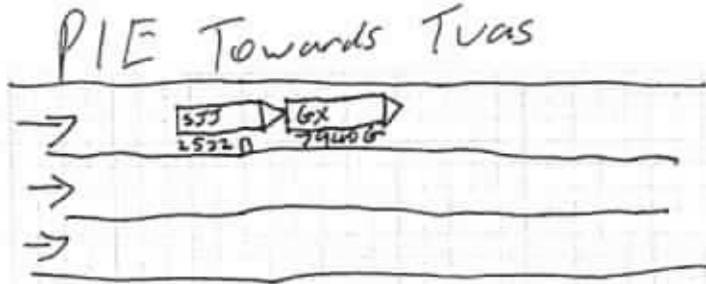
SKETCH PLAN

I WAS TRAVELING TOWARDS TUAS ON THE LEFT LANG.
AND I HIT THE CAR IN FRONT OF ME.

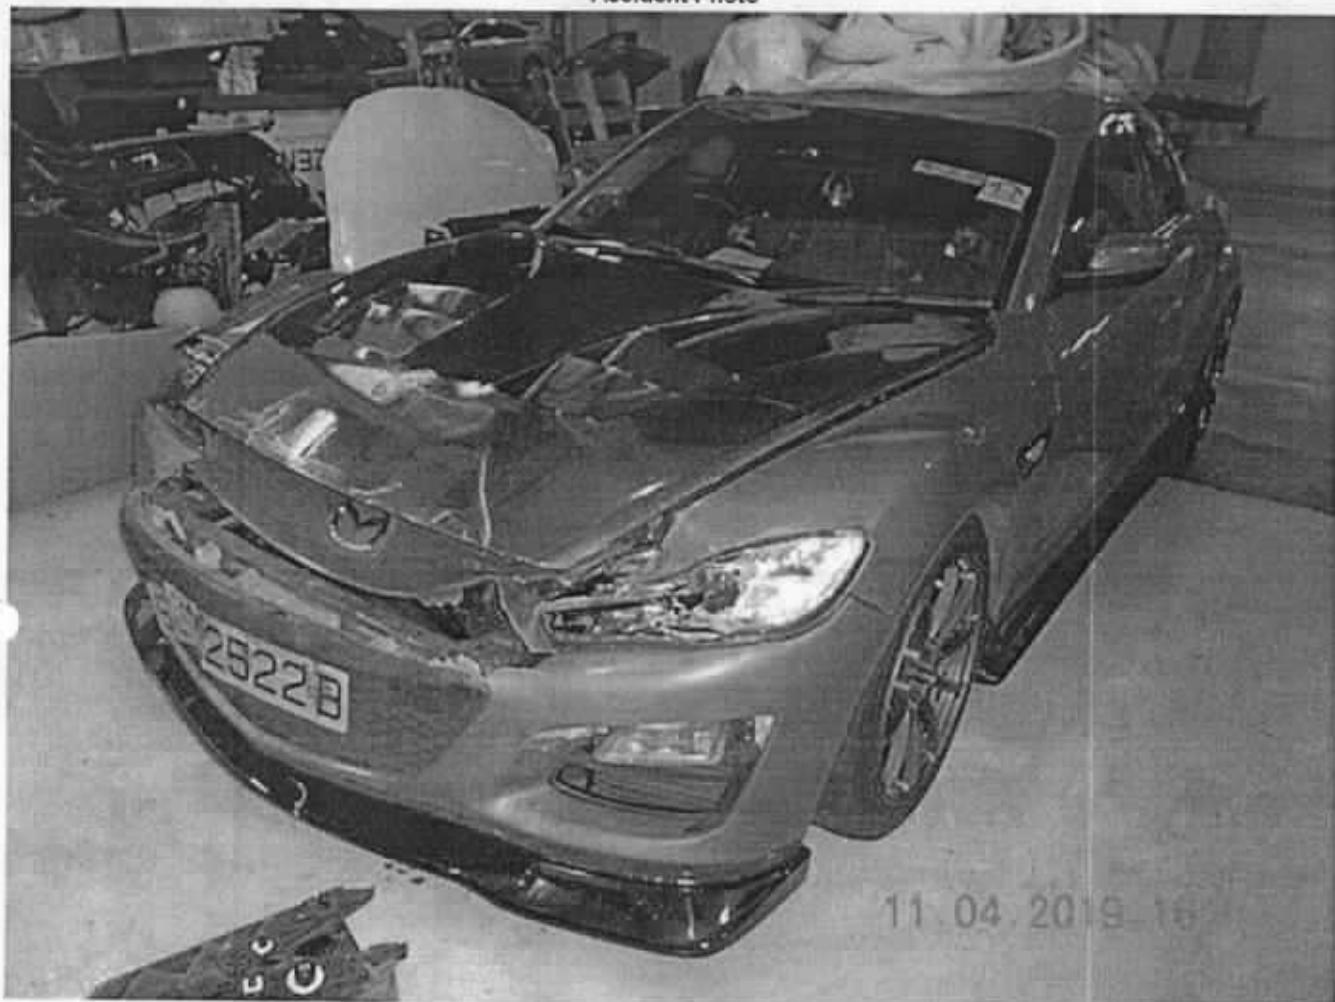
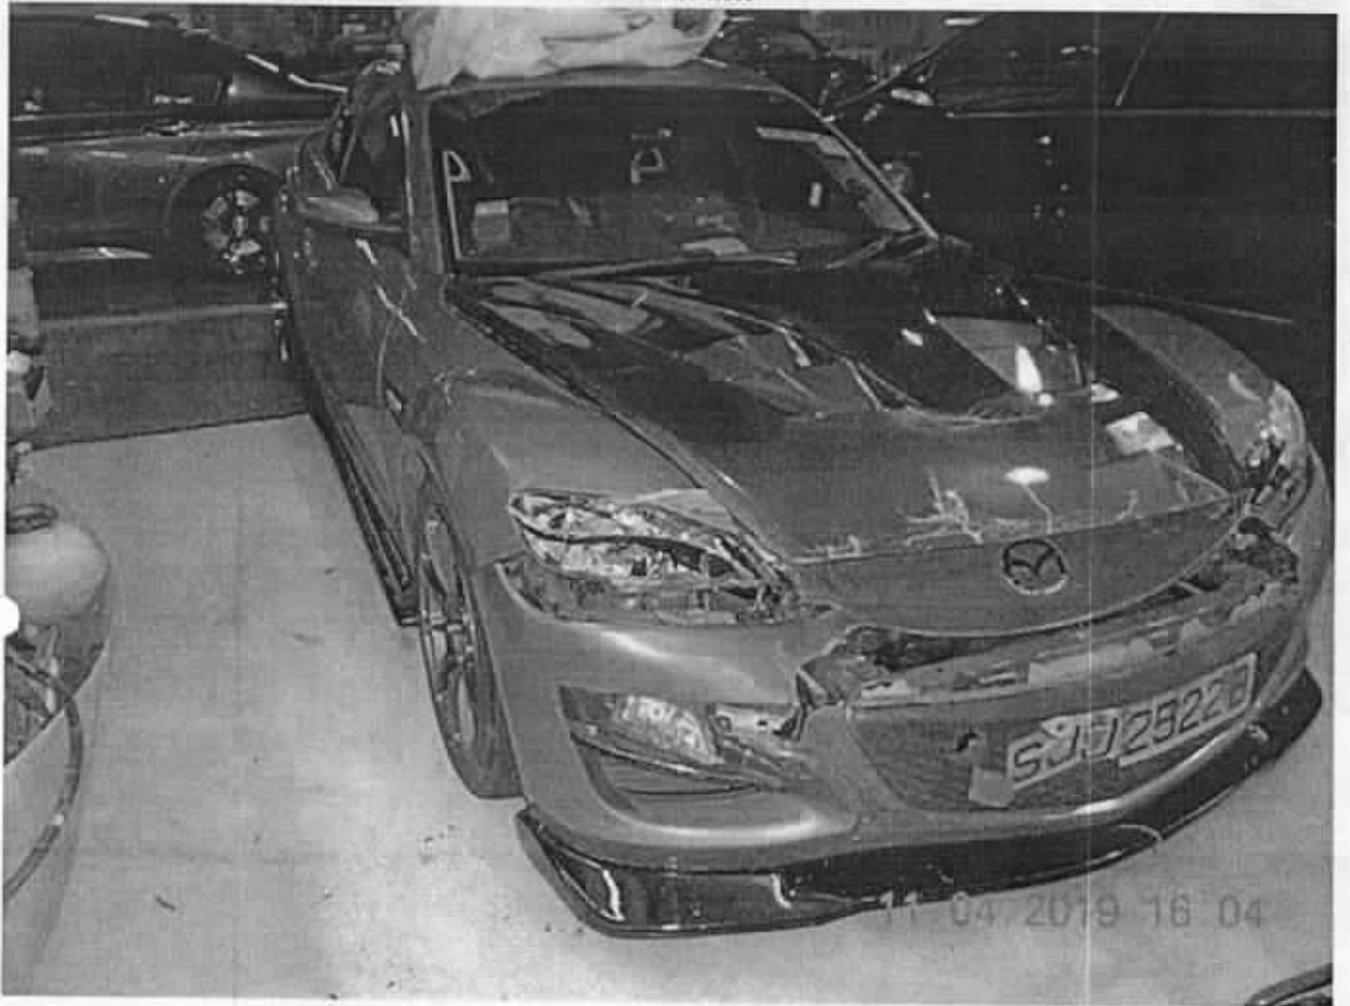
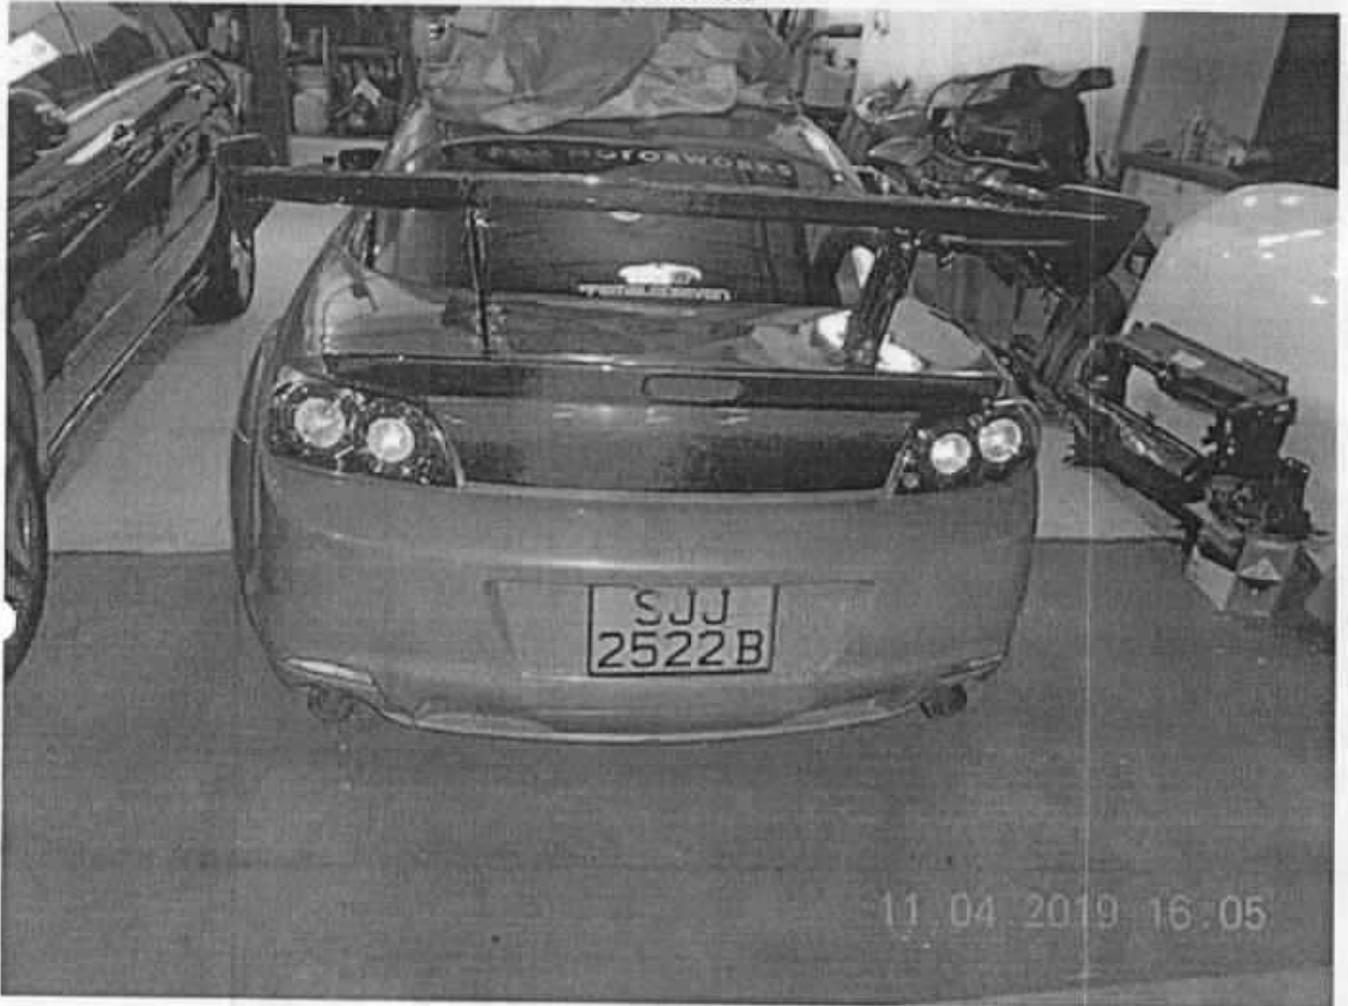
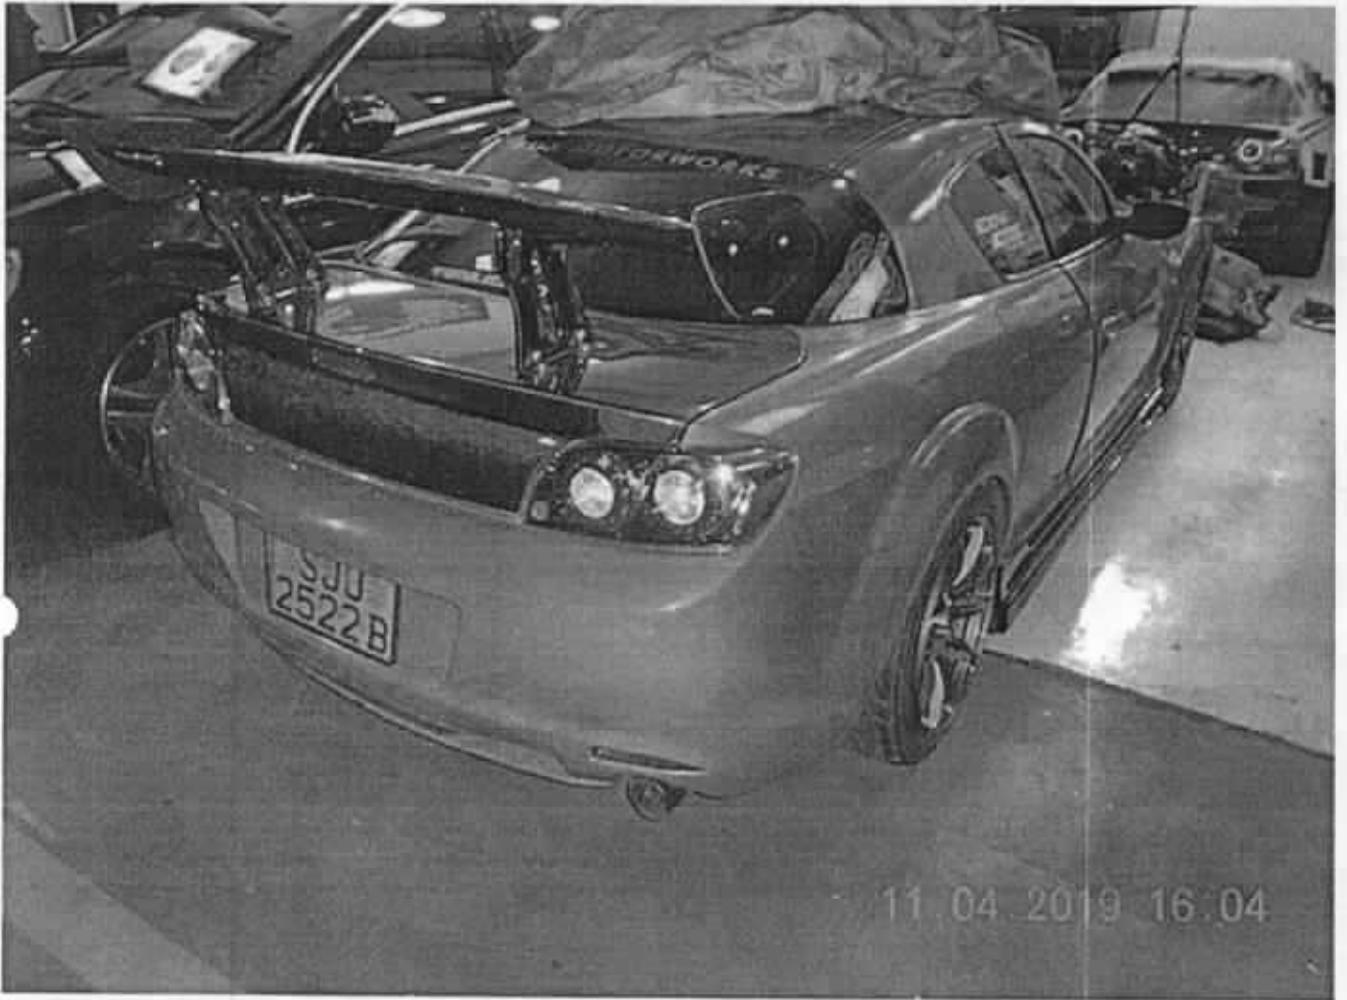
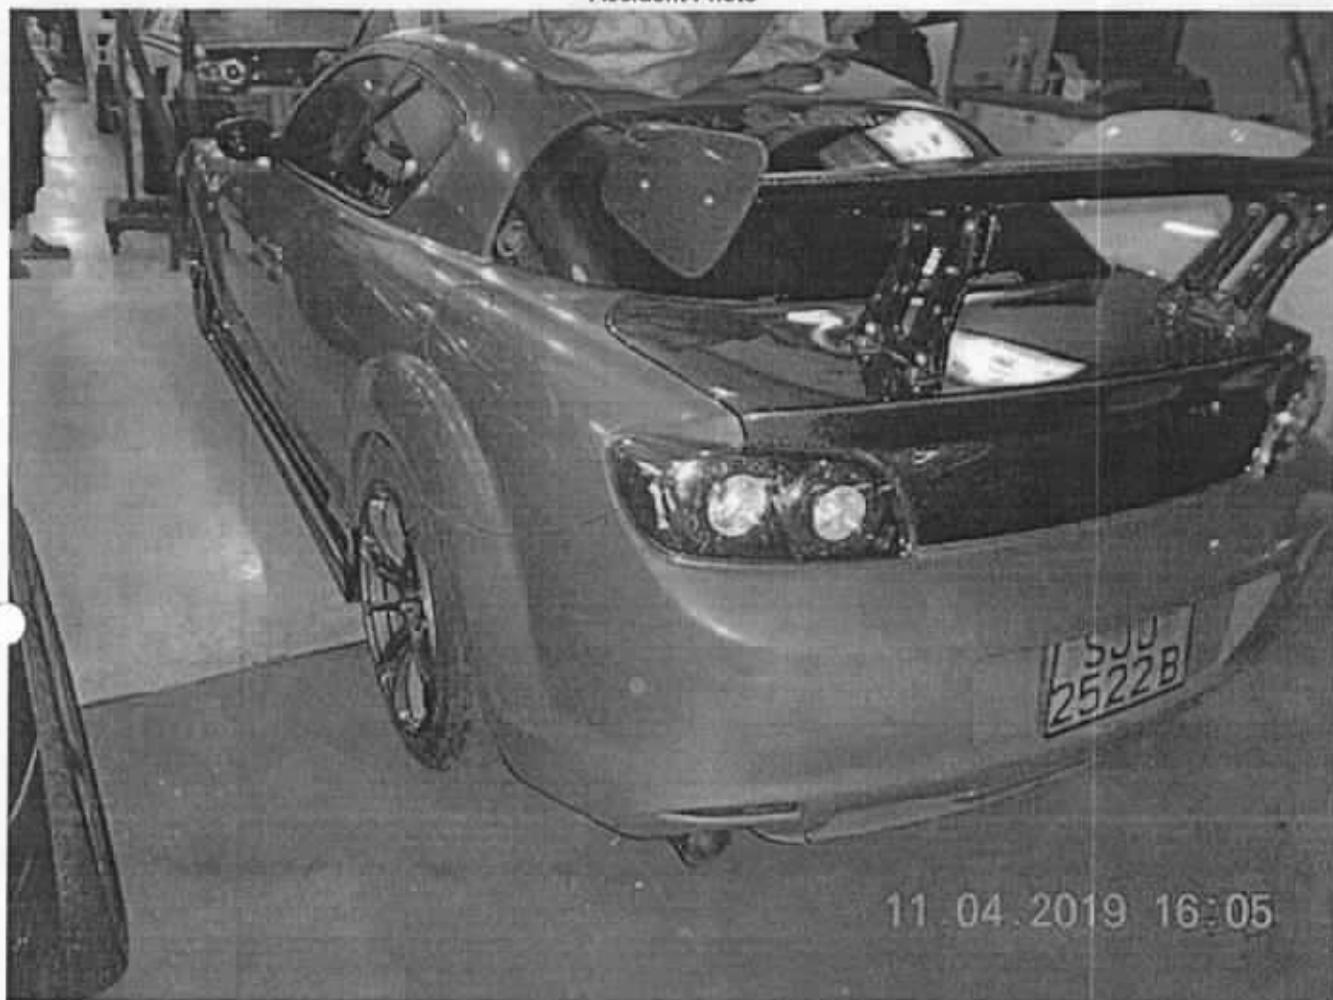
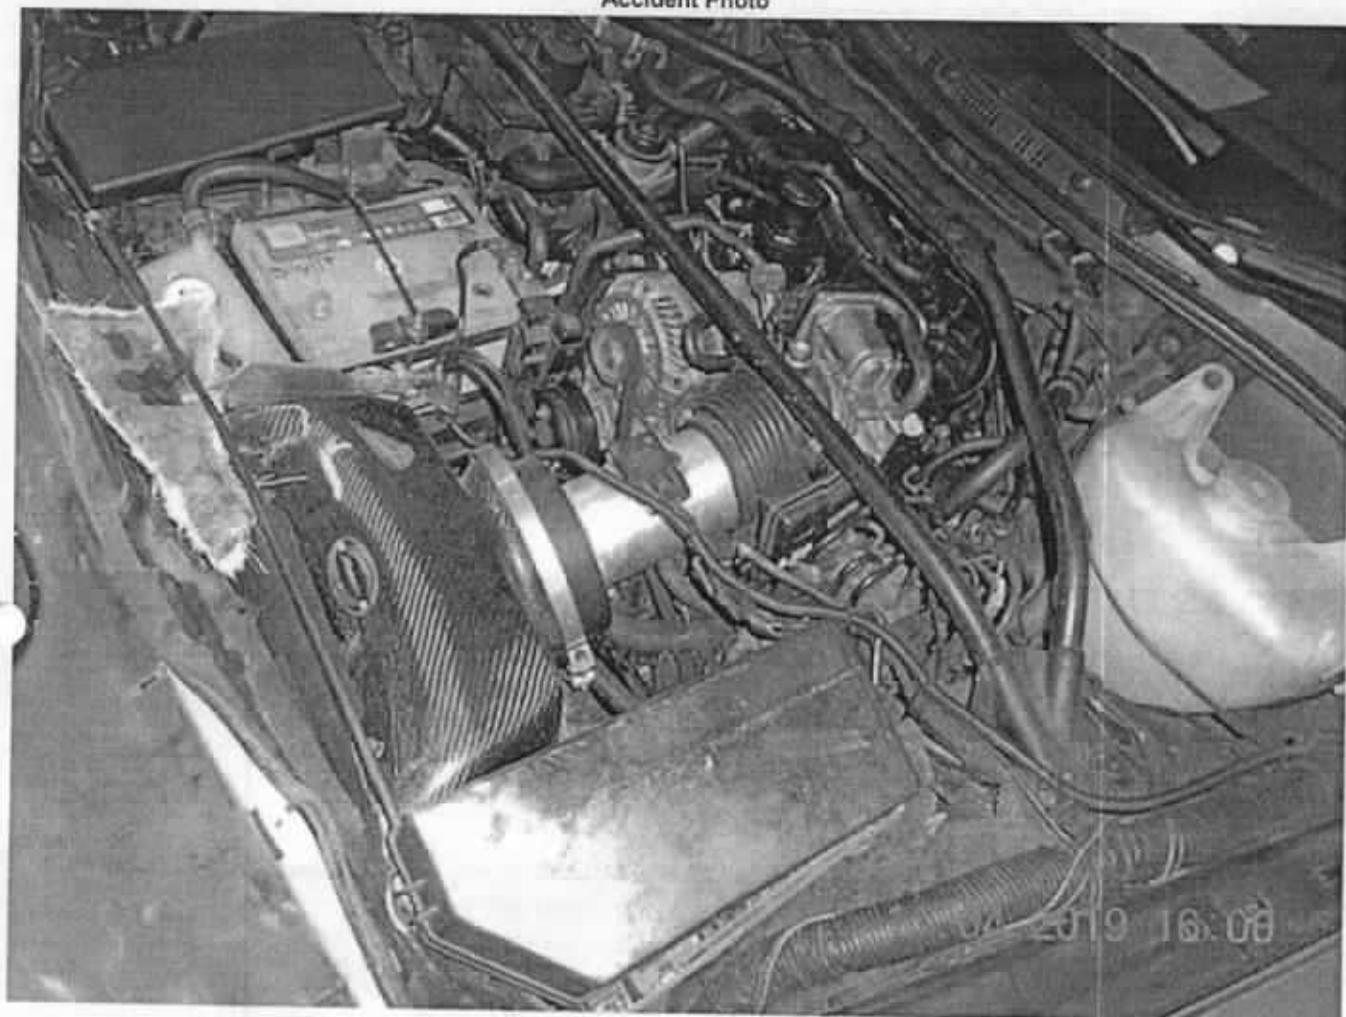
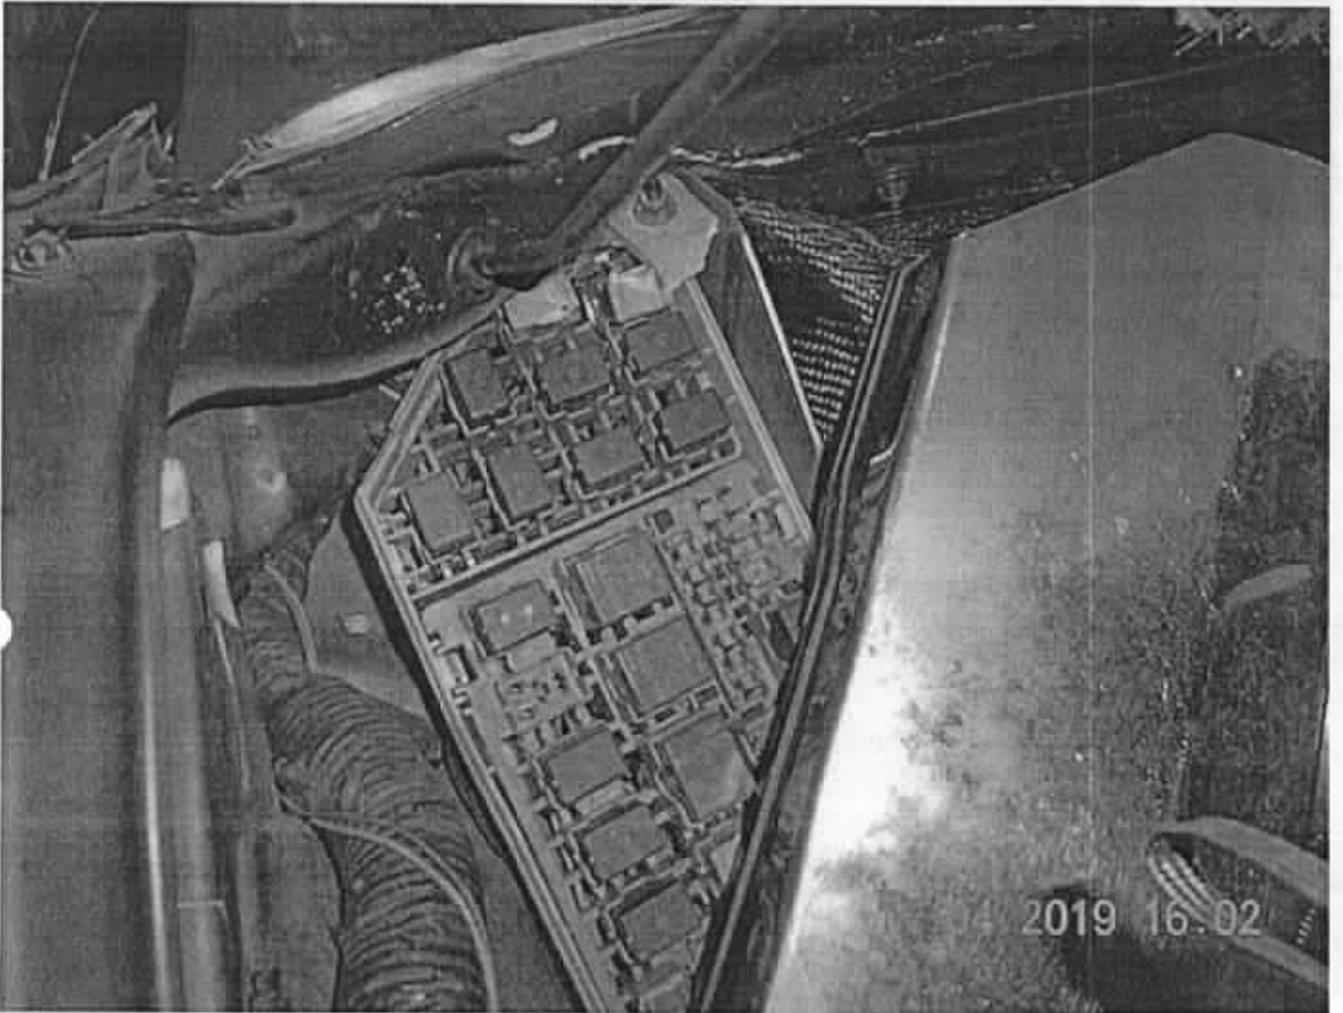
Accident Photo

The vehicle sustained impact / damages front portion and parts claimed are consistent to the accident.

Description of Damage:
The vehicle sustained damages at the front portion.

No.	Qty	Part No.	Particulars	Condition	Repairer's	Amount
1	1		*1 Pc Front Bonnet (WCP)	Cracked	855.00 F	*855.00 F
2	1		*1 Pc Front Bumper (WCP)	Cracked	620.00 F	*620.00 F
3	1		*1 Pc Front R/H Fender (WCP)	Bent	720.00 F	*720.00 F
4	1		*1 Pc Front L/H Fender (WCP)	Bent	750.00 F	*750.00 F
5	1		*1 Pc Front Bumper Lower Lid (WCP)	Cracked	320.00 F	*320.00 F
6	1		*1 Pc Front R/H Headlamp (WCP)	Broken	1,328.00 F	*1,328.00 F
7	1		*1 Pc Front L/H Headlamp (WCP)	Broken	1,328.00 F	*1,328.00 F
8	1		*1 Pc Front Support Panel (WCP)	Bent	520.00 F	*520.00 F
9	1		*1 Pc Front R/H Fog Lamp (WCP)	Cracked	320.00 F	*320.00 F
10	1		*1 Pc Front L/H Fog Lamp (WCP)	Cracked	320.00 F	*320.00 F
11	1		*1 Pc Radiator (WCP)	Cracked	860.00 F	*860.00 F
12	1		*1 Pc Front R/H Fog Lamp Cover (WCP)	Cracked	155.00 F	*155.00 F
13	1		*1 Pc Front L/H Fog Lamp Cover (WCP)	Cracked	155.00 F	*155.00 F
14	1		*1 Pc Engine Fuse Box Housing (WCP)	Cracked	1,250.00 F	*1,250.00 F

15	1		*1 Pc Radiator Spare Tank (WCP)	Broken	320.00 F	*320.00 F
16	1		*1 Pc Air Cleaner With Inlet Duct (WCP)	Deformed	820.00 F	*820.00 F
17	1		*1 Pc Havdness With Fuse Box Housing (WCP)	Cut	3,100.00 F	*3,100.00 F
18	1		*1 pc Air Con Condenser (WCP)	Serviceable	580.00 F	*- F
19	1		*1 Pc Front Bumper Reinforcement (WCP)	Bent	465.00 F	*465.00 F
Supplementary #1						
20	1		*1 Pc Intake Manifold Assemble (WCP)	Serviceable	860.00 F	*- F
21	1		*1 Set Intake Manifold Gasket (WCP)	Serviceable	65.00 F	*- F

No	Particulars	Lab.Type	Repairer's	Amount
Labour Items				
1	remove and replace all the parts mentioned above and knocking and straighten up the necessary affected areas	New	2,100.00	1,200.00
2	spray painting on affected areas	New	800.00	800.00
3	check wiring system engine	New	150.00	80.00
Gross Labour Cost (S\$)			3,050.00	2,080.00
