SURVEY REPORT

SURVEY OF VEHICLE NO. GN 9758G

AUTOMOBILE ASSESSMENT REPORT

ADJUSTMENT ON REPAIR COST FOR VEHICLE NO. GN 9758G (GBH 4330E)

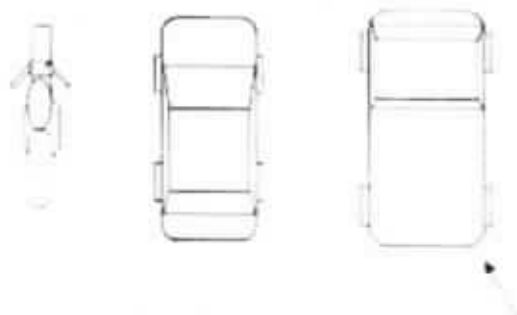
At the time of inspection, this vehicle sustained damages to the **Rear O/S** portion. Please see attached schedule for details.

Market Value: -
Salvage Value: -
Repair Limit (Nett Loss): -
Repairer's estimate: **Not Provided**
Nett Saving: -
Excess: -
Sum Insured: -
Our adjusted amount: **\$ 3,600.00**
Estimated Repair Days: **07 days**

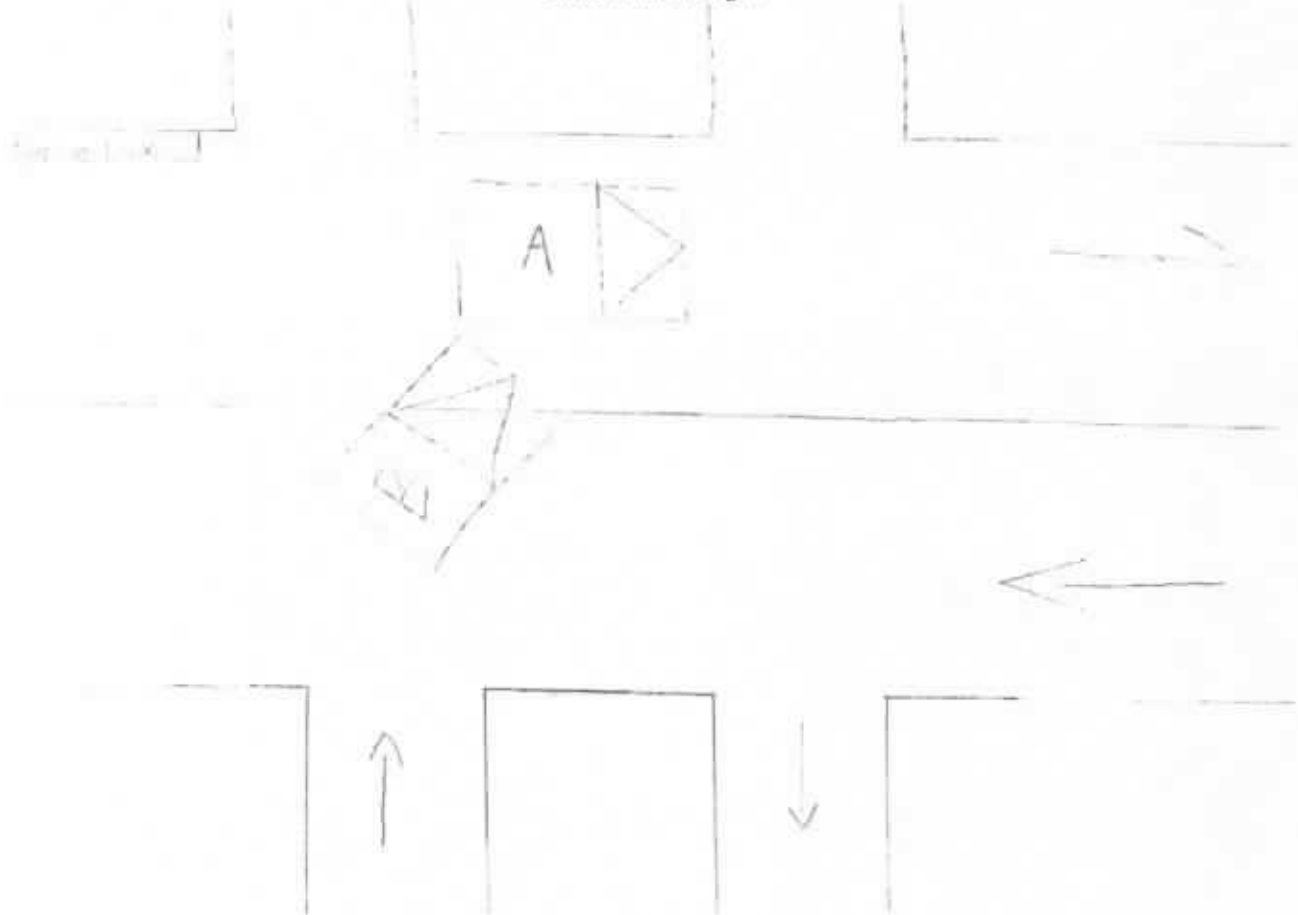
Sketch Plan #2 Pg. 1

I was travelling along Rivervale Link and suddenly vehicle B exited from one of the condo from opposite side of the road and made a right turn. Vehicle B hit into the right rear area of my vehicle A while making the right turn.

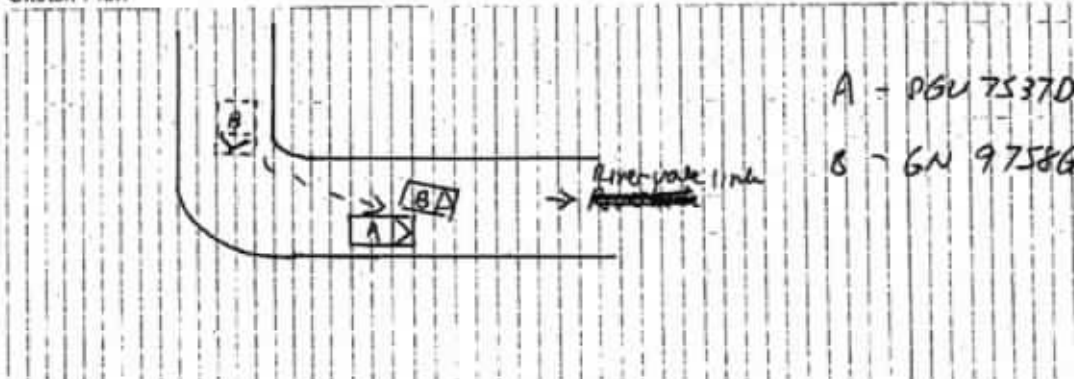
Sketch Plan

I was travelling straight on the extreme right lane and I was going about 20km per hour when out of a sudden a span GN 975PG which was speeding make a sharp left turn and abruptly cut into my lane and collided onto my left front bumper. I have taken photos of the skid mark on the road to prove that he was speeding and failed to brake in time which caused the accident.
