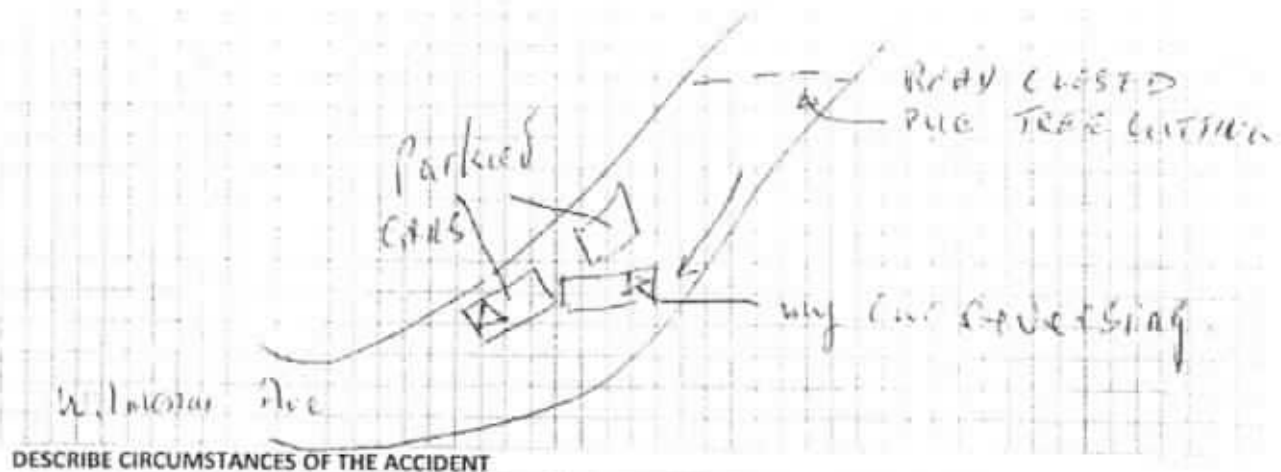
SKETCH PLAN

I was going out as I knew the bend the normal route was blocked by the parking contractor.

I had to reverse. As I reversed I hit the parked vehicle - Damage to my rear right side of the car and his vehicle's rear left.
