RE: PRS-ANR-SKJ1507R.pdf; Our ref: LCH.my/AMK10-90269.19 / OUR REF:

VEHICLE DAMAGE INSPECTION REPORT

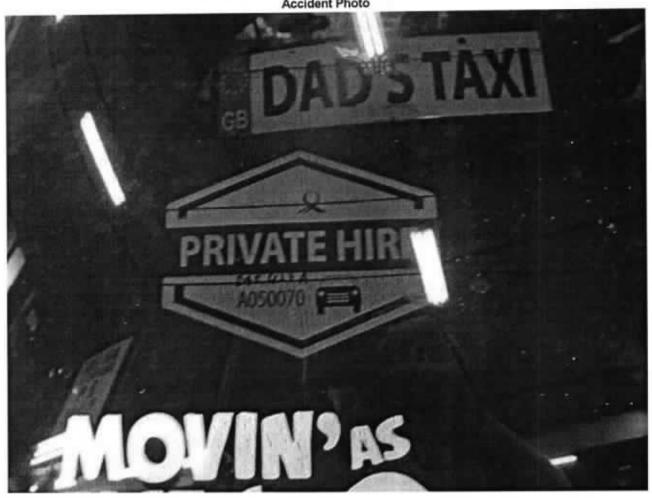
Accident Photo

I proceeded to check my vehicle and realized that the rear of vehicle was badly damaged and dented. The rear door and the bumper of my vehicle was damaged too.
