## VEHICLE INSPECTION REPORT

Registration No : SJR 9969 H  
Make / Model : Hyundai Avante  
Chassis No : KMH DU41BR9U799311  
Engine No : G4FC9U679091

## VEHICLE DAMAGE INSPECTION REPORT

Handling Insurer: MSIG Insurance (Singapore) Pte. Ltd. Policy No: MSD/VMS/18-994798  
 Claimant Vehicle No: SJR9969H Insured Vehicle No: FBN2668M  
 Date of Loss: 05/02/2019 Nature of Claim: TP Claim No: MSC/V/19-000214

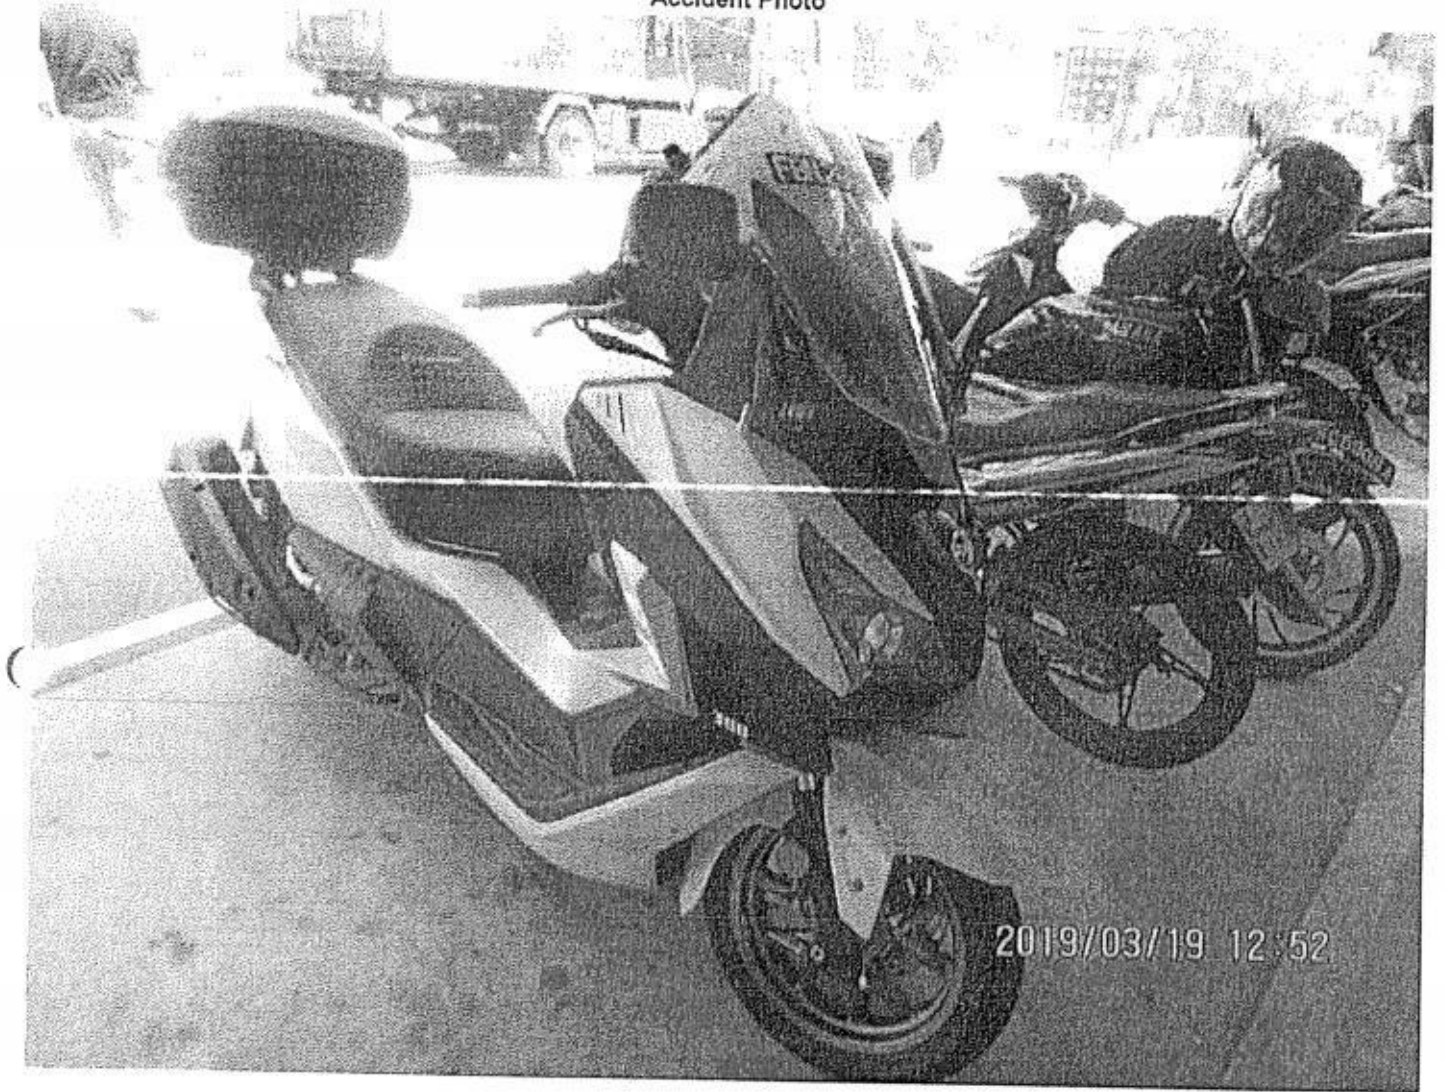
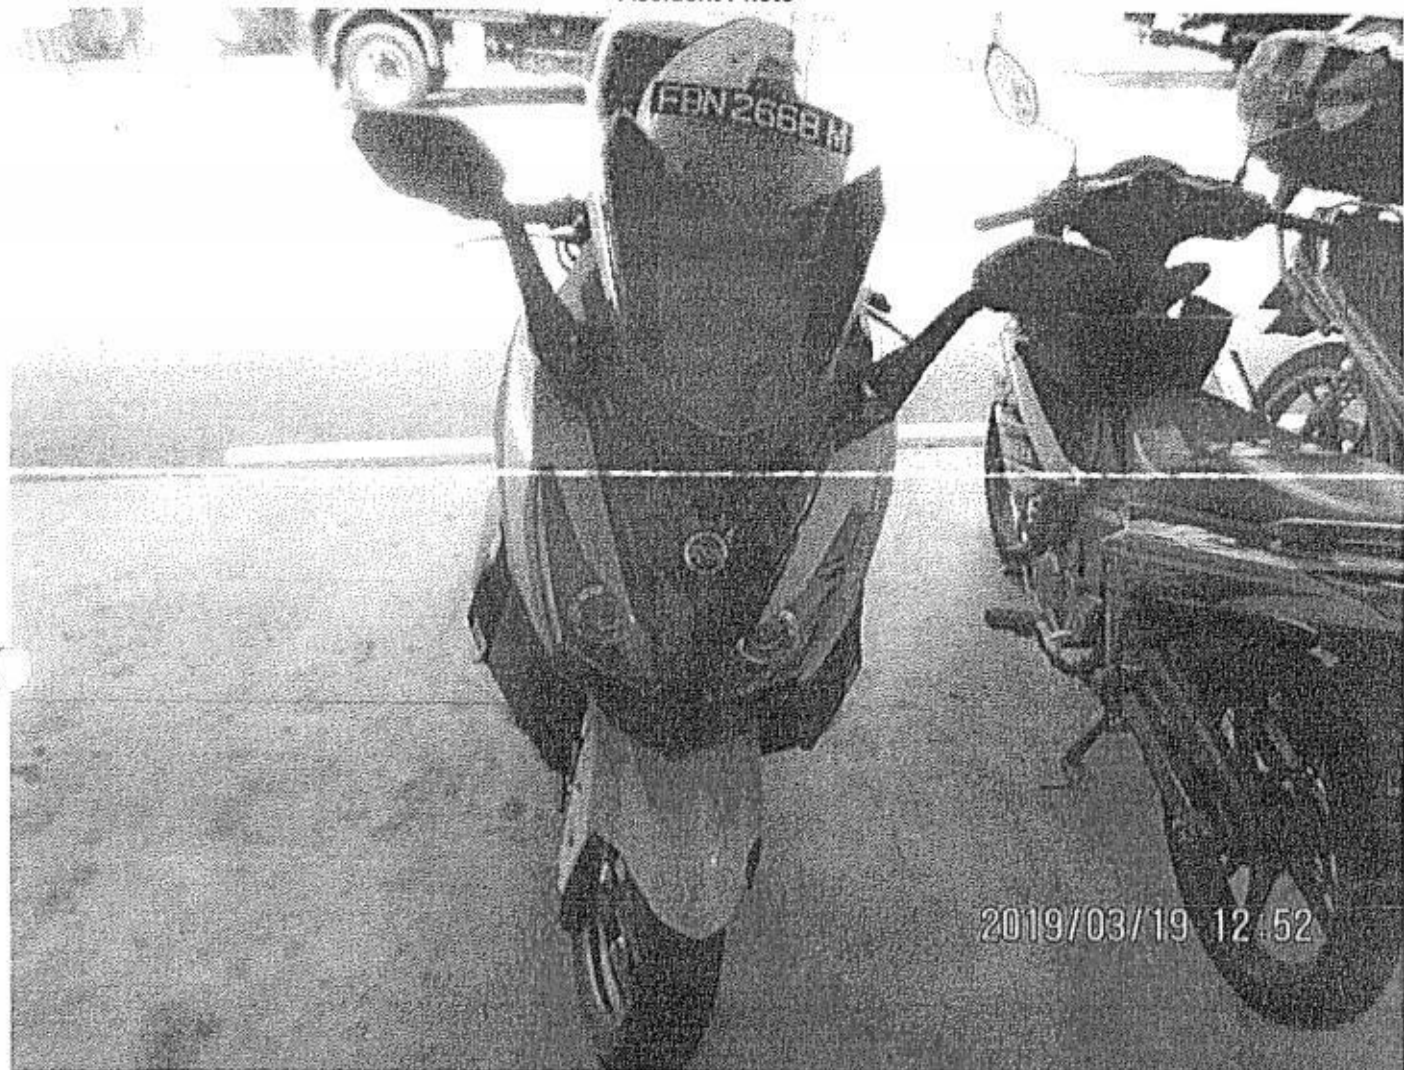
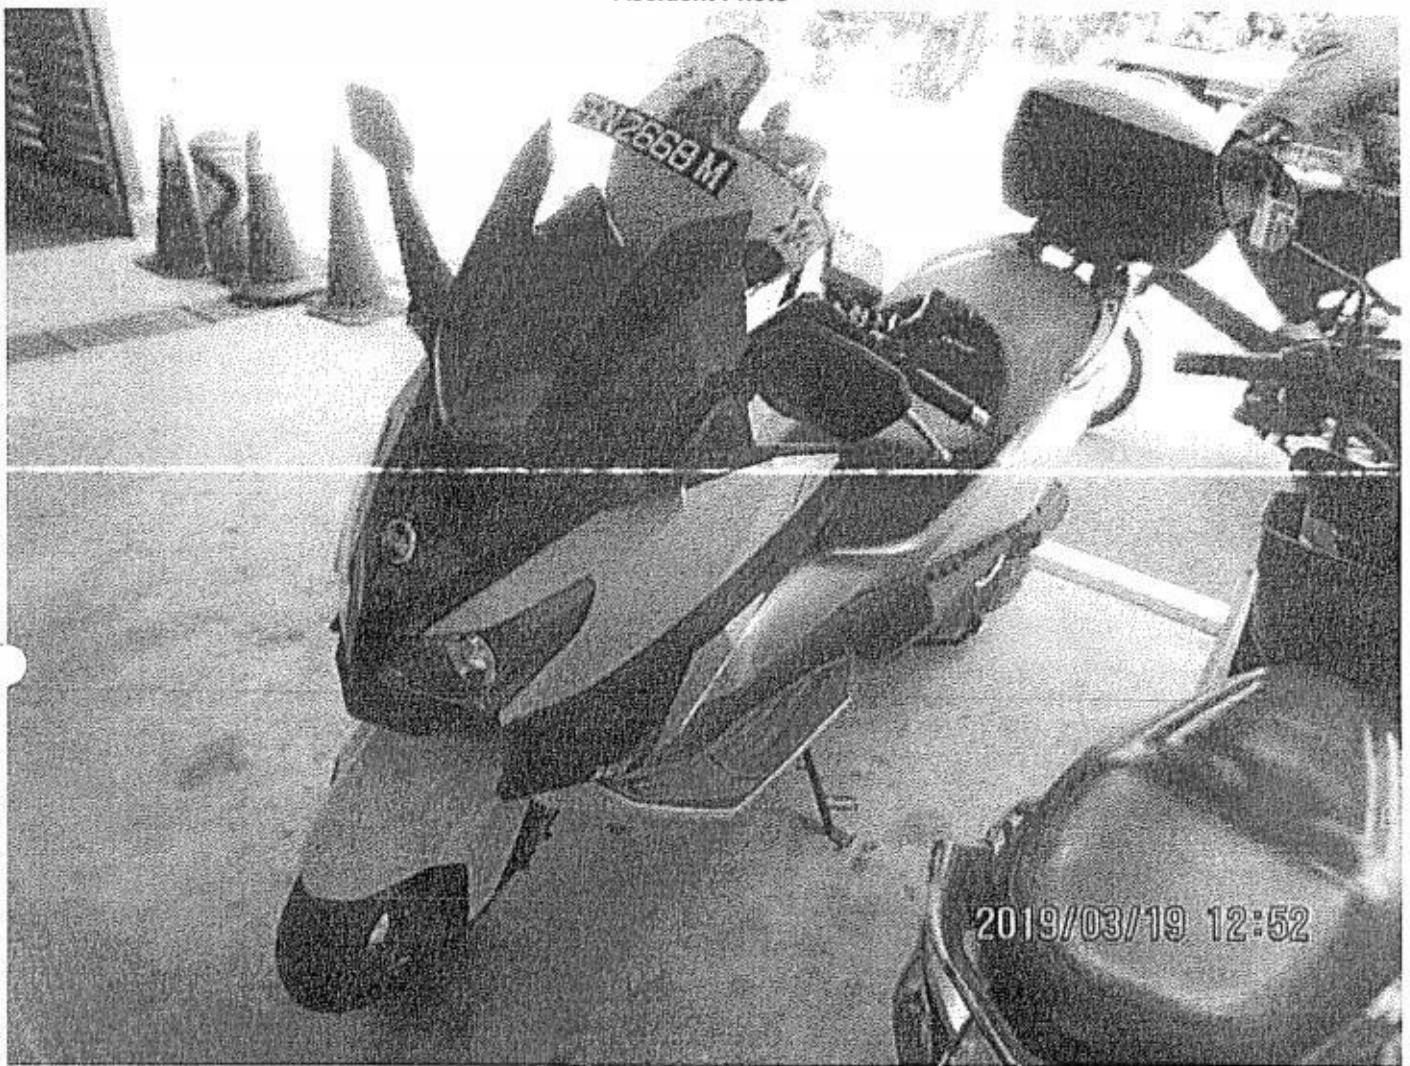
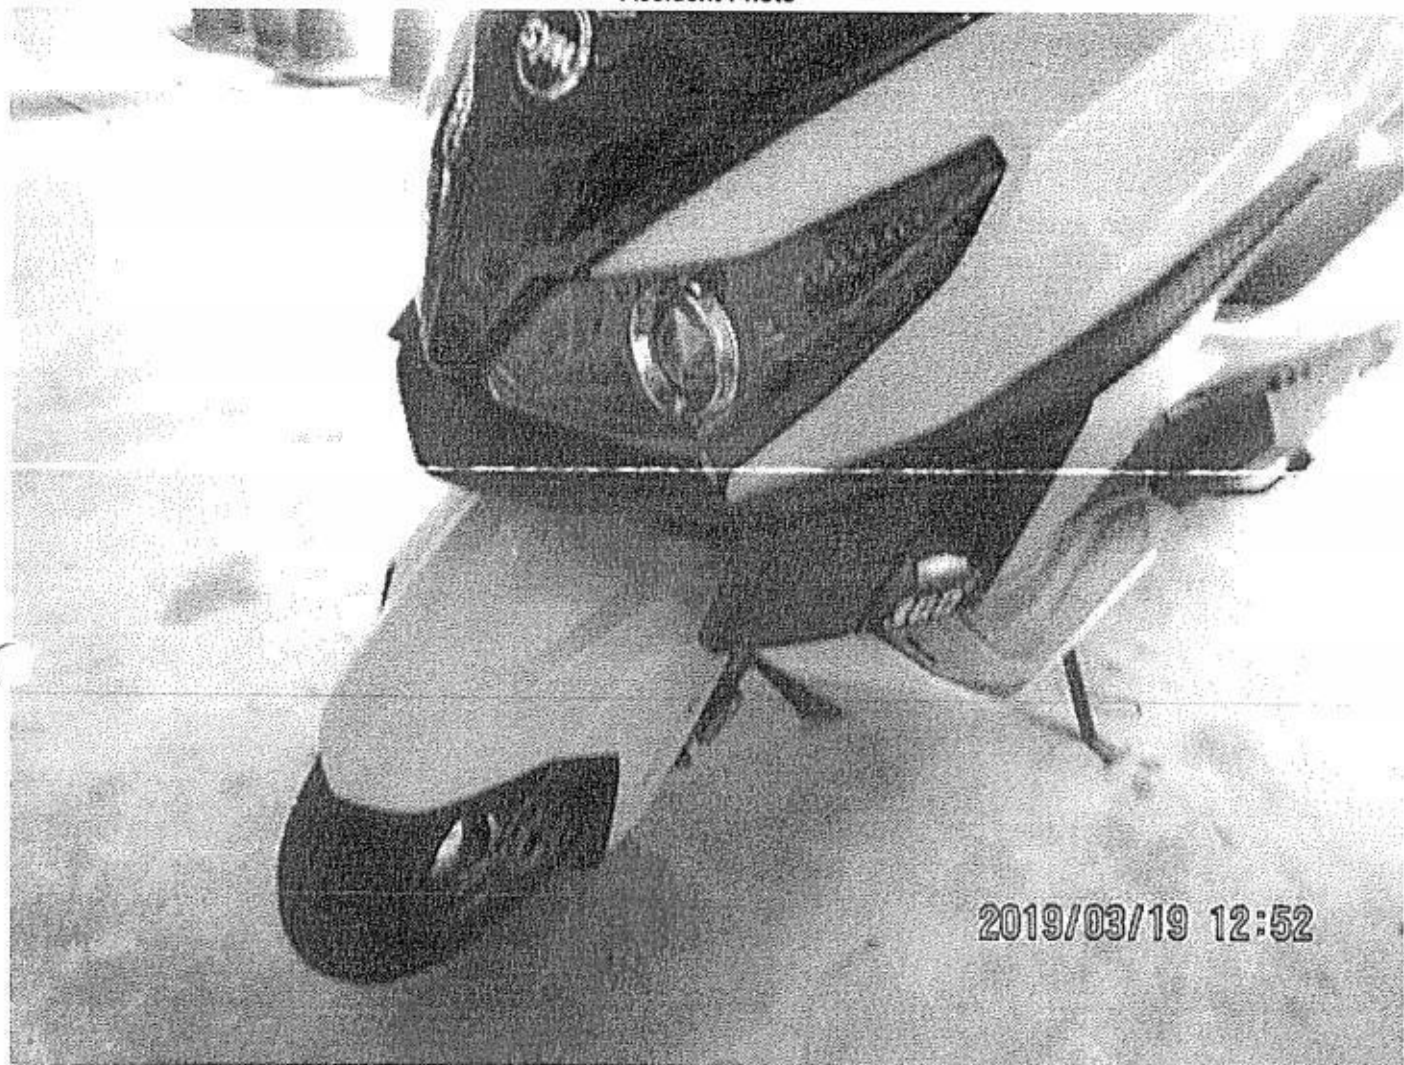
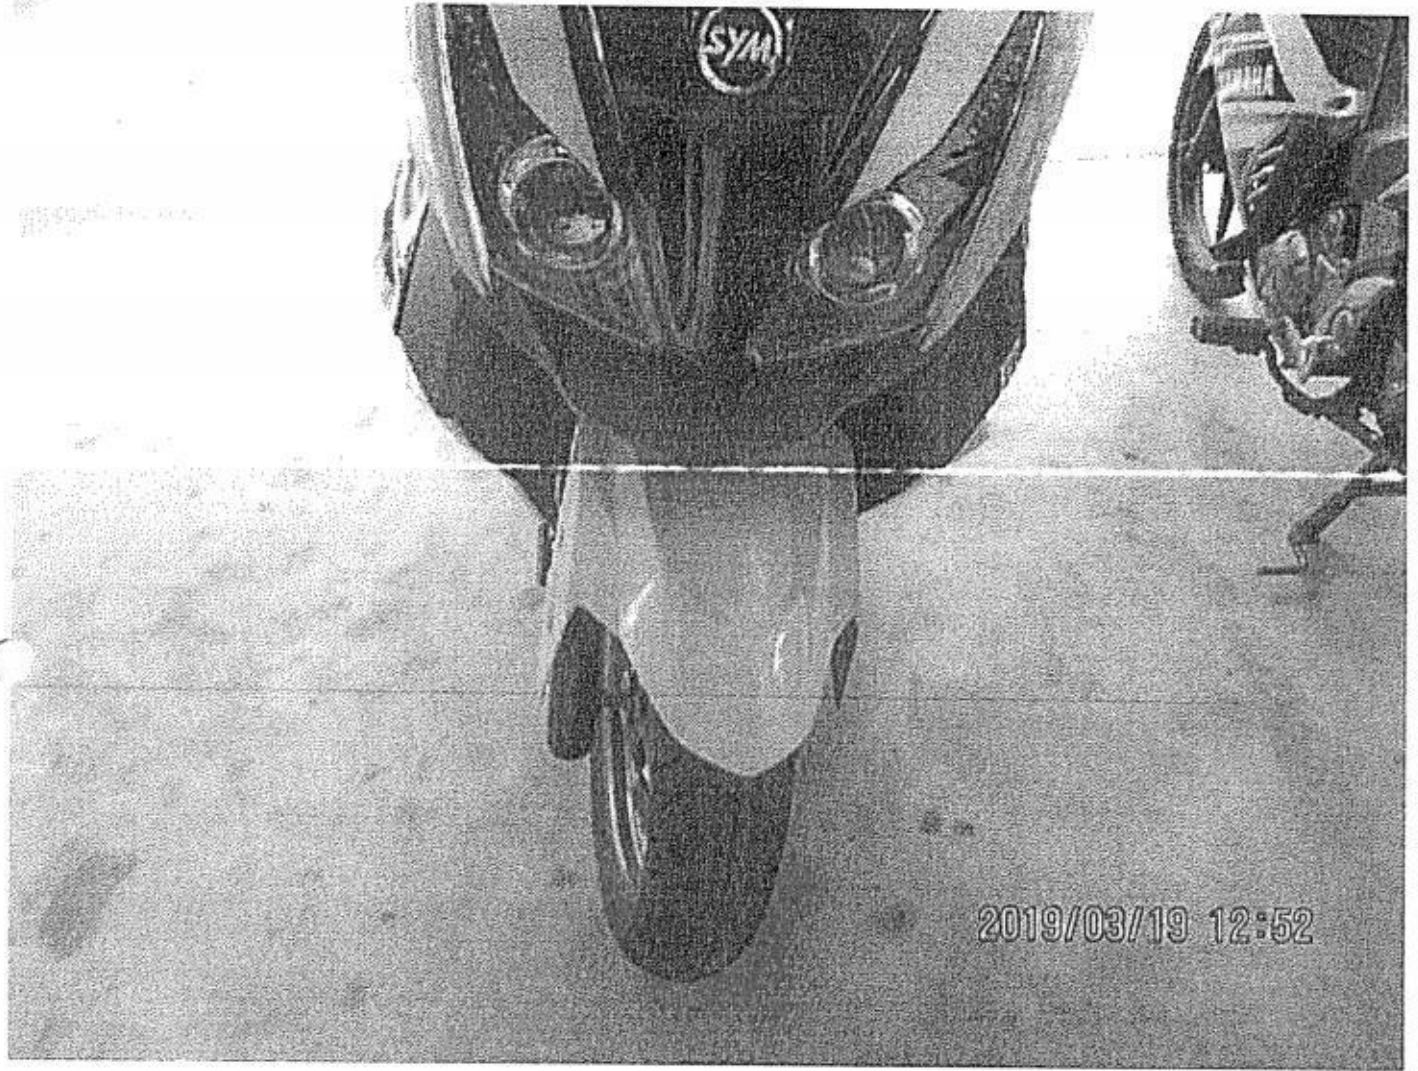
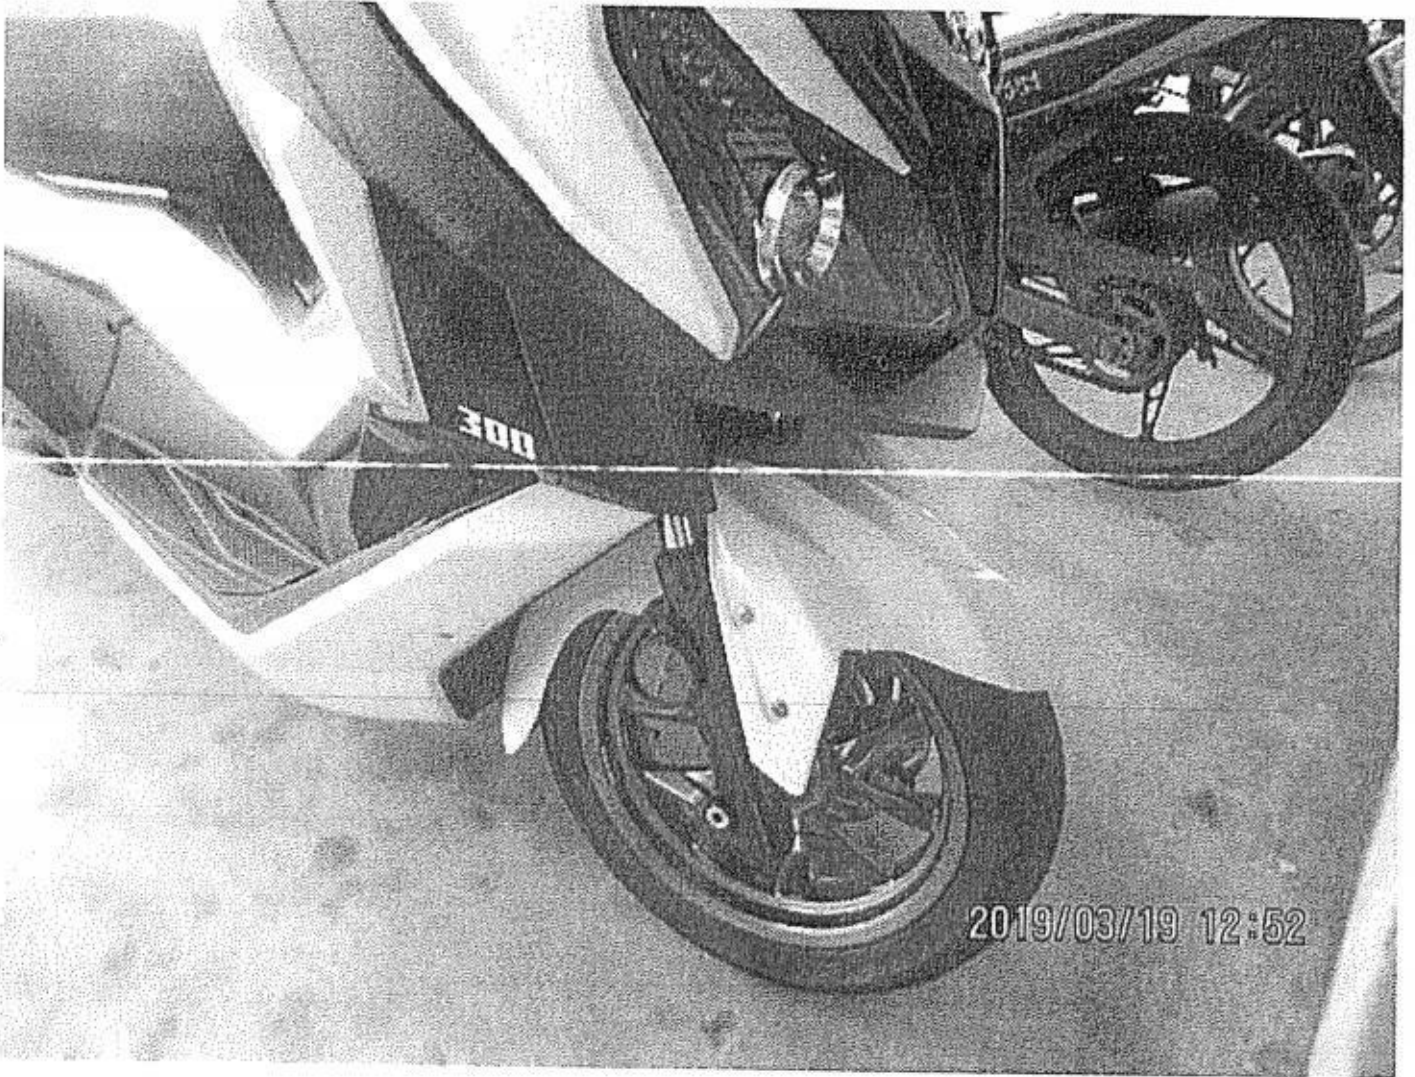
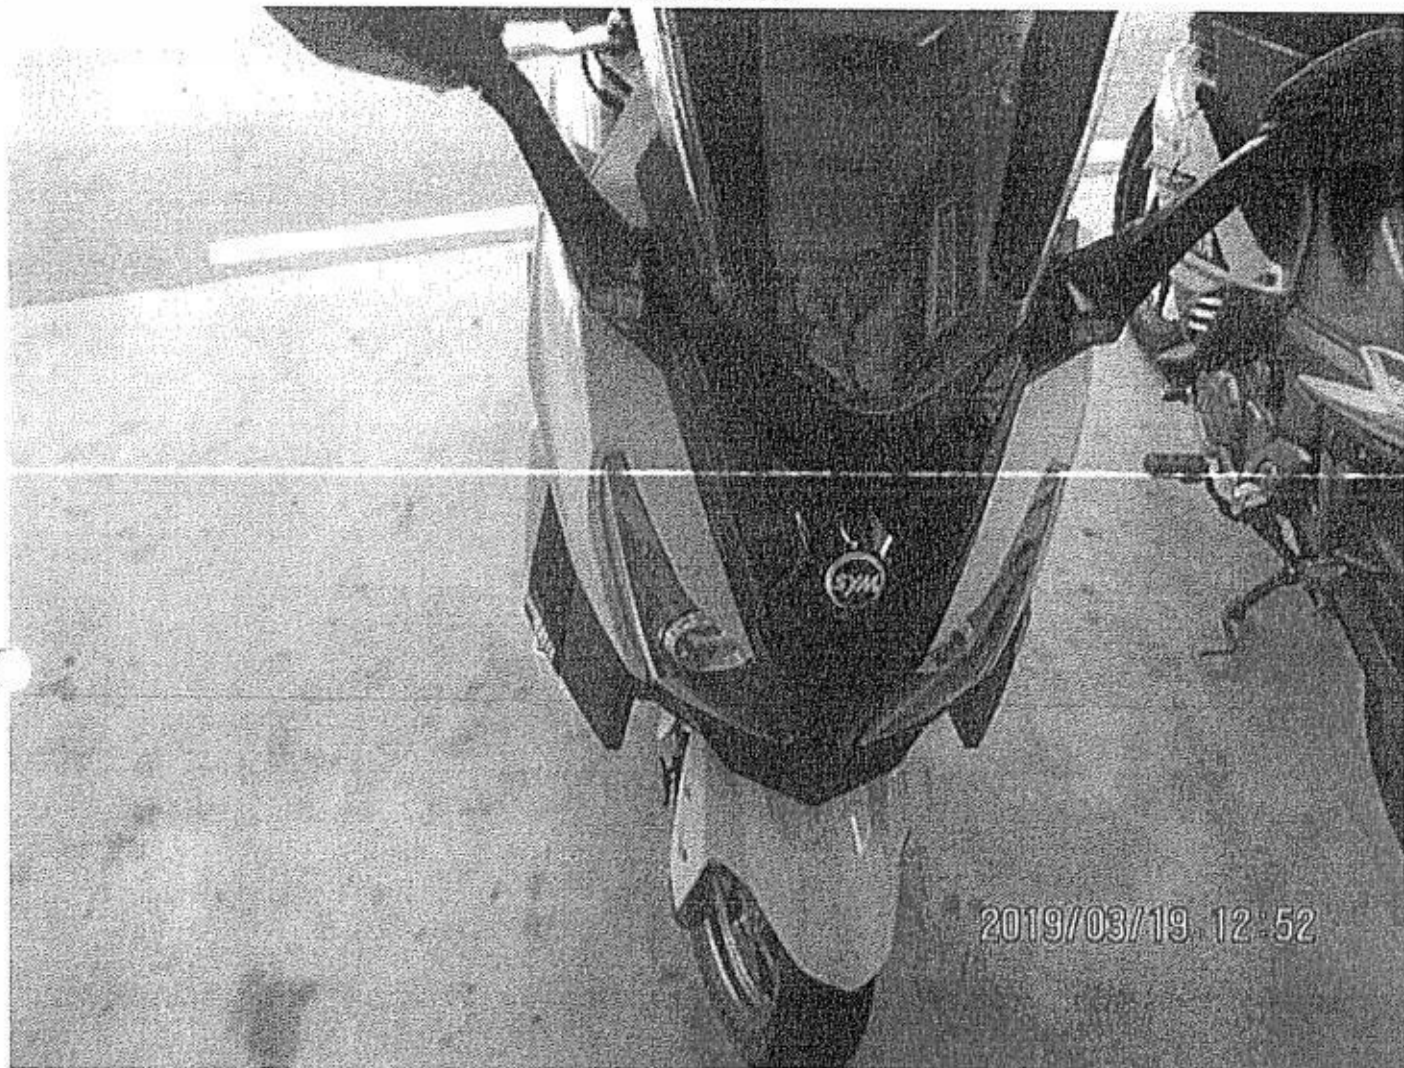
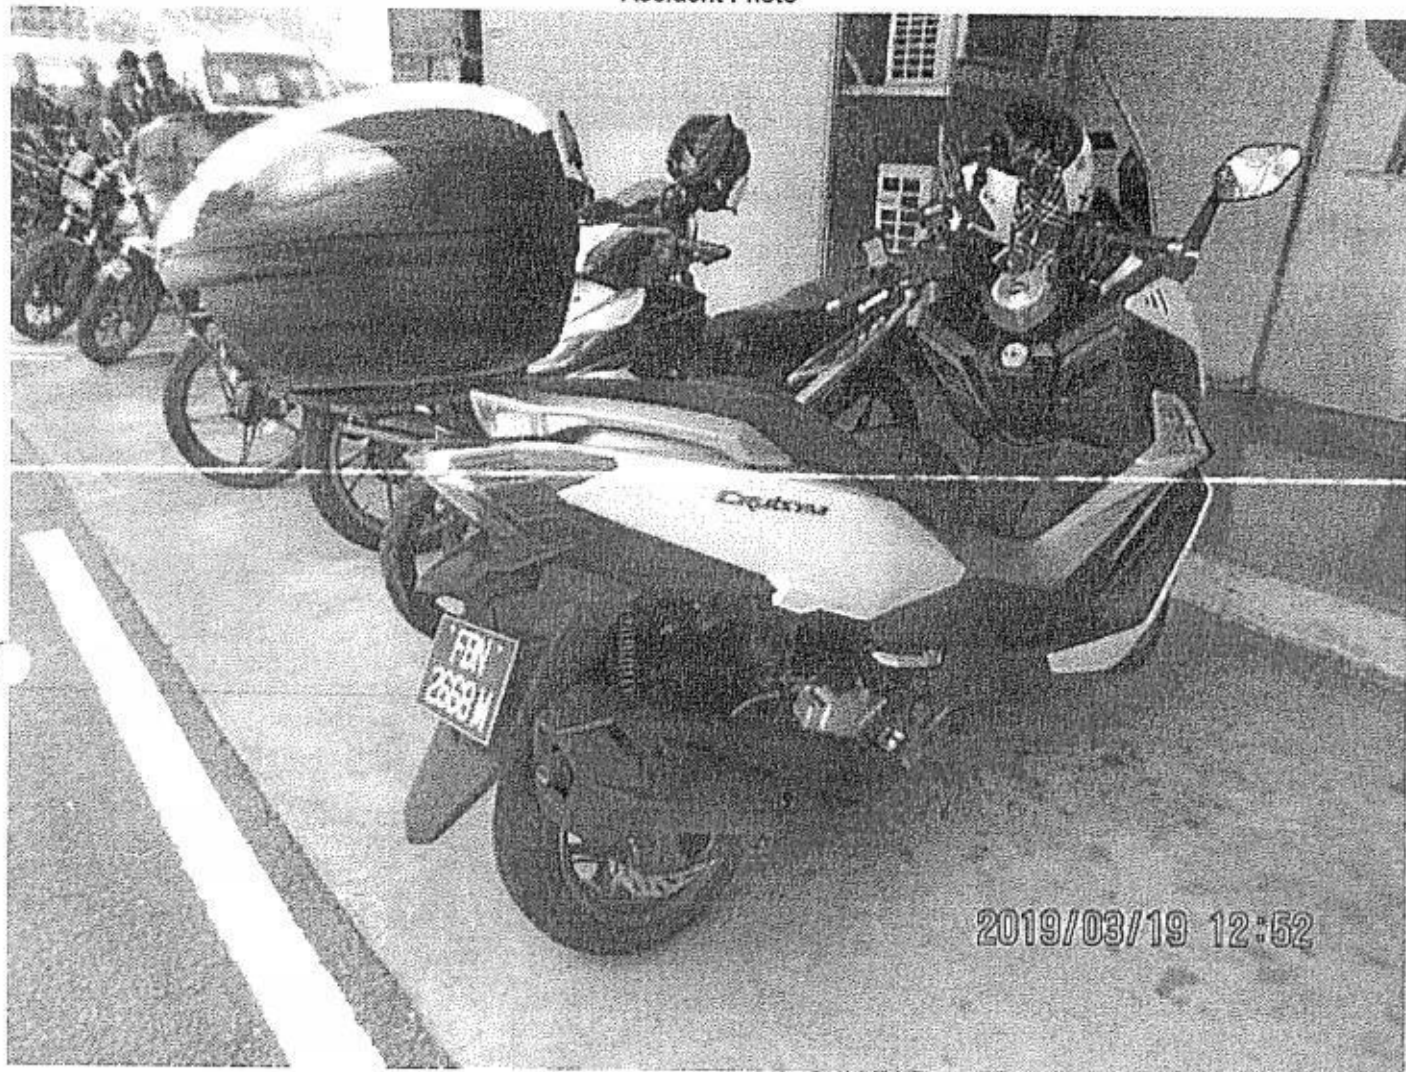
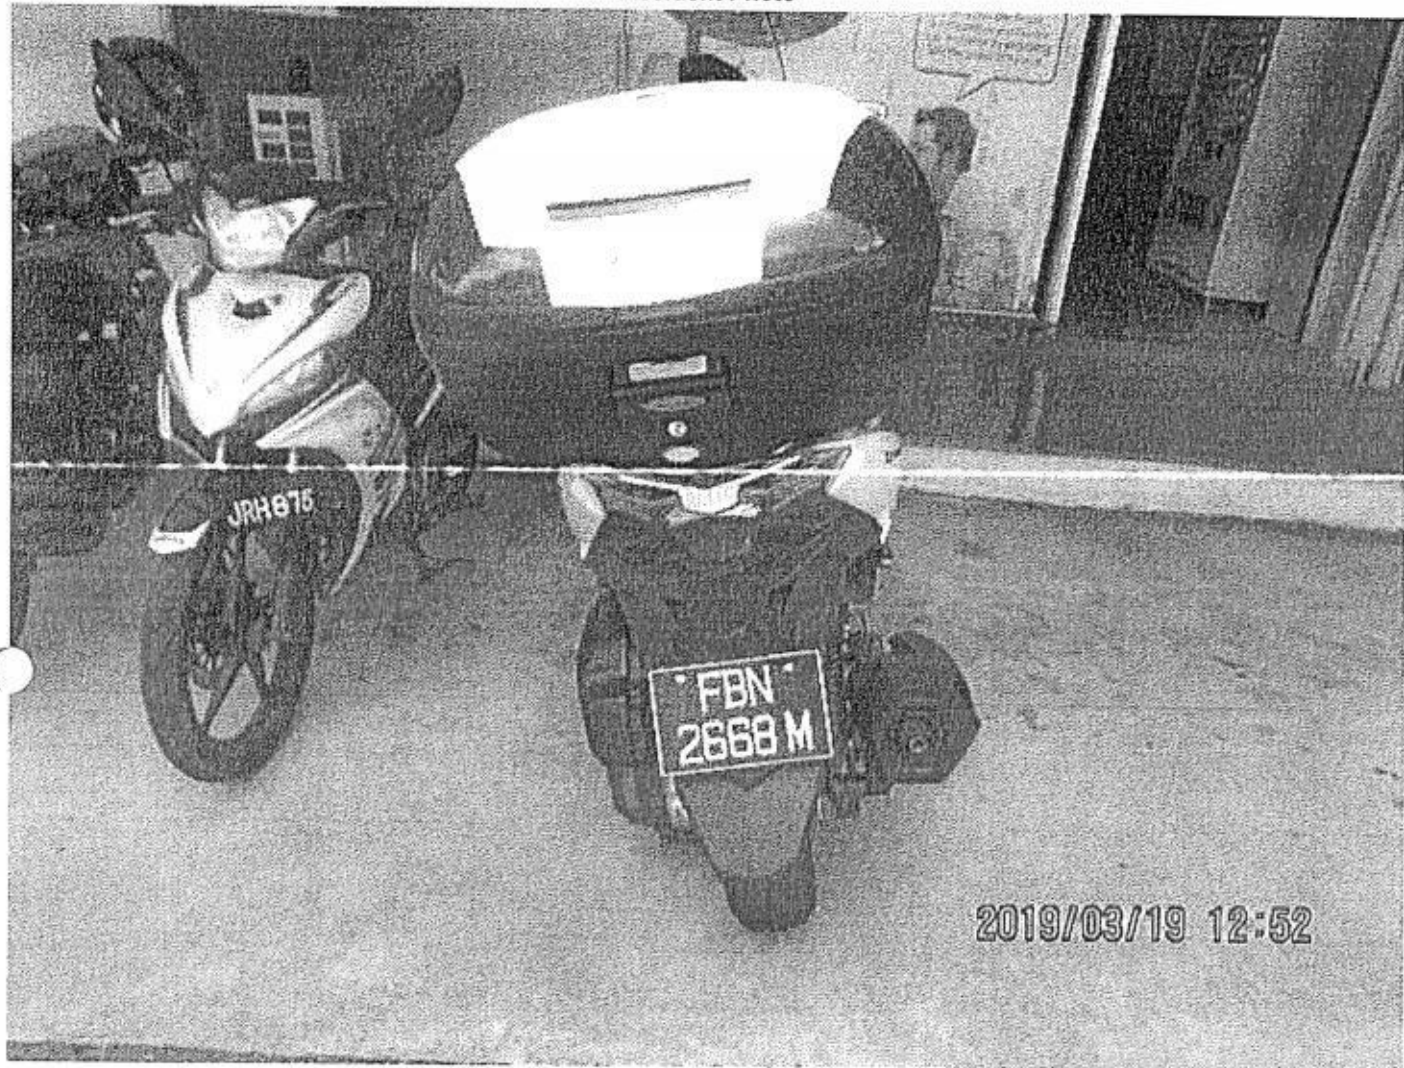
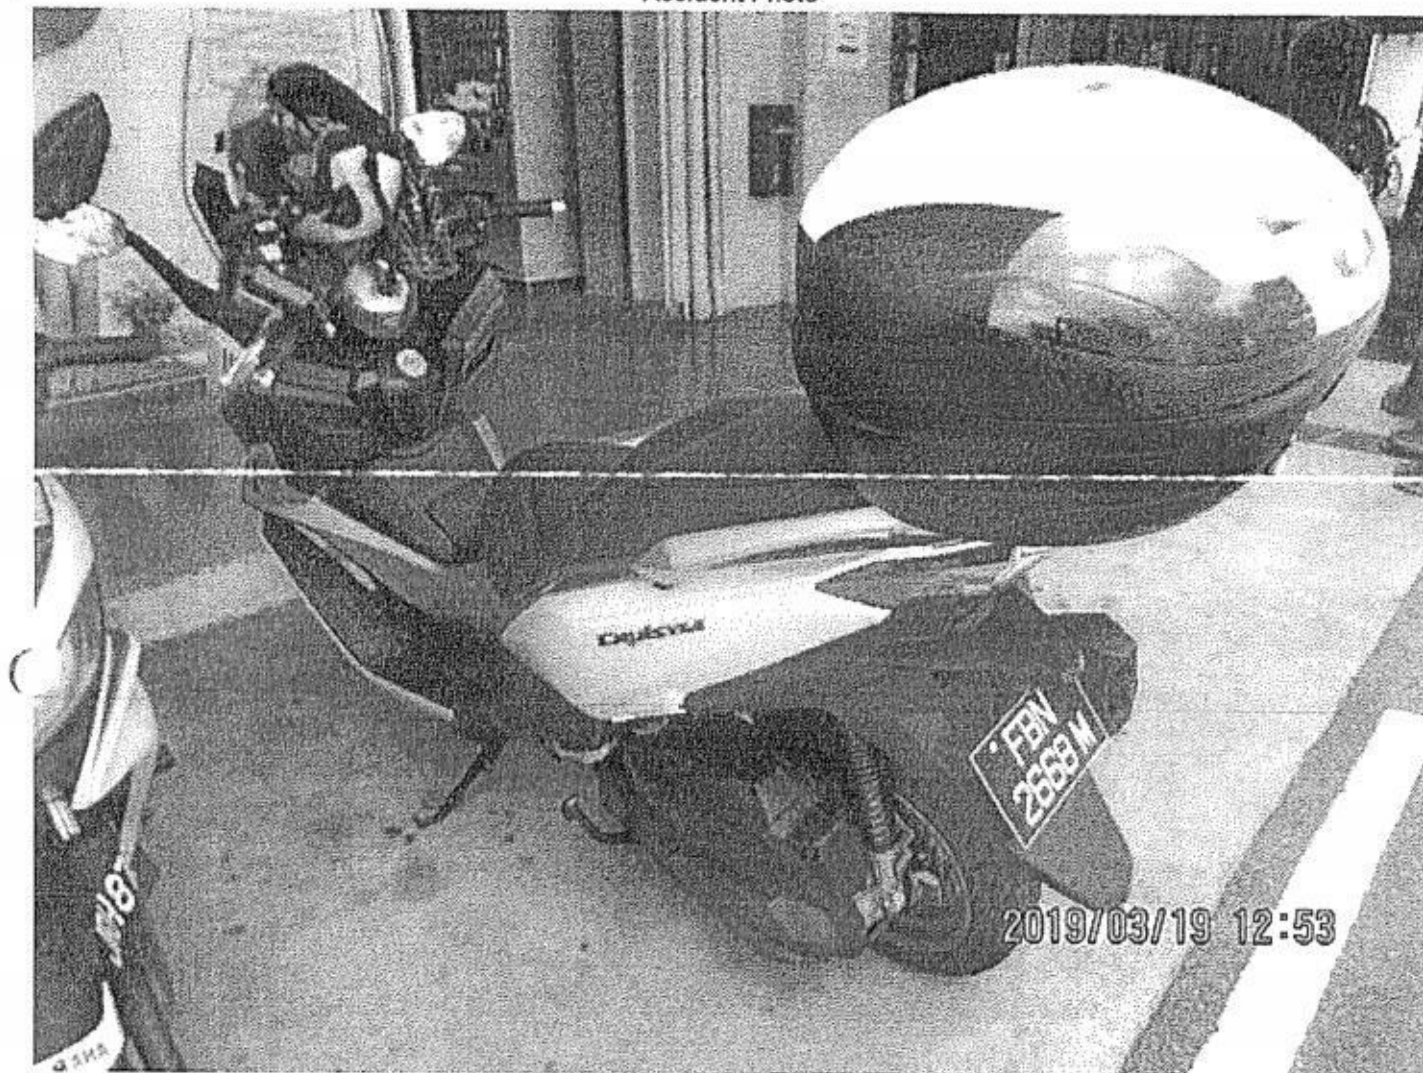
Accident Photo

The impact damages sustained on the vehicle at the time of inspection is on the rear n/s portion.  
(Details refer to the photographs attached)
