**VEHICLE INSPECTION REPORT**

Report No. : PAS/TP/0190818

Vehicle Registration No. : SKG8375Z
Make & Model : Volkswagen Jetta
Date of Registration : 11/10/2012
Colour : White

VEHICLE DAMAGE INSPECTION REPORT

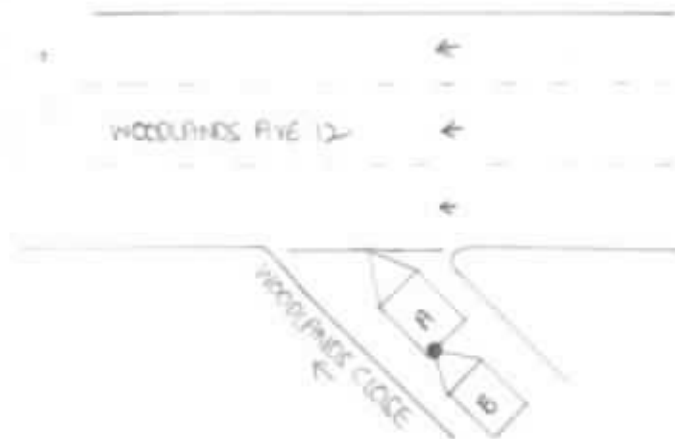
SKETCH PLAN

A - 5K683752
B - 52V2750P

AS PER POLICE REPORT.

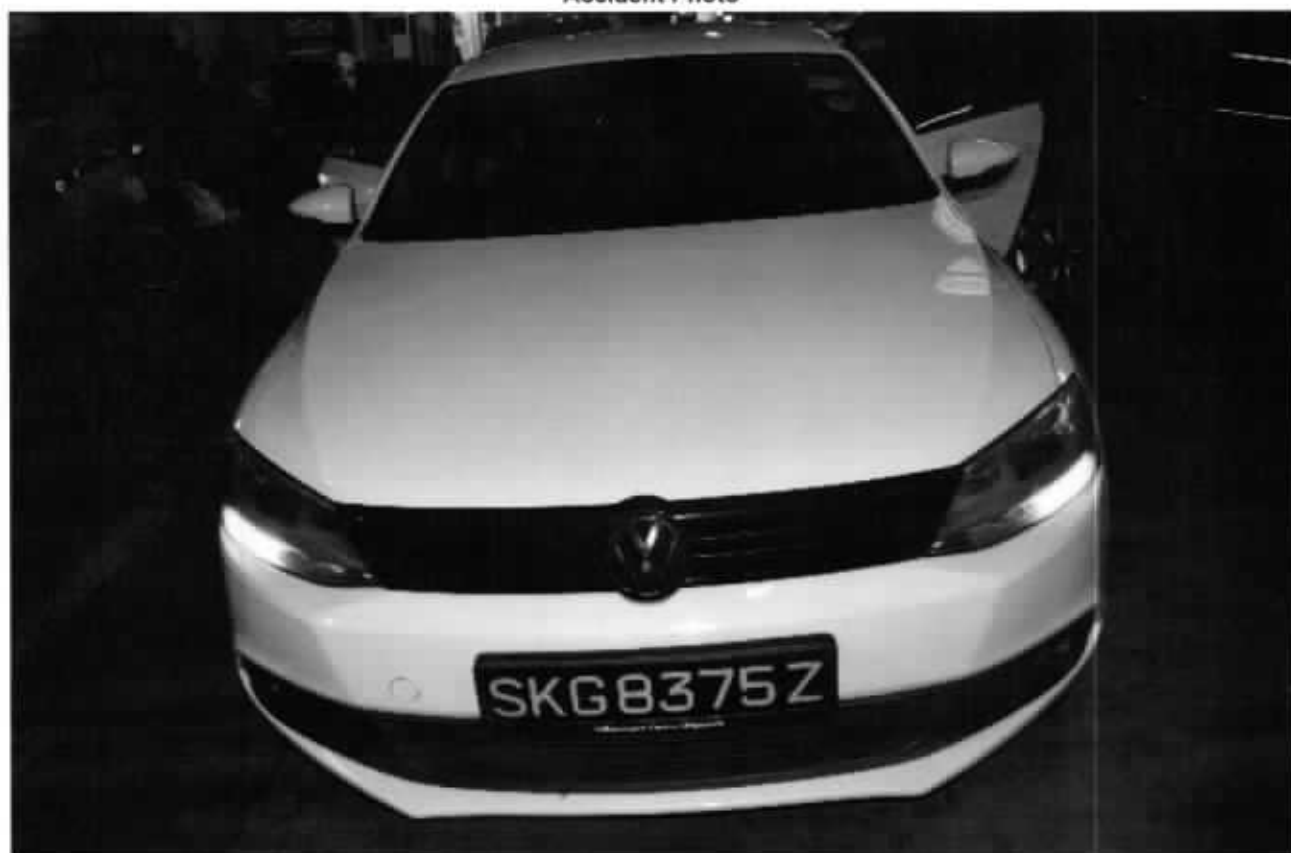
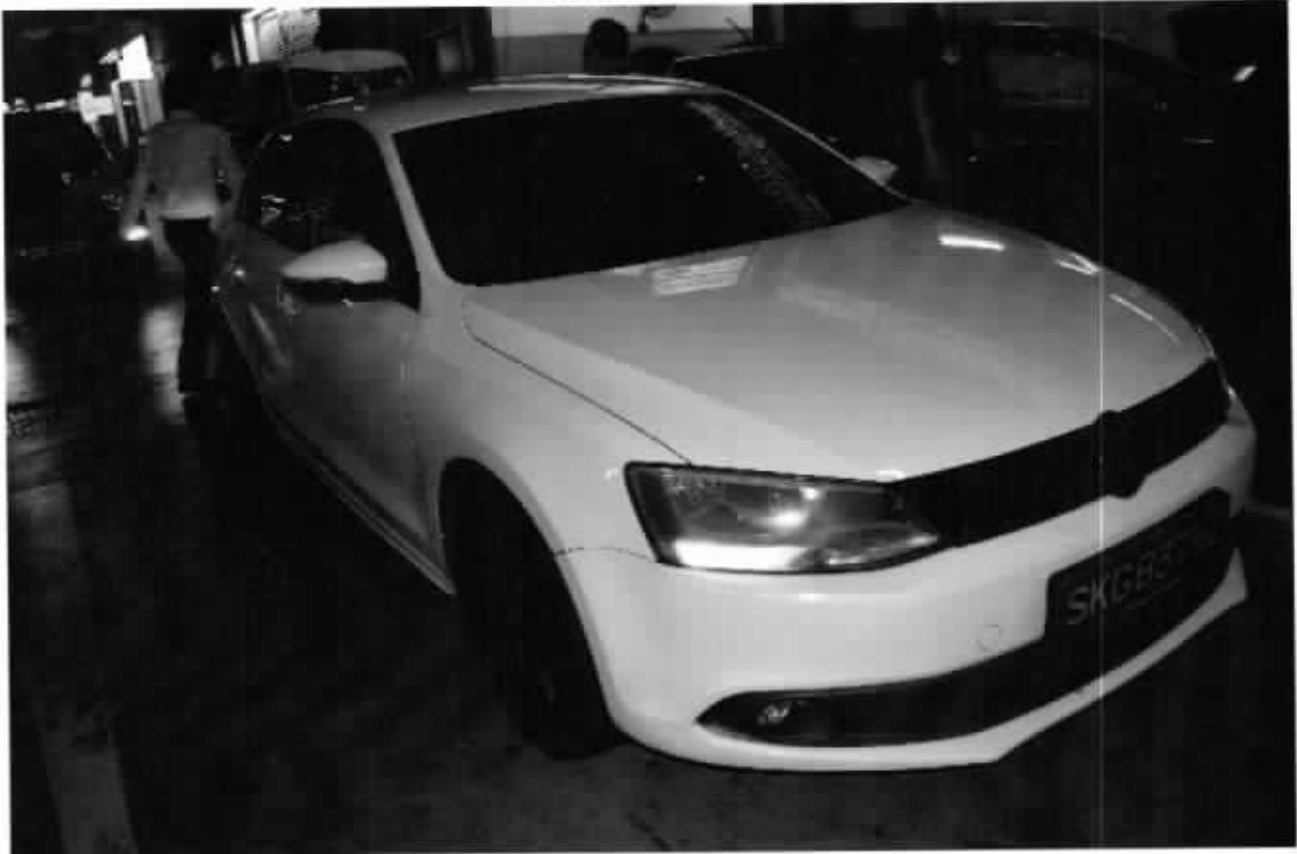
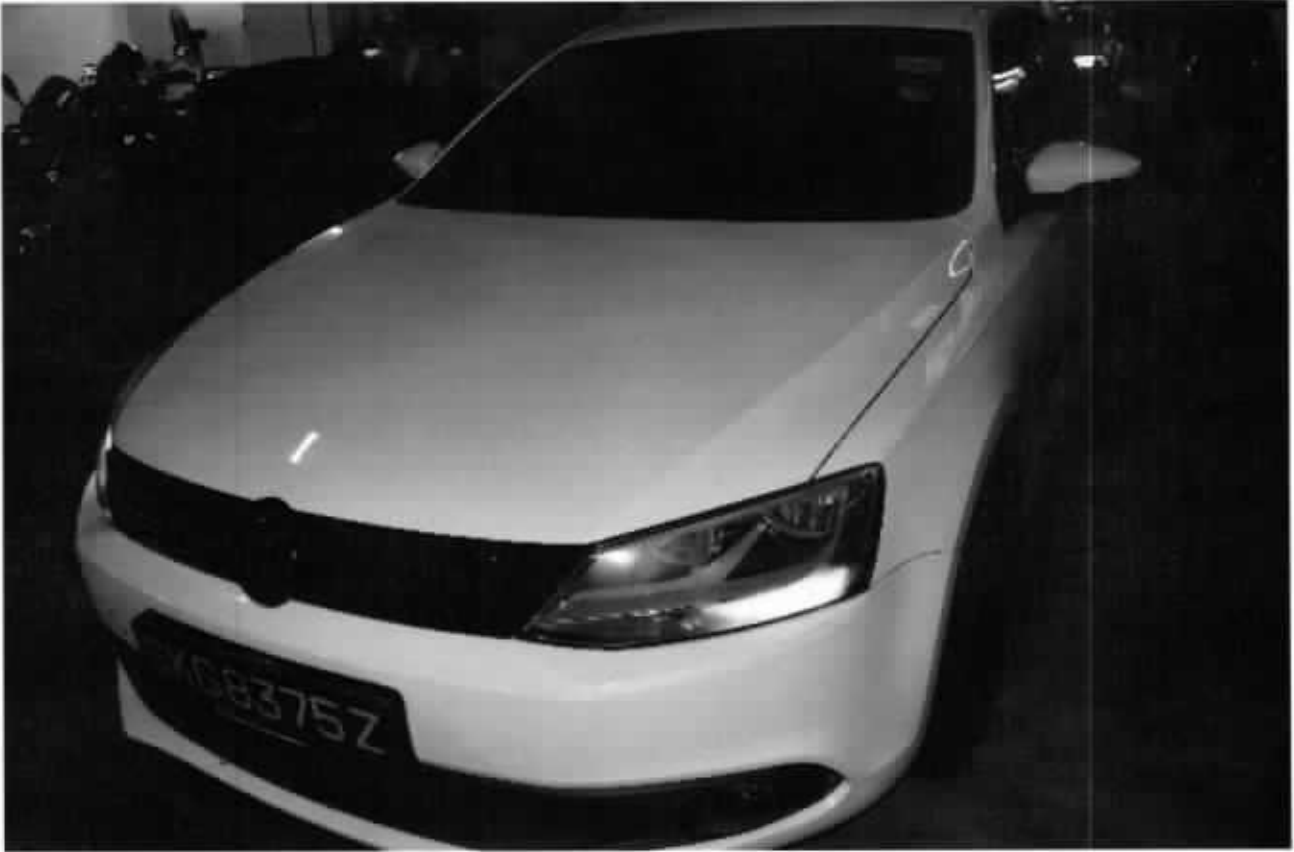
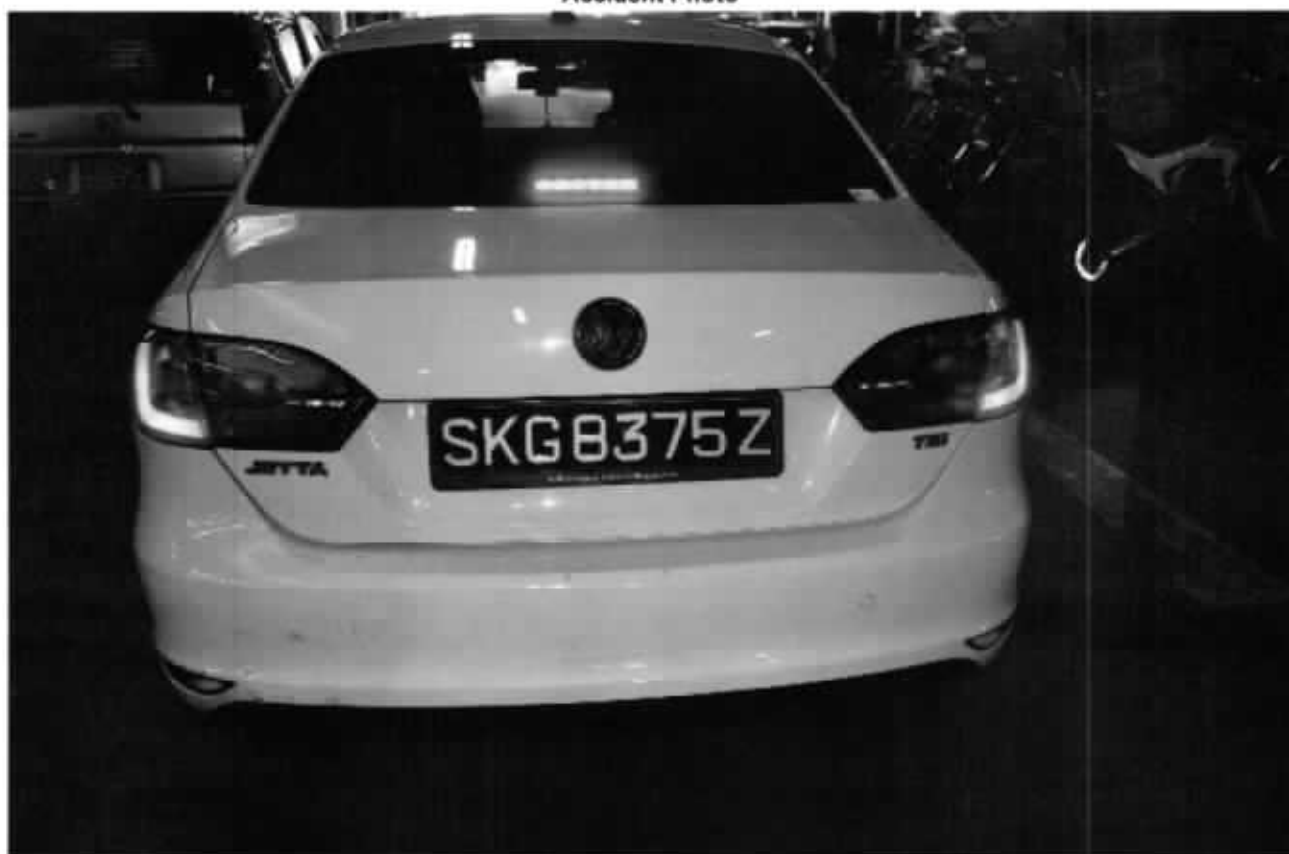
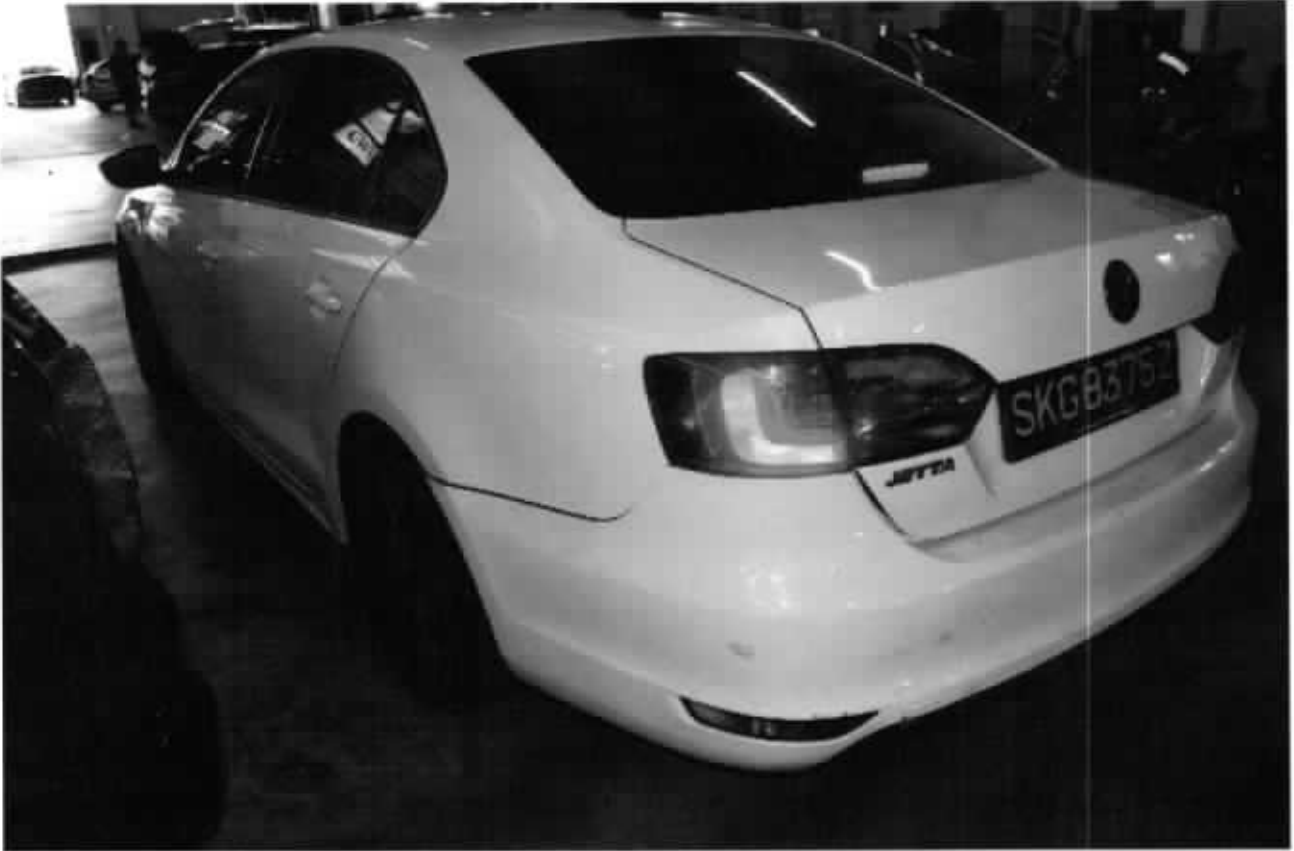
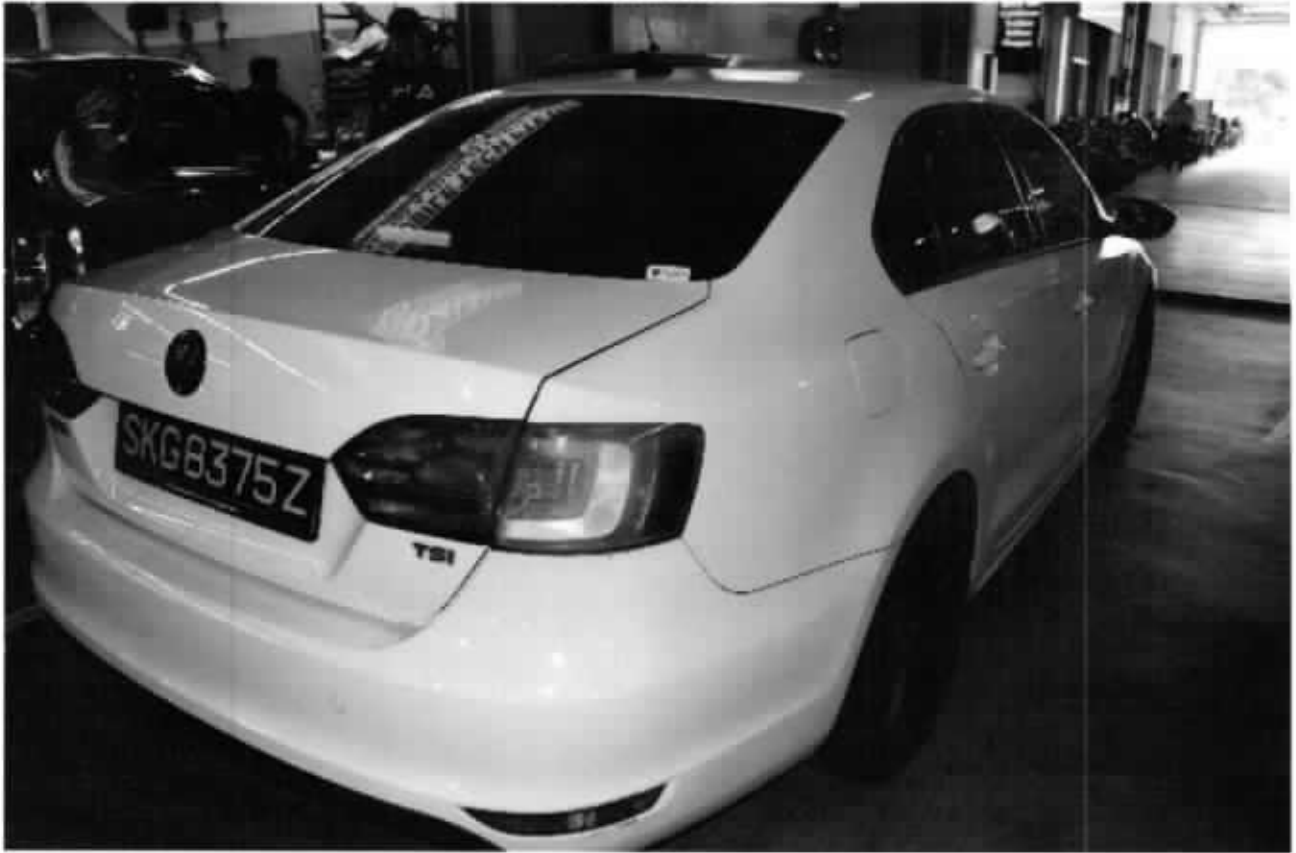
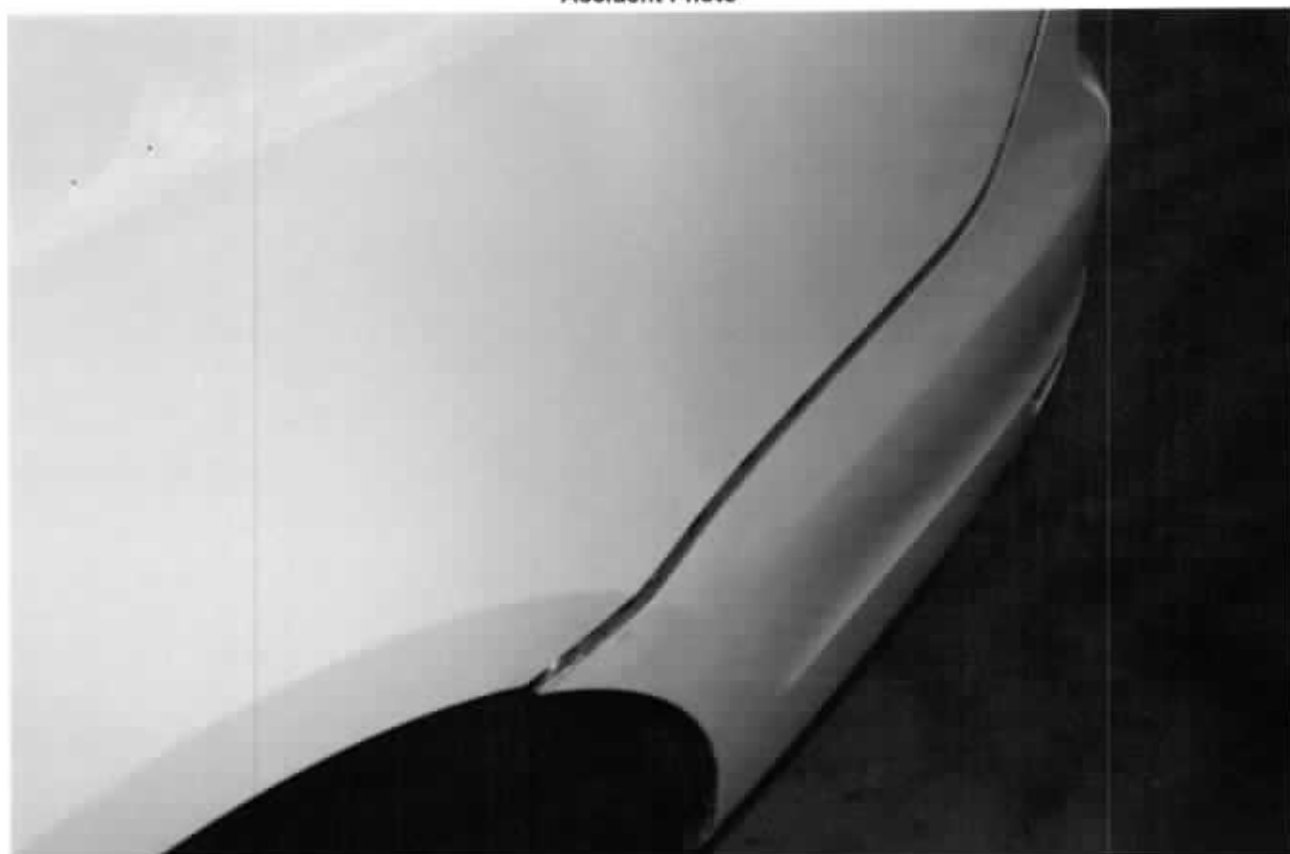
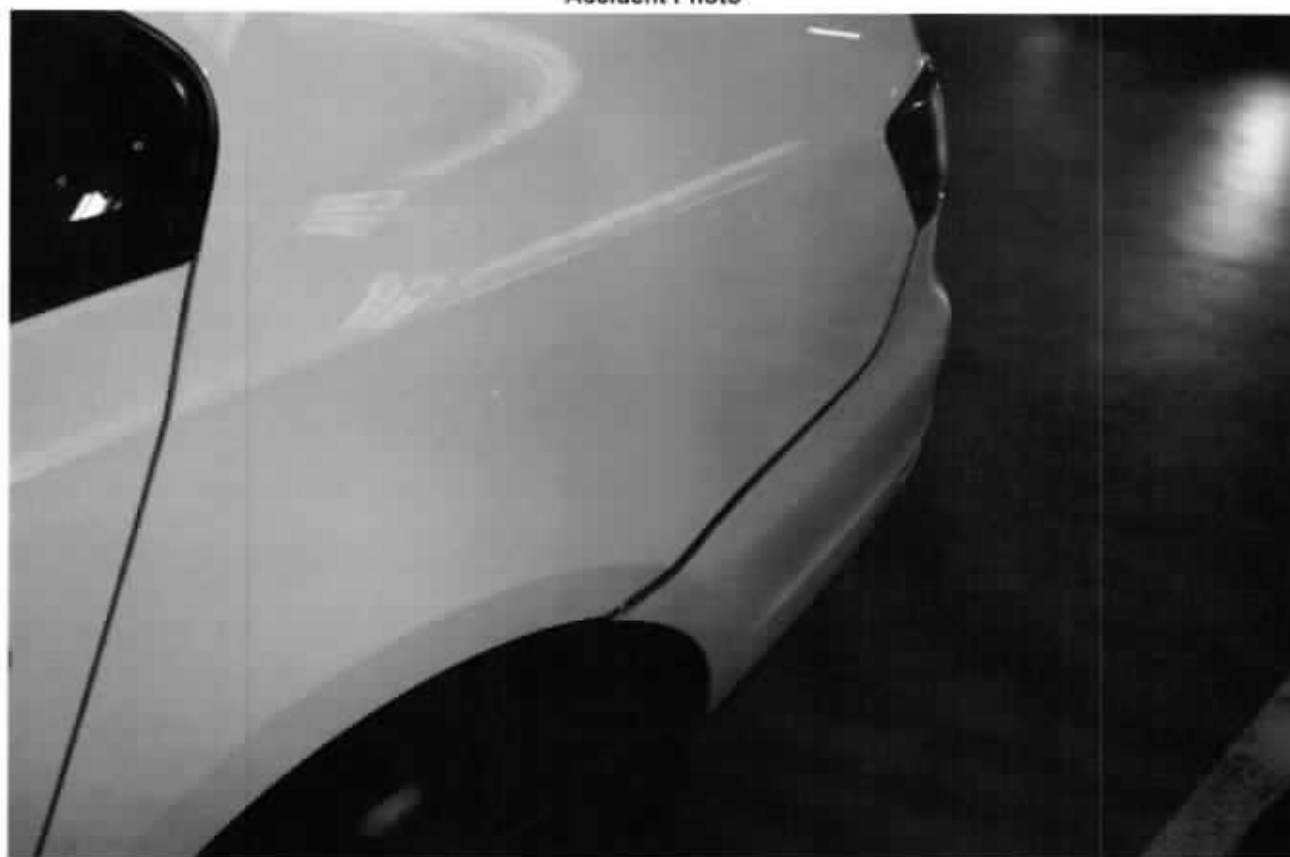
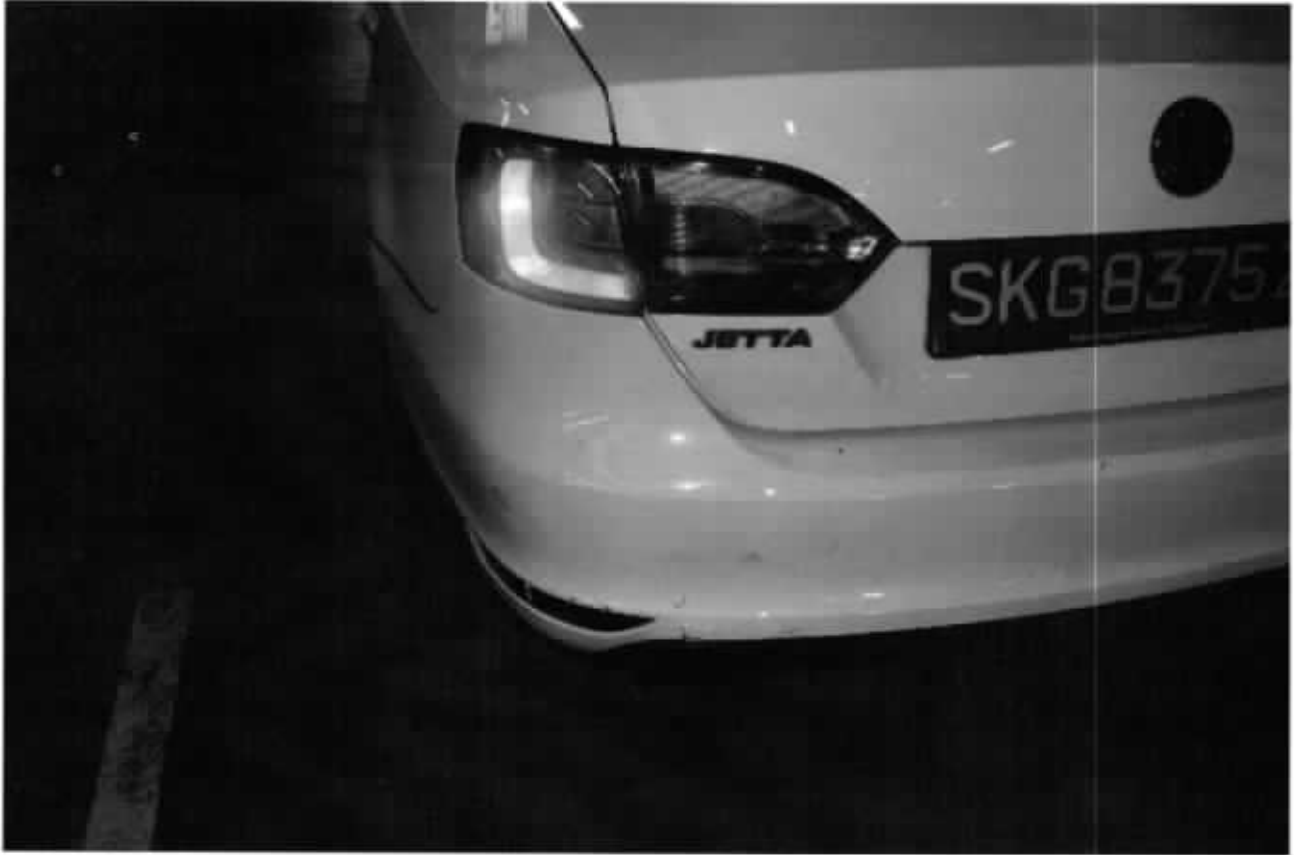
Accident Photo

I was driving as such I stop my car at the stop line, to look out for vehicles coming from my right side. When I stopped my car, suddenly my car moved forward and felt that a vehicle had hit onto my rear side. I asked my passenger about his condition and he informed that was alright. As such I get out from my car to make a checked. I discovered that a car had hit onto my rear side. The other driver came out also. I asked the other driver what happened and he informed that he was driving and was looking on his right side for incoming vehicles however he did not notice my car that was in front. Thus he was unable to stopped his vehicle and hit onto my car rear side.

Both of us took photos of our car and damages. Both of us exchange particulars. The driver was not injured, no visible injuries. No medical attention required. I told the driver that I send to my car to the workshop and access the damages fee, he agreed. He also wish to settle privately.
