MOTOR SURVEY ASSIGNMENT

INITIAL INSPECTION REPORT OF VEHICLE NO. PA 786X.

ADJUSTMENT ON REPAIR COST FOR VEHICLE NO. PA 786X

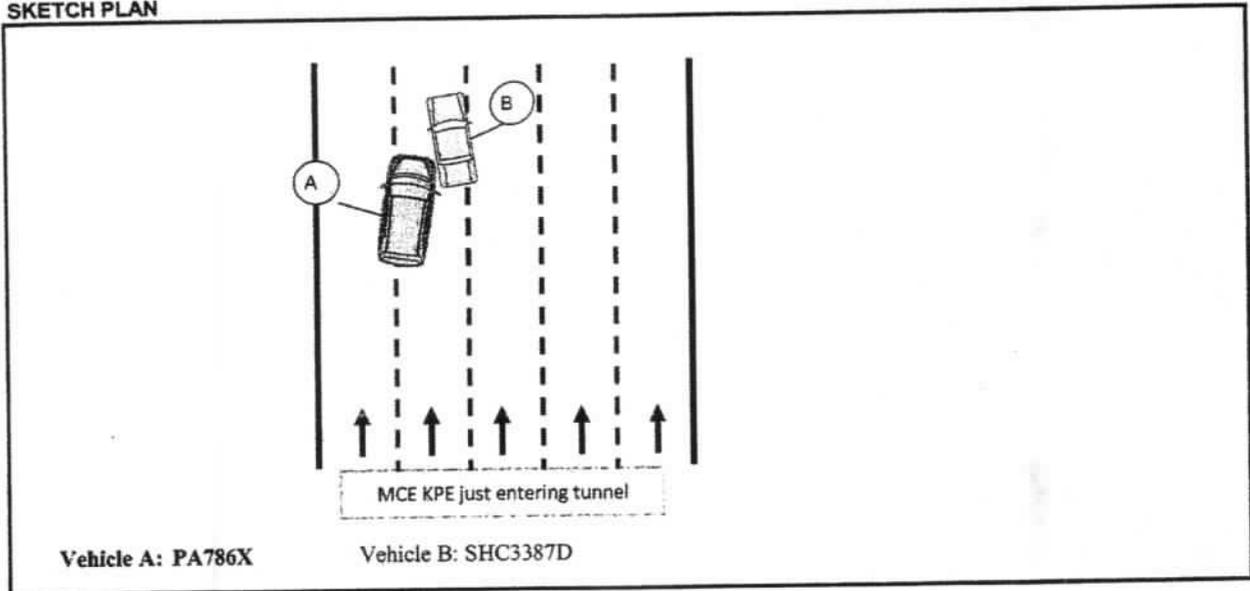
SKETCH PLAN

I was making the lane change from lane 5 to lane 4 after checking for safety. While I was almost completing the lane change, vehicle B changed lane from lane 3 to lane 4, from my rear right. Vehicle B sped up and overtook my vehicle A. This resulted in the left rear wheel area of vehicle B to side swipe into the right front wheel area of my vehicle A.

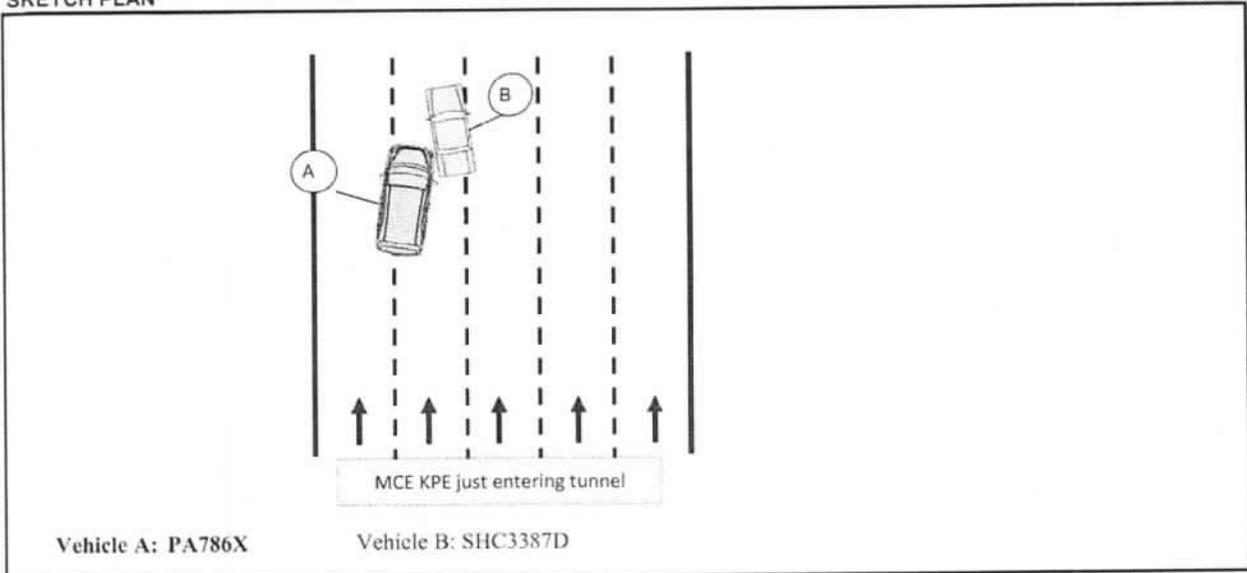
SKETCH PLAN

I was making the lane change from lane 5 to lane 4 after checking for safety. While I was almost completing the lane change, vehicle B changed lane from lane 3 to lane 4, from my rear right. Vehicle B sped up and overtook my vehicle A. This resulted in the left rear wheel area of vehicle B to side swipe into the right front wheel area of my vehicle A.
