THIRD PARTY SURVEY ACCIDENT HAPPENED ON 22 May 2018

As per your instruction dated **28 May 2018** with regard to the above matter. We have carried out a physical inspection on the said vehicle **SLP 3379 L**. We enclosed herewith our report and findings as follows:

1. Policy Particulars :- THIRD PARTY CLAIM			
Insured Veh.	SJH 1289S	Veh. Inspected	SLP 3379L
Policy No.		Coverage (\$)	0.00
Claim No.	1201800006319	Excess (\$)	0.00
Assign From	JOSEY LOH	Assign Date	24/04/2019

ADJUSTMENT ON REPAIR COST FOR VEHICLE NO. SLP 3379L

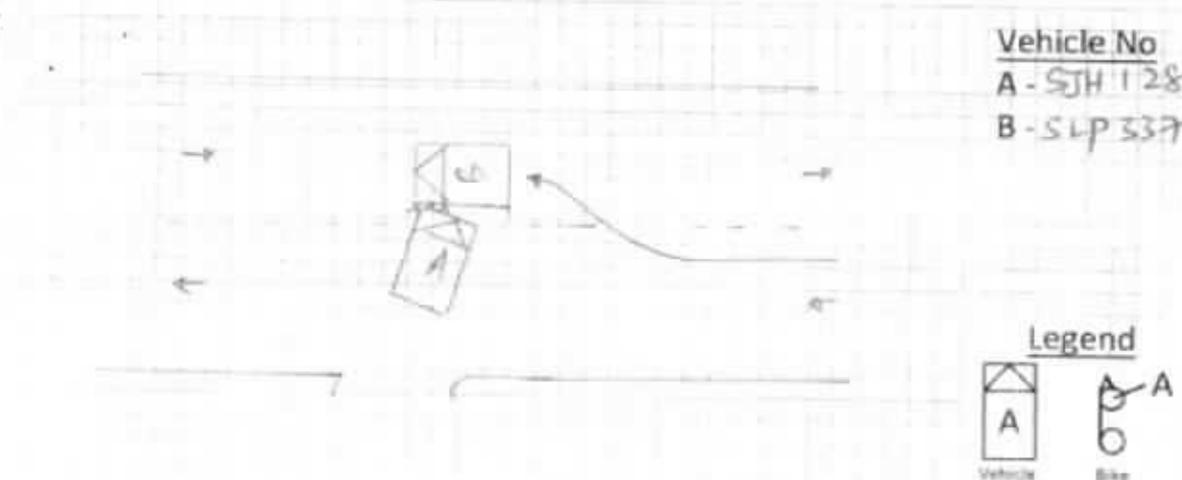
Sketch Plan #2

After check oncoming vehicle was cleared so i proceeded to move out. Out of sudden, a vch B from numbers side swipe onto my front left portion while i'm almost finish my proceed way.
