Insured Vehicle No	: XE3188L	Accident Date	: 27/04/2019
TP Vehicle No	: PC746B	Assignment Date	: 29/04/2019
Make	: GOLDEN DRAGON XML6957J14	Est. Duration of Repair	: 7.00
Date of Inspection	: 30/04/2019		
Inspection At	: CONNECT3 (HQ) 566 WOODLANDS ROAD SINGAPORE 728697

Point of Impact / General Description of Damages

VEHICLE DAMAGE INSPECTION REPORT

Our File No: CS/MSG19007518/JQD3Q2
Date: 17/05/2019

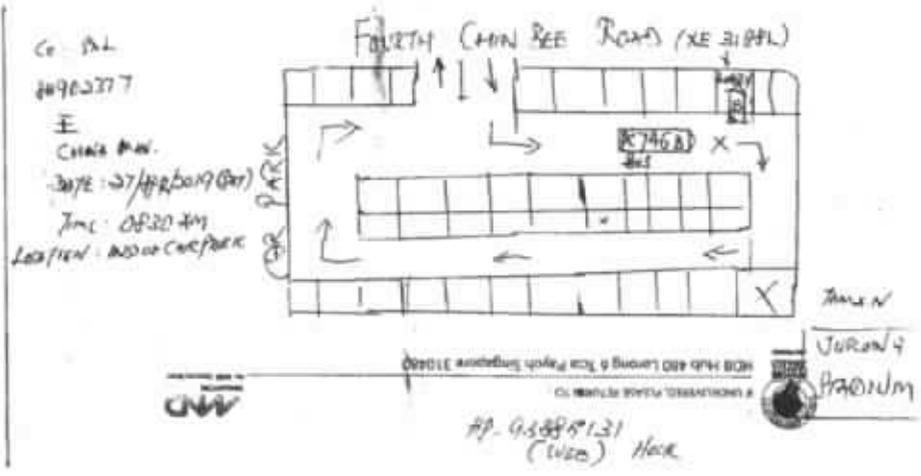
Accident Sketch Plan Pg. 1

On 27/04/2019 @ 08:30hrs, I was driving my car PC 746B into Fourth
 Chin Bee Road Carpark intend to park my car. While I was driving
 straight, a lorry XE3188L suddenly reversed out from the lot & hit
 onto my car LH pylon while I was driving past.
