Accident Date : 16 March 2019
Inspection Date : 21 March 2019
Repairer Name : Jementah Motor Works
Blk 14 Defu Lane 10
#01-406 Singapore 539195

The impact damages sustained on the vehicle at the time of inspection is on the rear portion.
(Details refer to the photographs attached)

VEHICLE DAMAGE INSPECTION REPORT

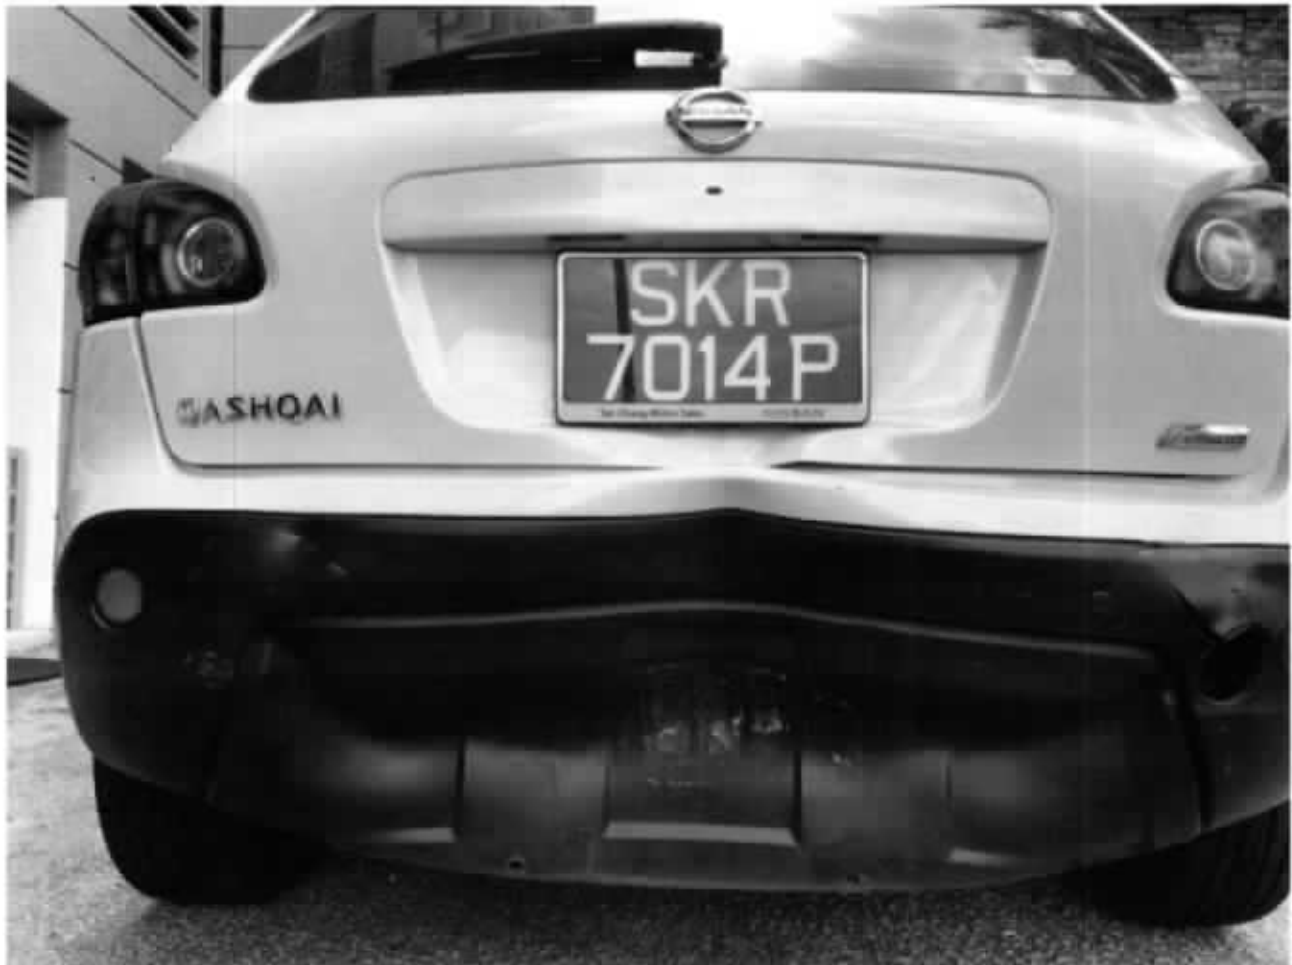
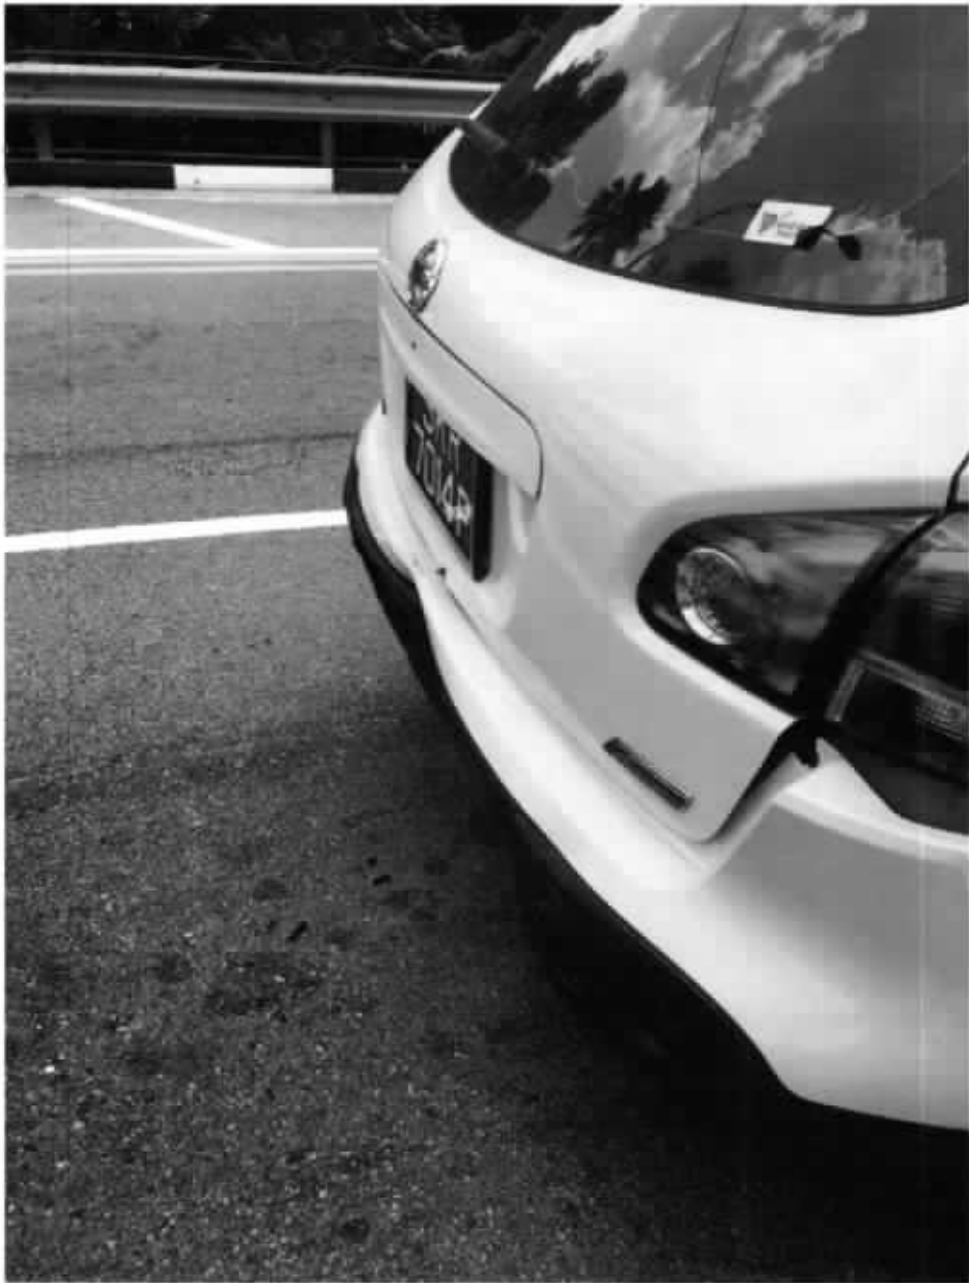
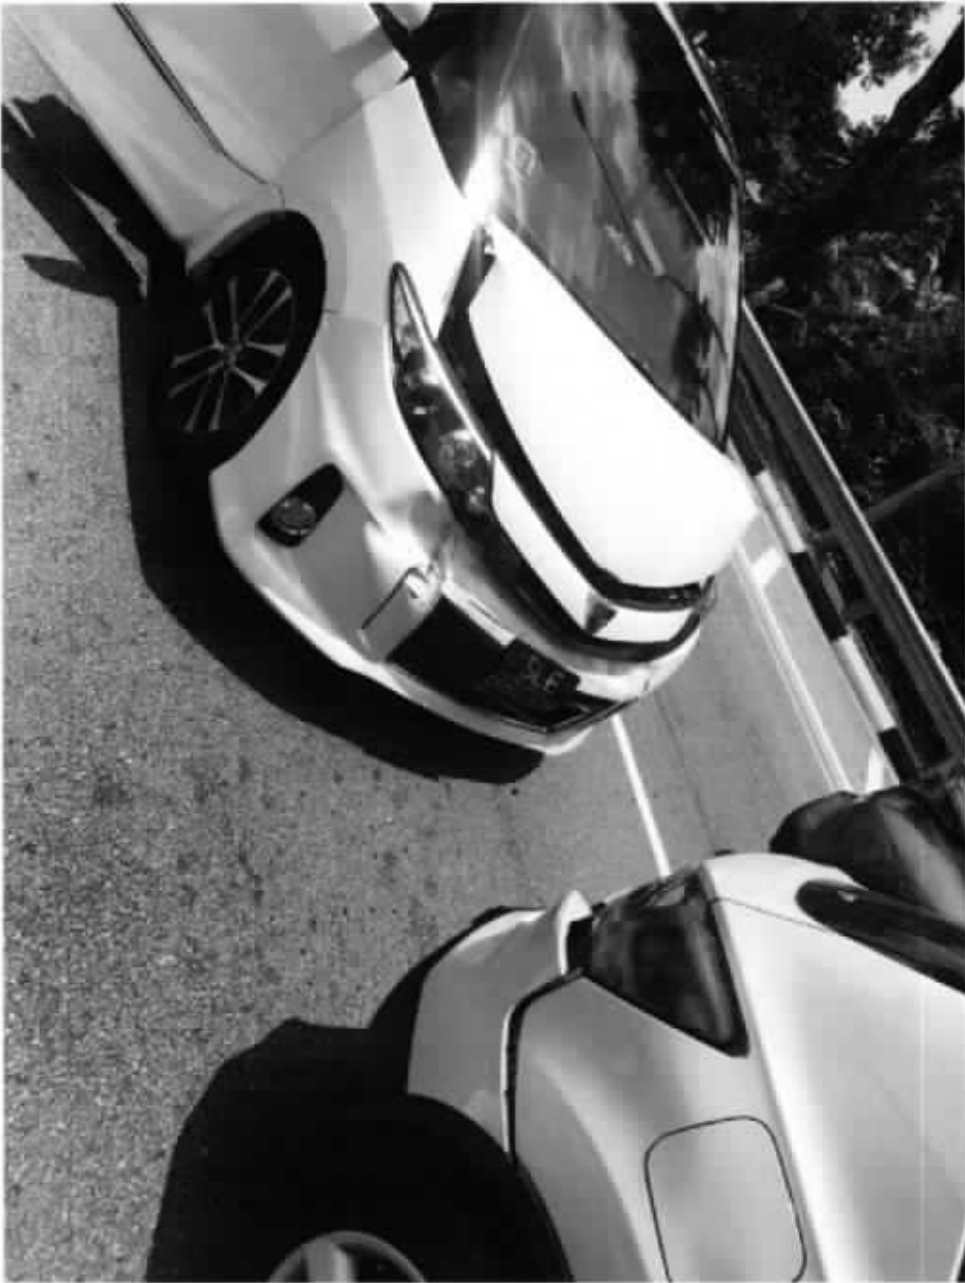
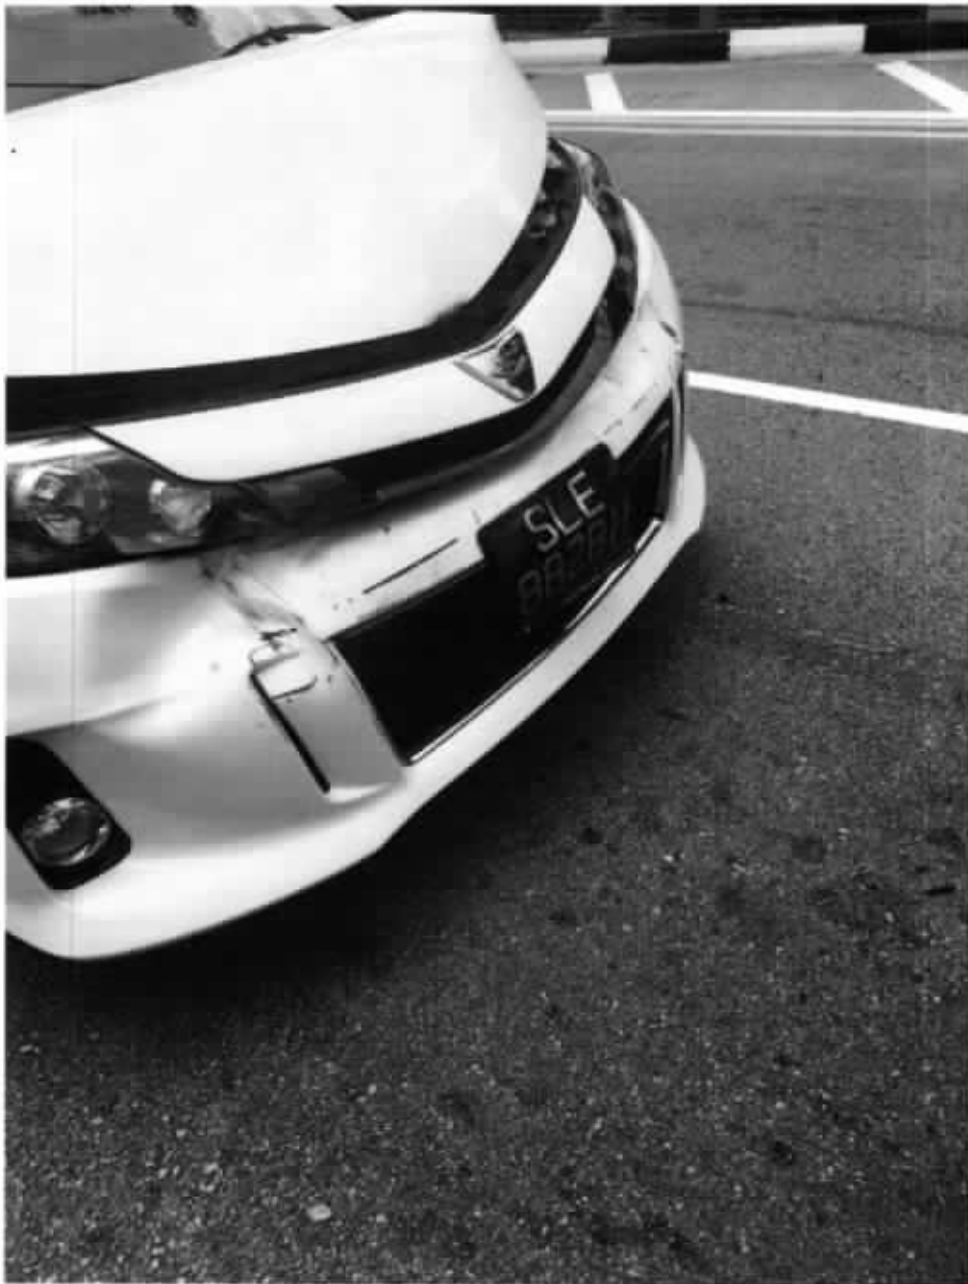
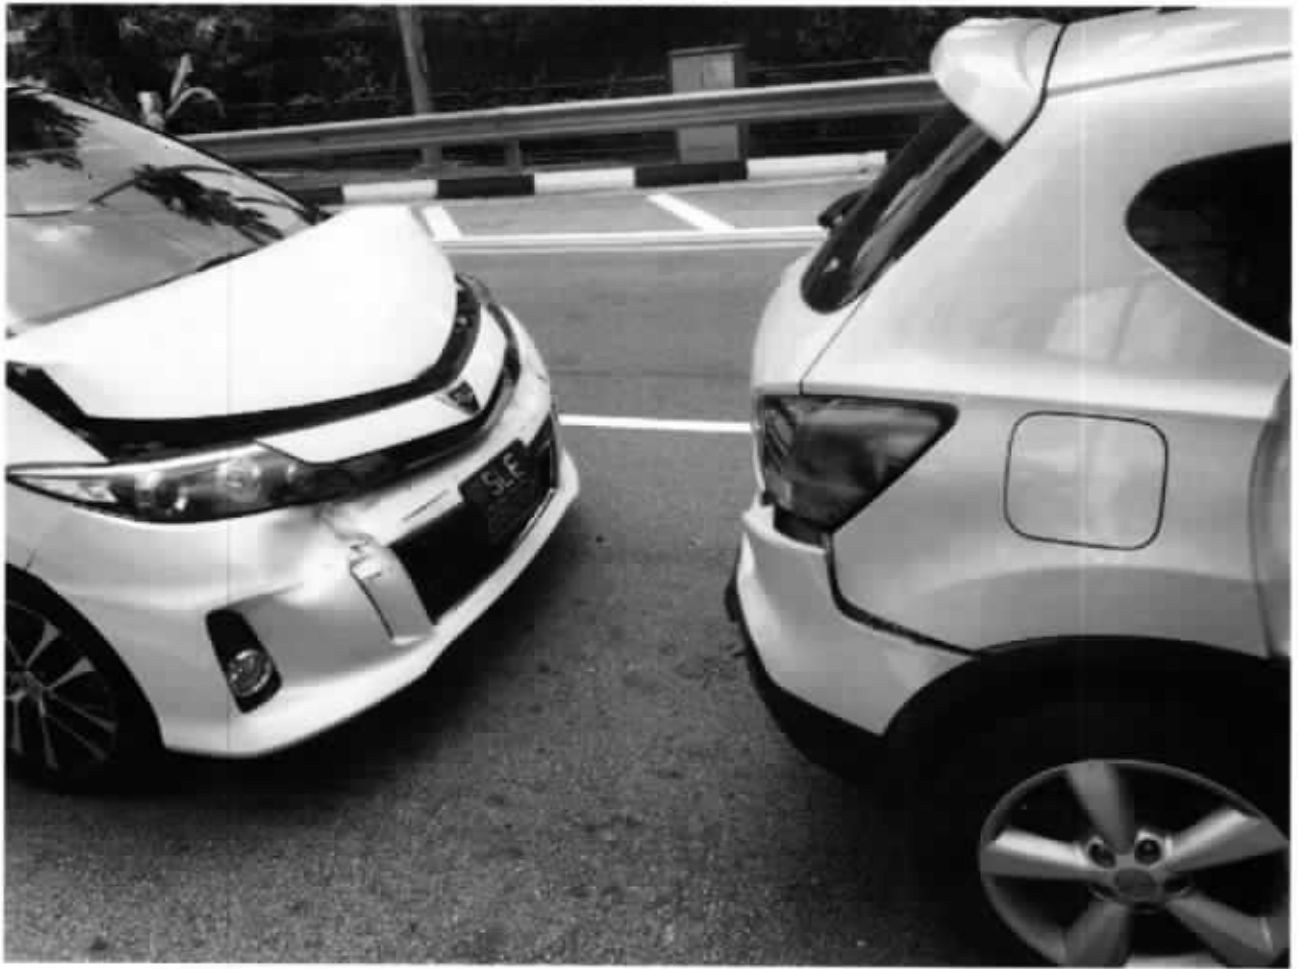
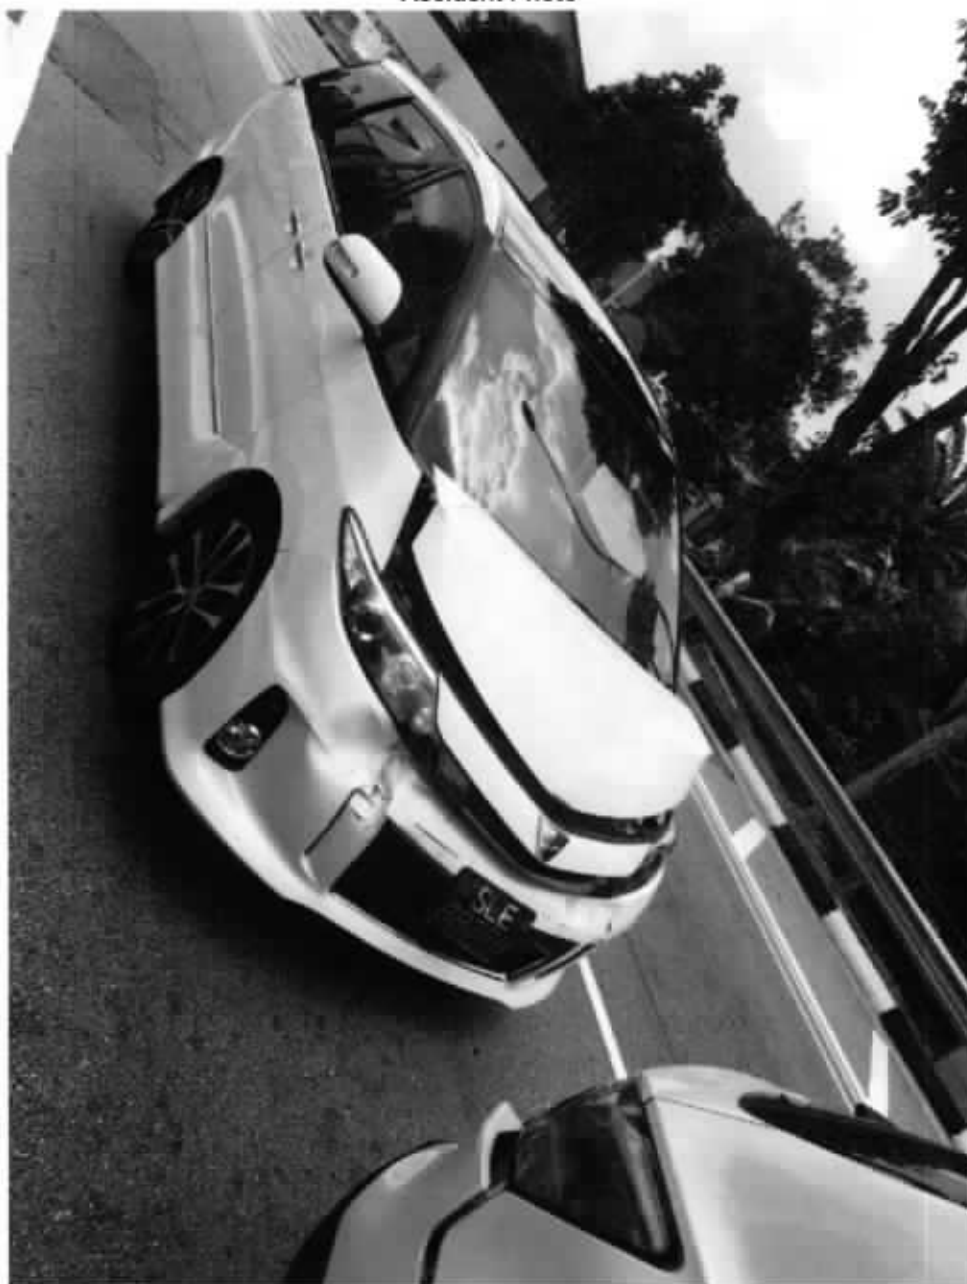
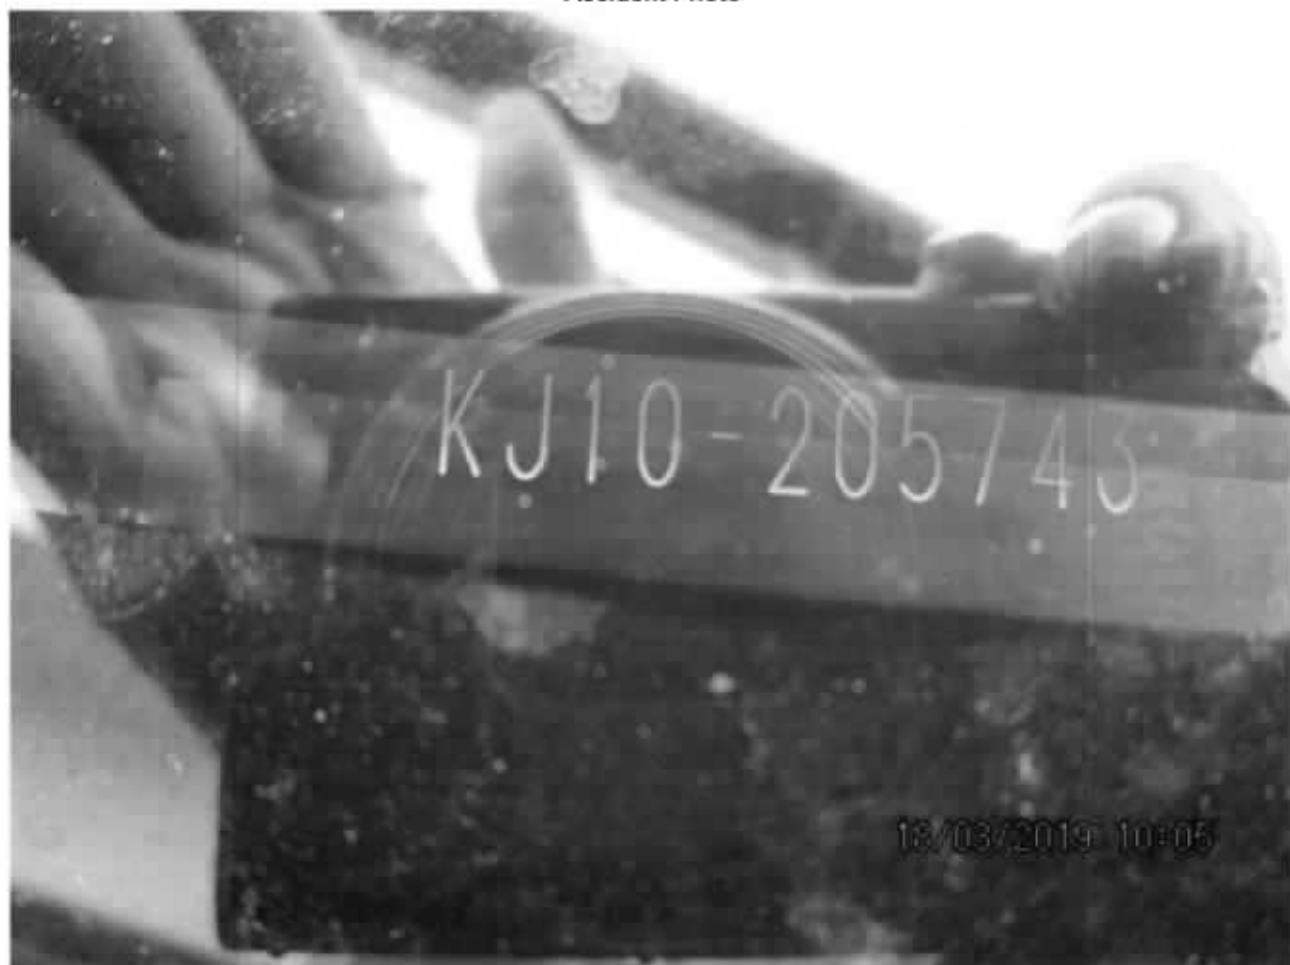
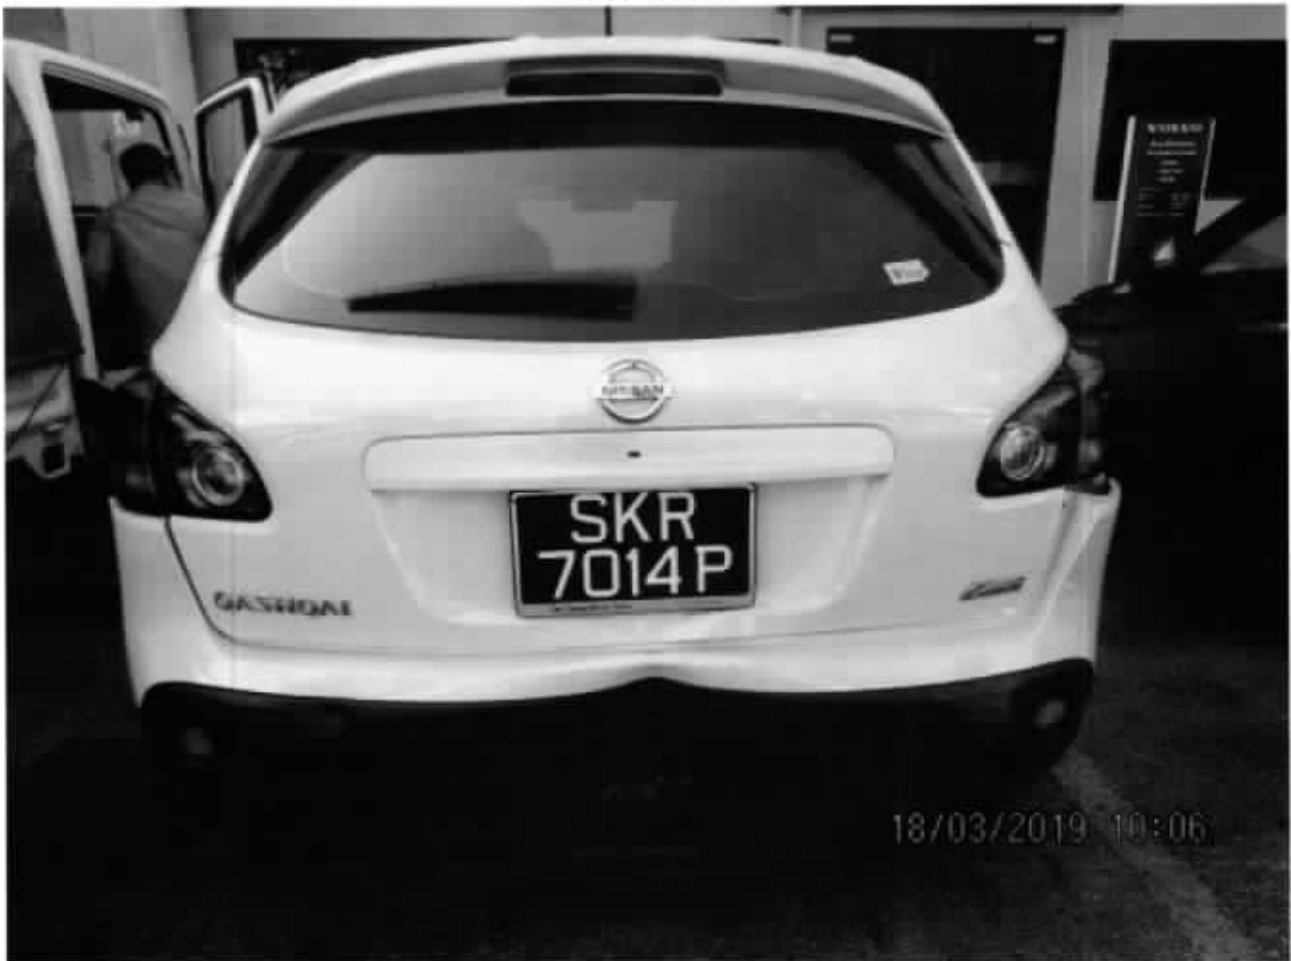
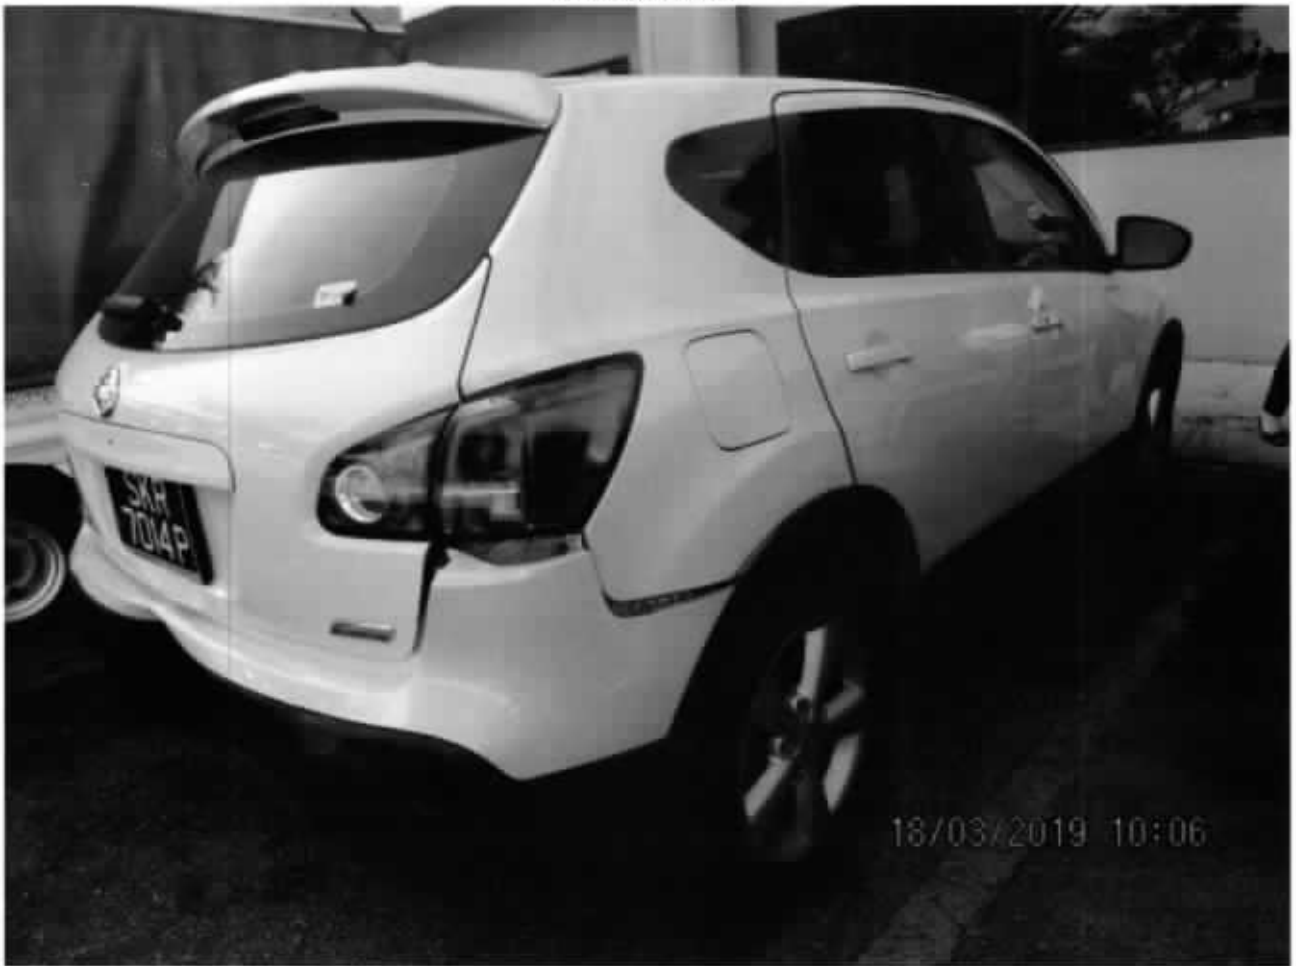
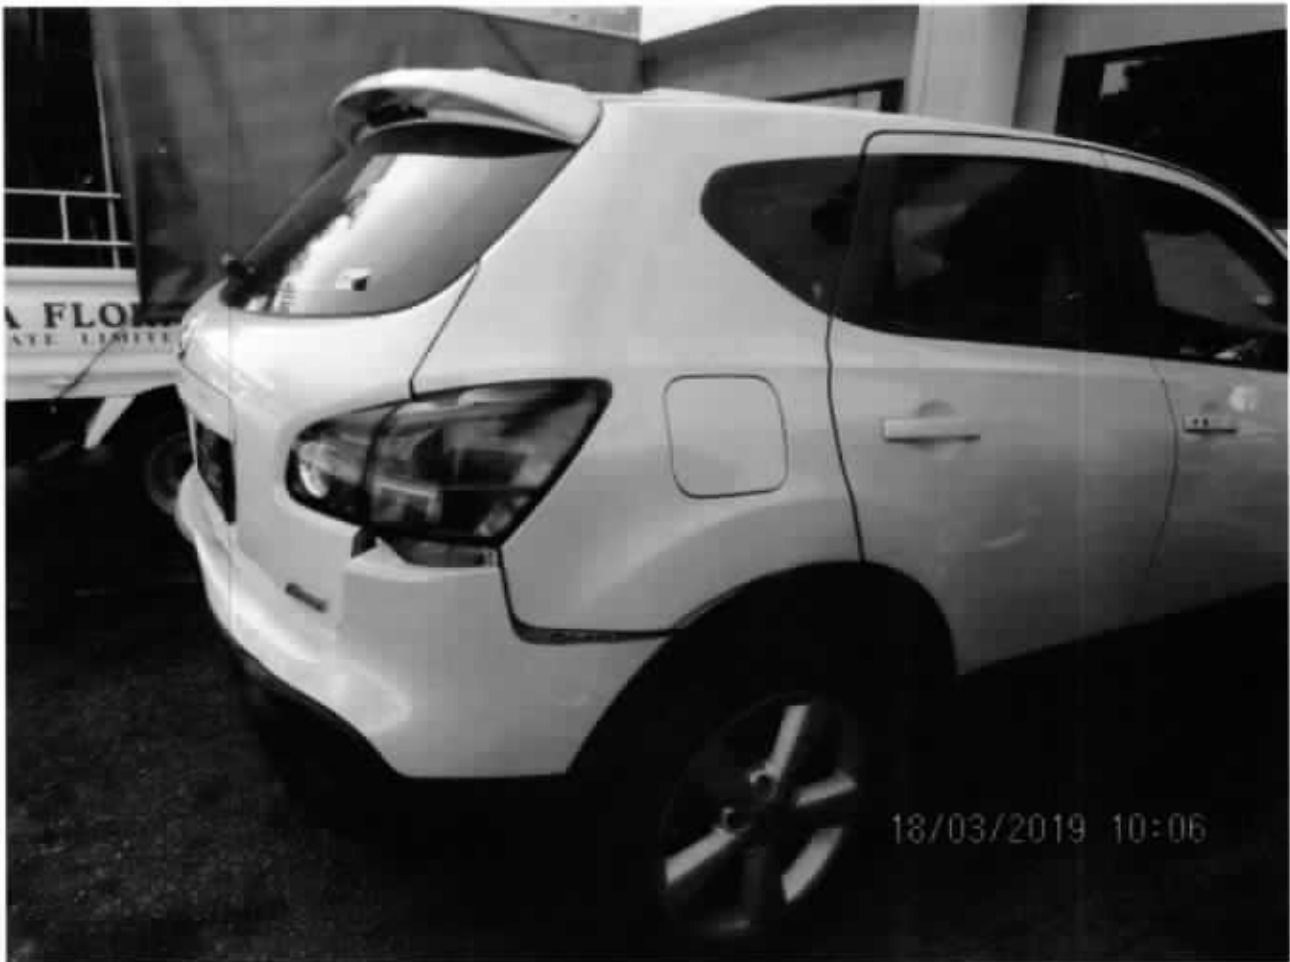
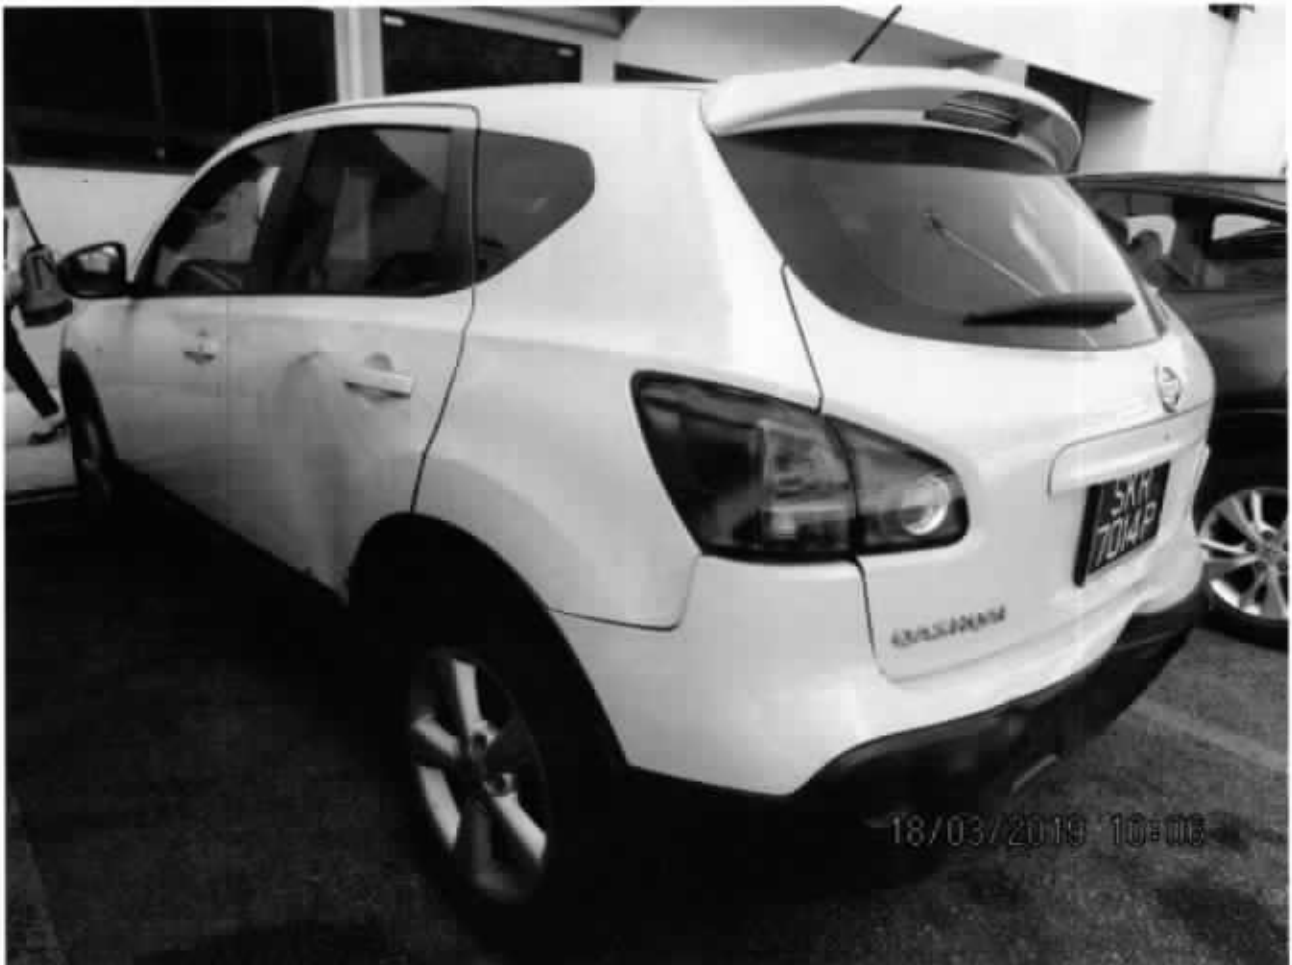
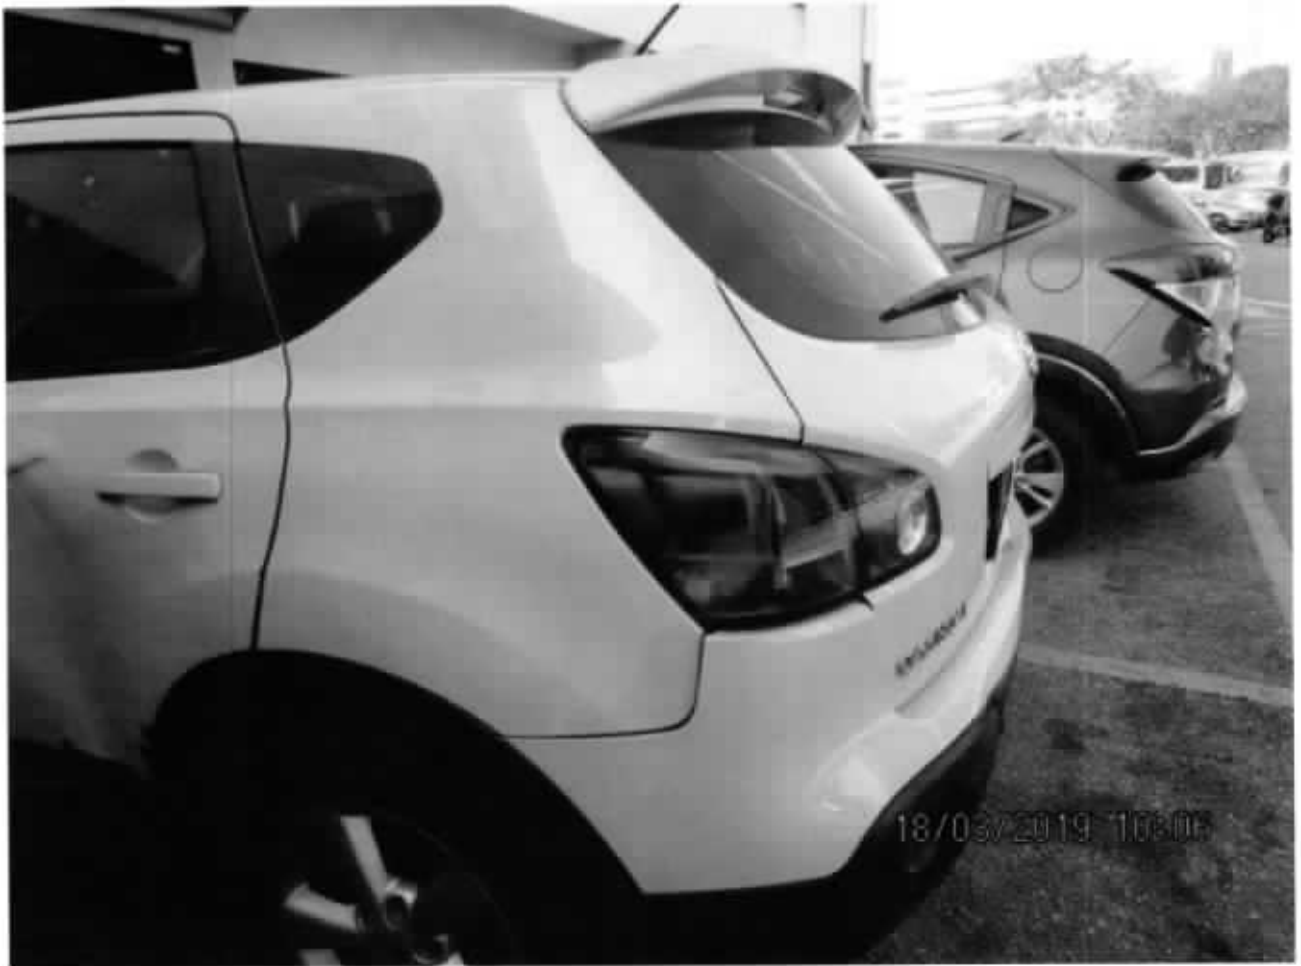
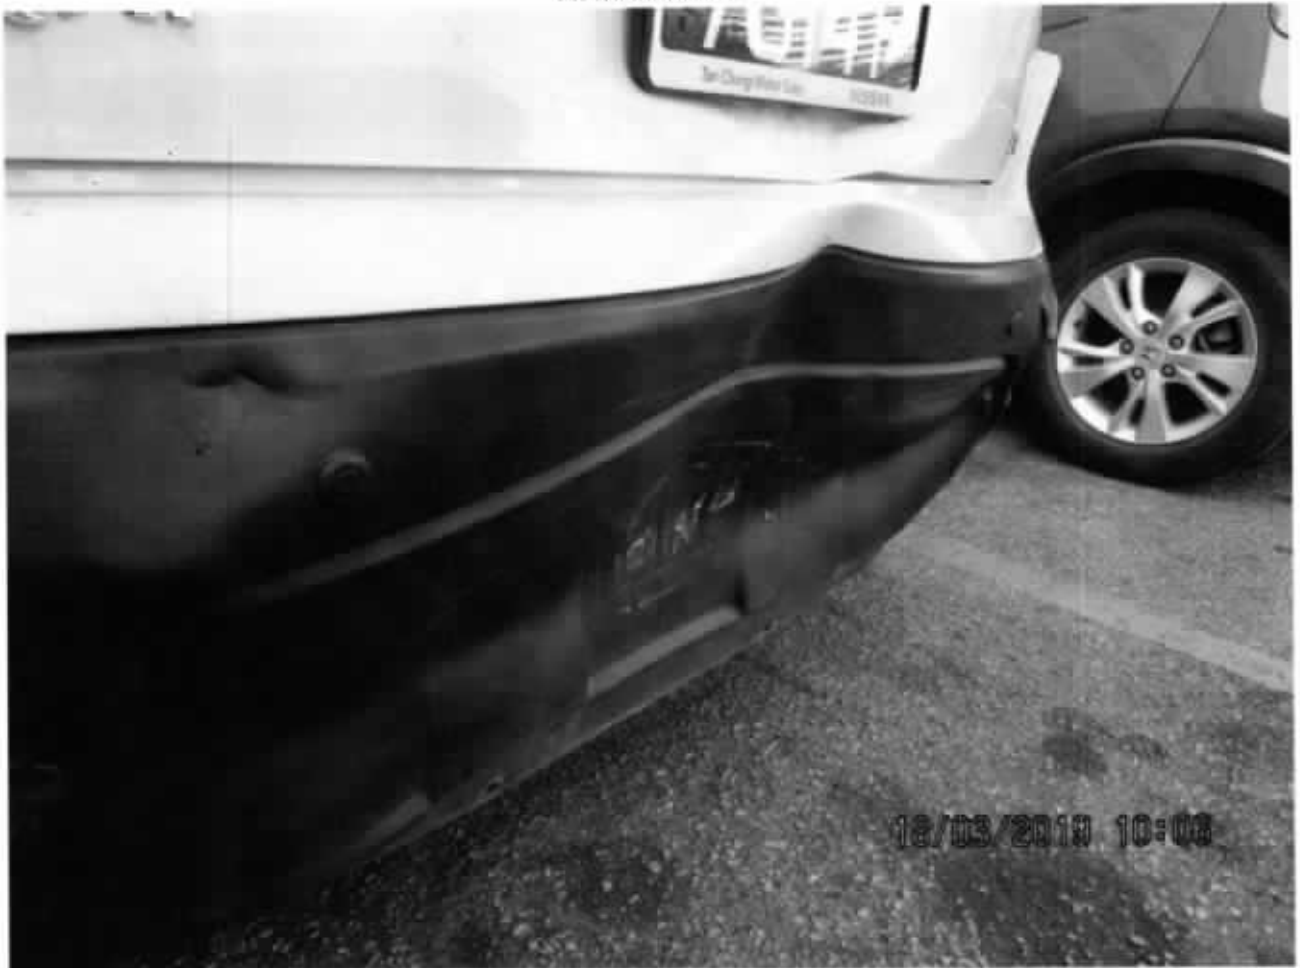
Accident Photo

The UIC / Chassis frame / Body Structure affected due to collision.

The repairer has agreed to undertake the job at a **Lump Sum of \$ 6,500.00** on a contractual basis.
