To Inspect Vehicle No: SJT 8916G

**Subject:** RE: TP CLAIMS - SJT8916G AGAINST GBD8996D AT HILLVIEW AVENUE / our ref: snm19d201893

Manufacturer	VOLKSWAGEN
Model	TIGUAN 2.0T AUTO 5N12T3 4WD
Exact Purpose for which vehicle was being used at time of accident	
Are you claiming under your own insurance policy for repair to your vehicle?	NO
If No, Please state action to be taken	THIRD PARTY
Vehicle Category	PRIVATE CAR

## VEHICLE DAMAGE INSPECTION REPORT

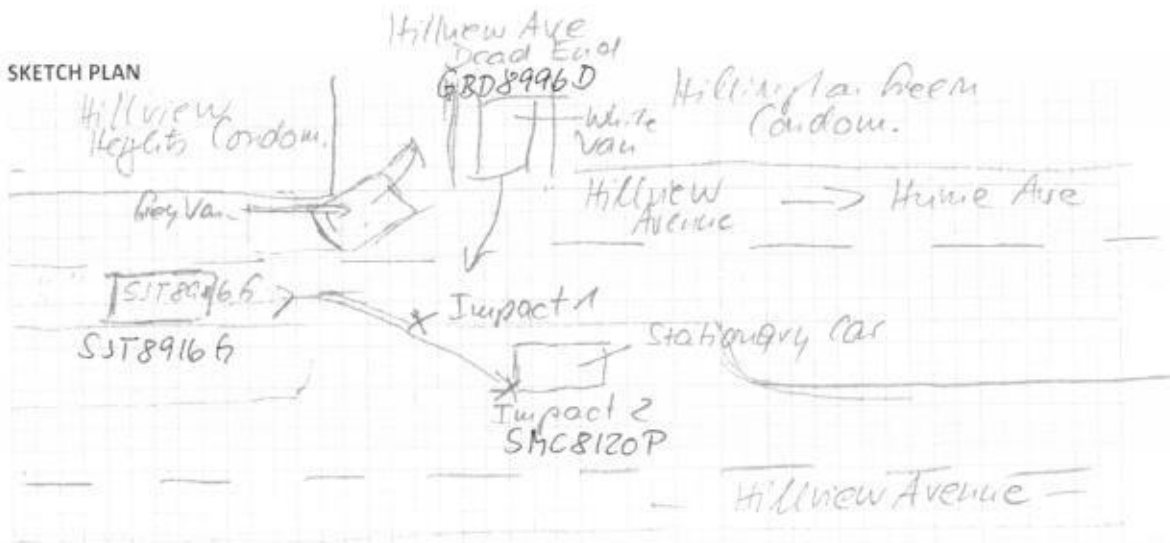
## SKETCH PLAN

LICENSE PLATE: SJT89166	ACCIDENT DATE & TIME: 26.04.2019 17 <sup>00</sup>
CONTACT NUMBER: 9338 4884	E-MAIL ADDRESS: midisel.haus@gmx.net
LOCATION: HILLVIEW AVENUE	
<p>We drove on right lane of dual carriage in the direction towards Hume Avenue. On the left lane was a van that was about to turn into a Hillview Avenue Dead end behind Hillington Green. In front of that van suddenly a white van pulled out of the dead end for a right turn about 10m in front of us. It was invisible to us behind the turning vehicle. I tried to <del>brake</del> <sup>to stop right</sup> brake hard and tried to evade the white van but <del>was</del> only partially successful. The van still hit me hard on the front left part of my vehicle. I came to a stop by hitting a hard vehicle that was waiting for its left turn in the opposite direction of Hillview Avenue. Video footage is available. The street surface was wet after rain.</p>
