## 1. Policy Particulars :- THIRD PARTY CLAIM (RESURVEY INSPECTION)

| Insured Veh. | SHB 9000K | Veh. Inspected | SHD 7243D |

| THE VEHICLE SUSTAINED DAMAGES AT THE REAR PORTION.<br>DAMAGES SEE DETAILS. |

**ADJUSTMENT ON REPAIR COST FOR VEHICLE NO. SHD 7243D**

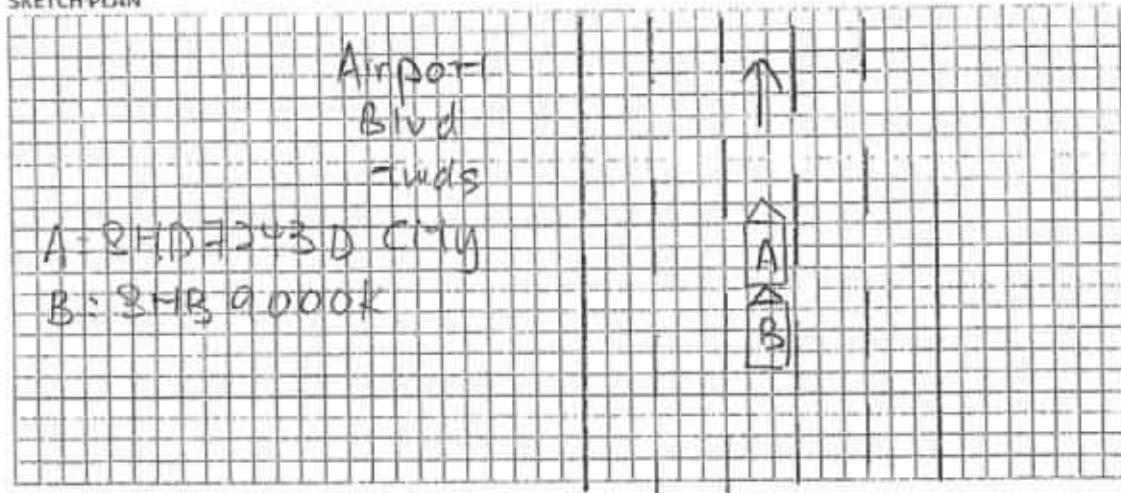
## SKETCH PLAN

On 29/4/19 at about 23:25 hrs, I picked up a female passenger from Terminal 3. When I driving at above said location, veh in front applied brake to stop and I doing so. A few second later, I felt an impact from my taxi behind. Veh B it front portion collided onto the rear portion of my taxi. No injury reported in this accident.
