SLJ 9710E

MCT19040786

Vehicle No.:	SLJ9710E
Vehicle to be Exported:	No
Intended Deregistration Date:	06 May 2019
Vehicle Make:	NISSAN
Vehicle Model:	LATIO CVT 1.5L ABS D/AIRBAG 2WD 4DR
Primary Colour:	White
Manufacturing Year:	2009
Engine No.:	HR15116262B
Chassis No.:	JN1BAAC11Z0021607
Maximum Power Output:	80.0 kW (107 bhp)
Open Market Value:	\$19,161.00
Original Registration Date:	28 Dec 2009
First Registration Date:	28 Dec 2009
Transfer Count:	2
Actual ARF Paid:	\$19,161.00

## VEHICLE DAMAGE INSPECTION REPORT

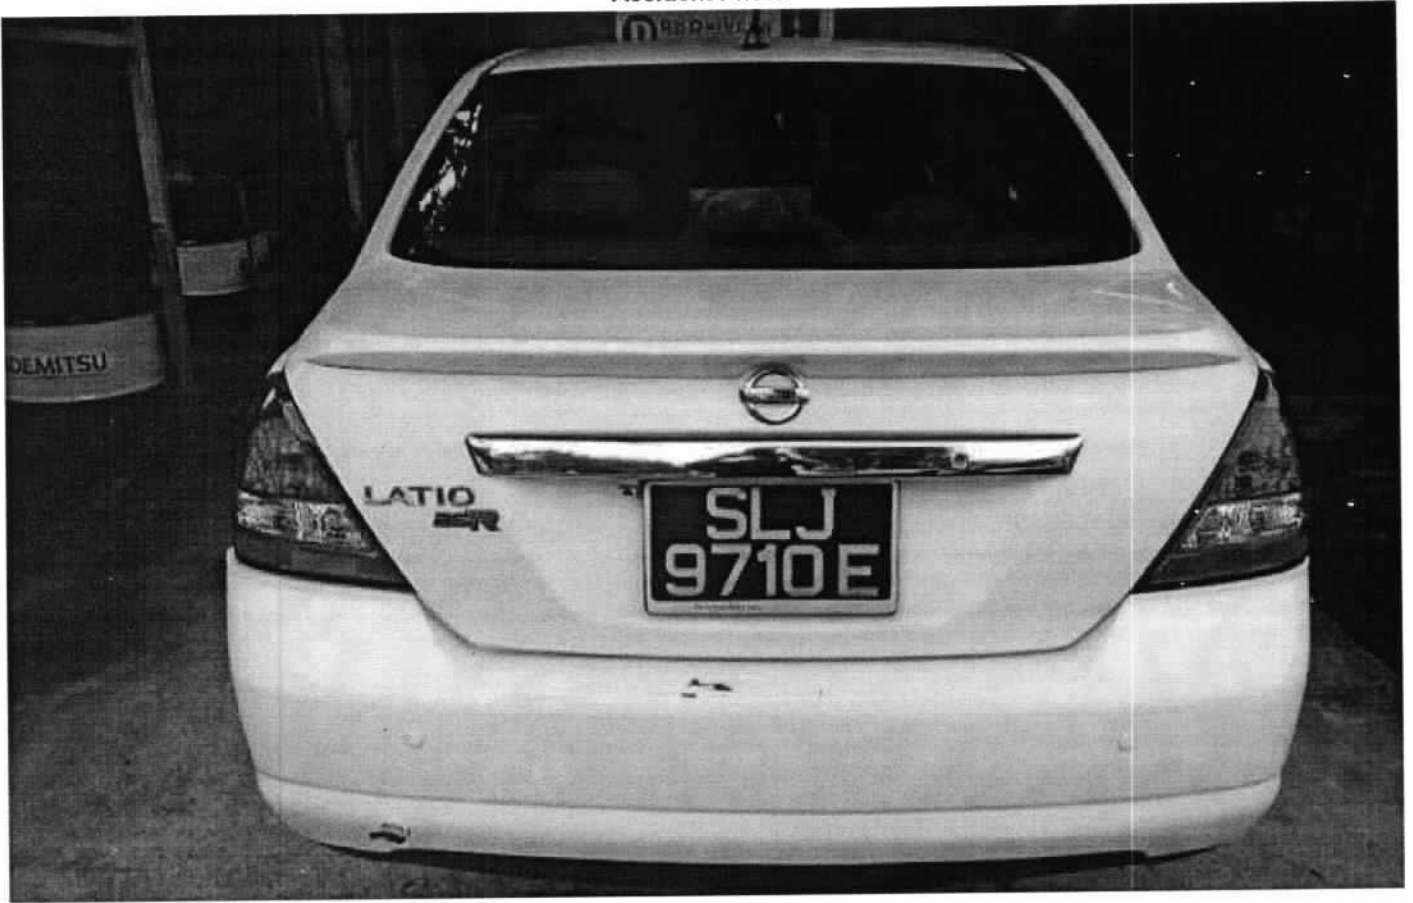
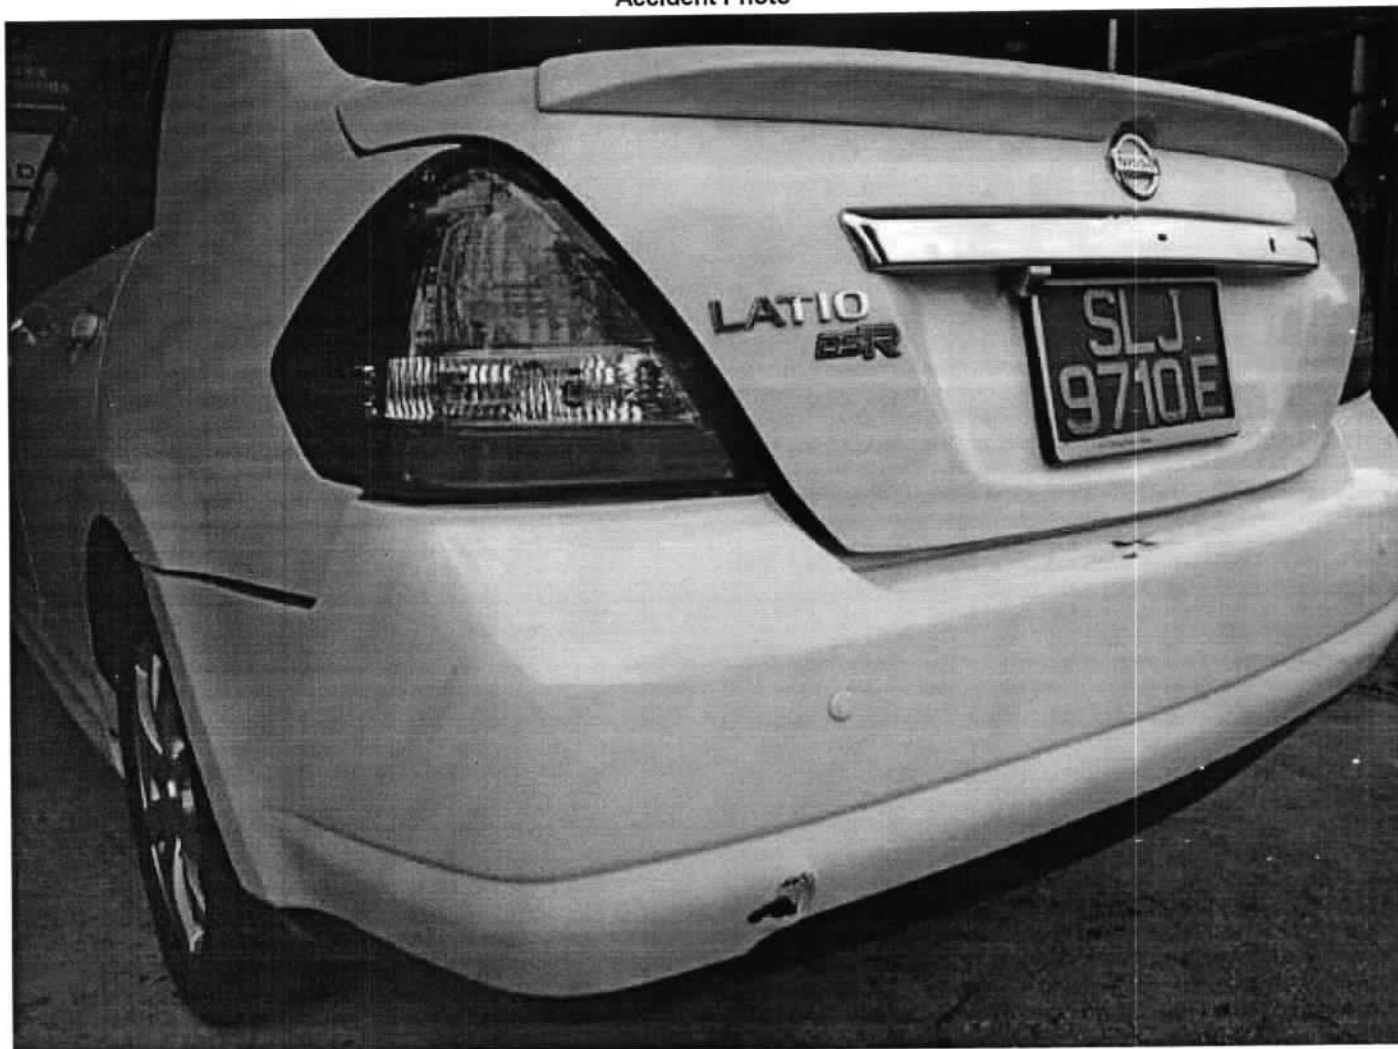
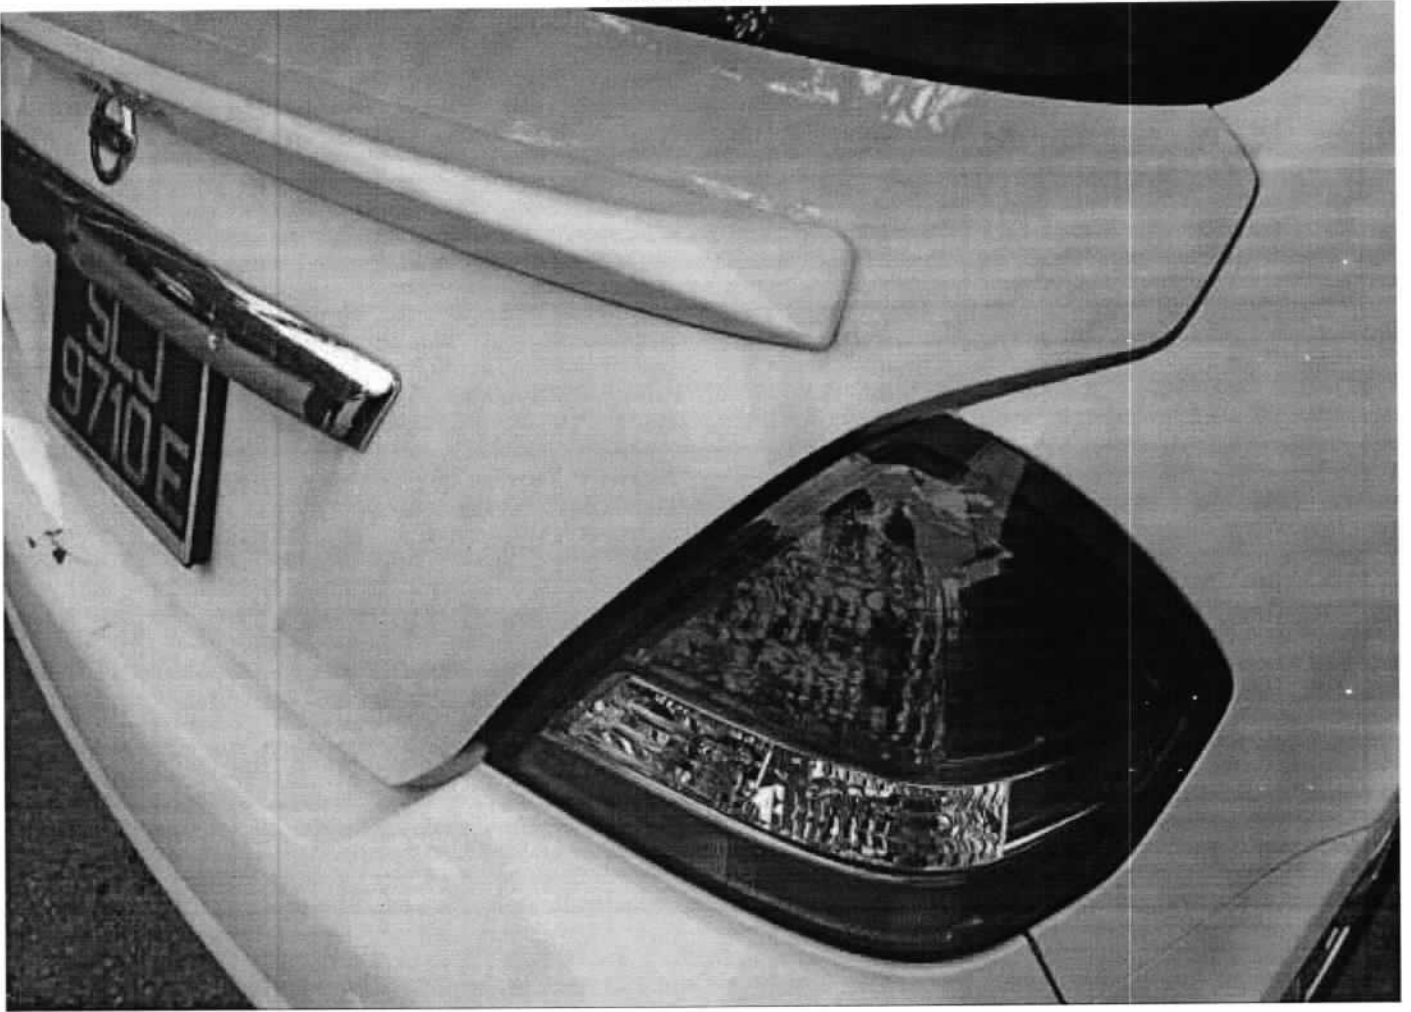
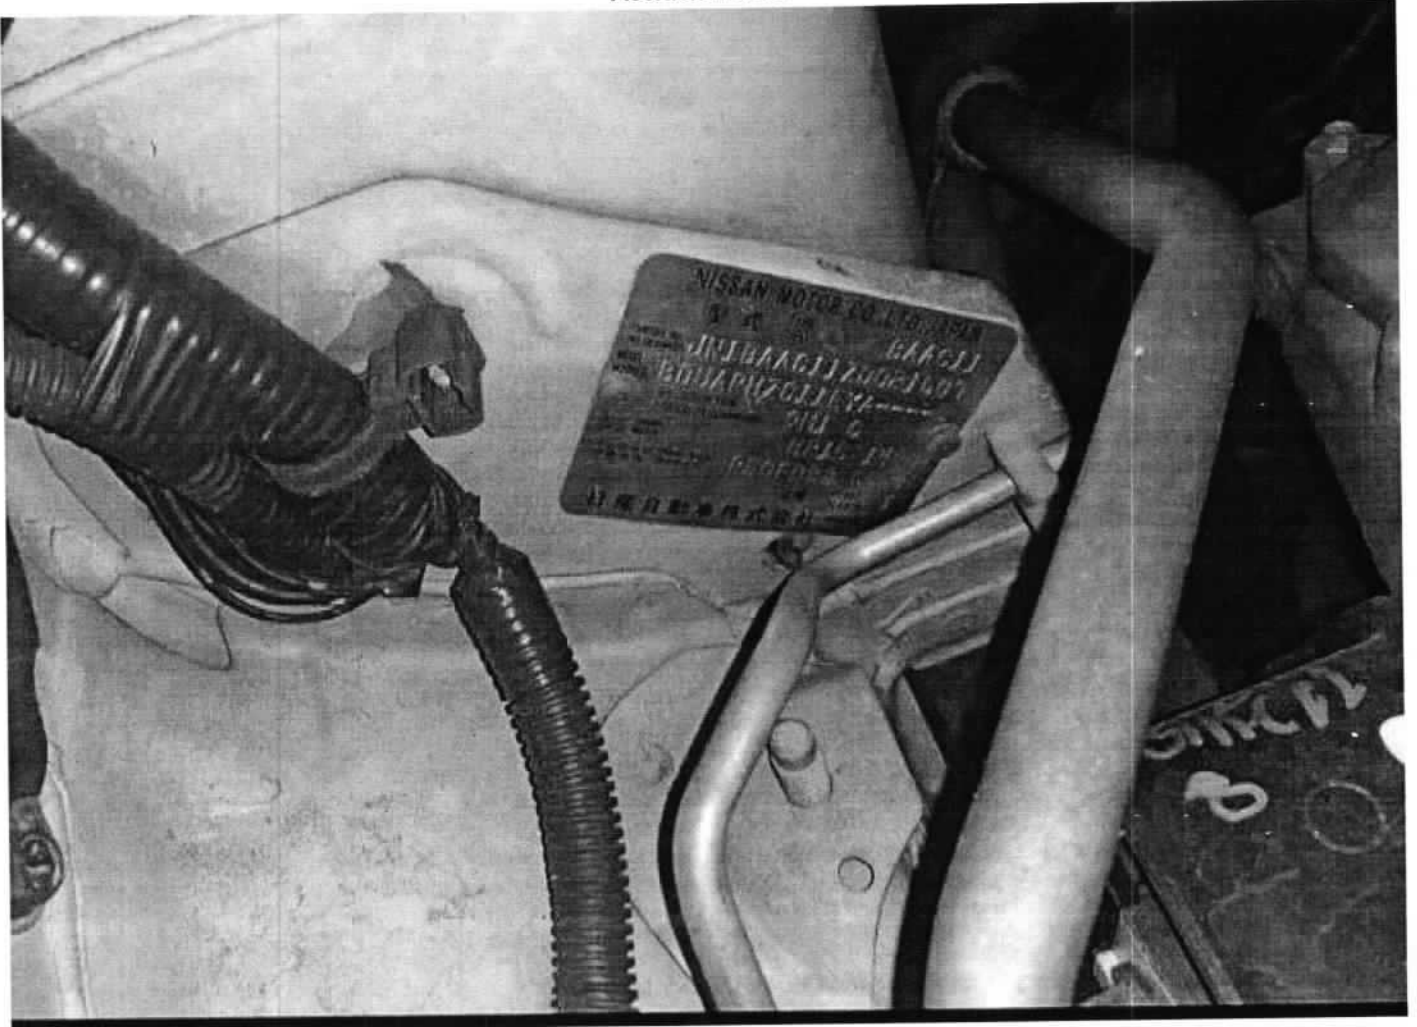
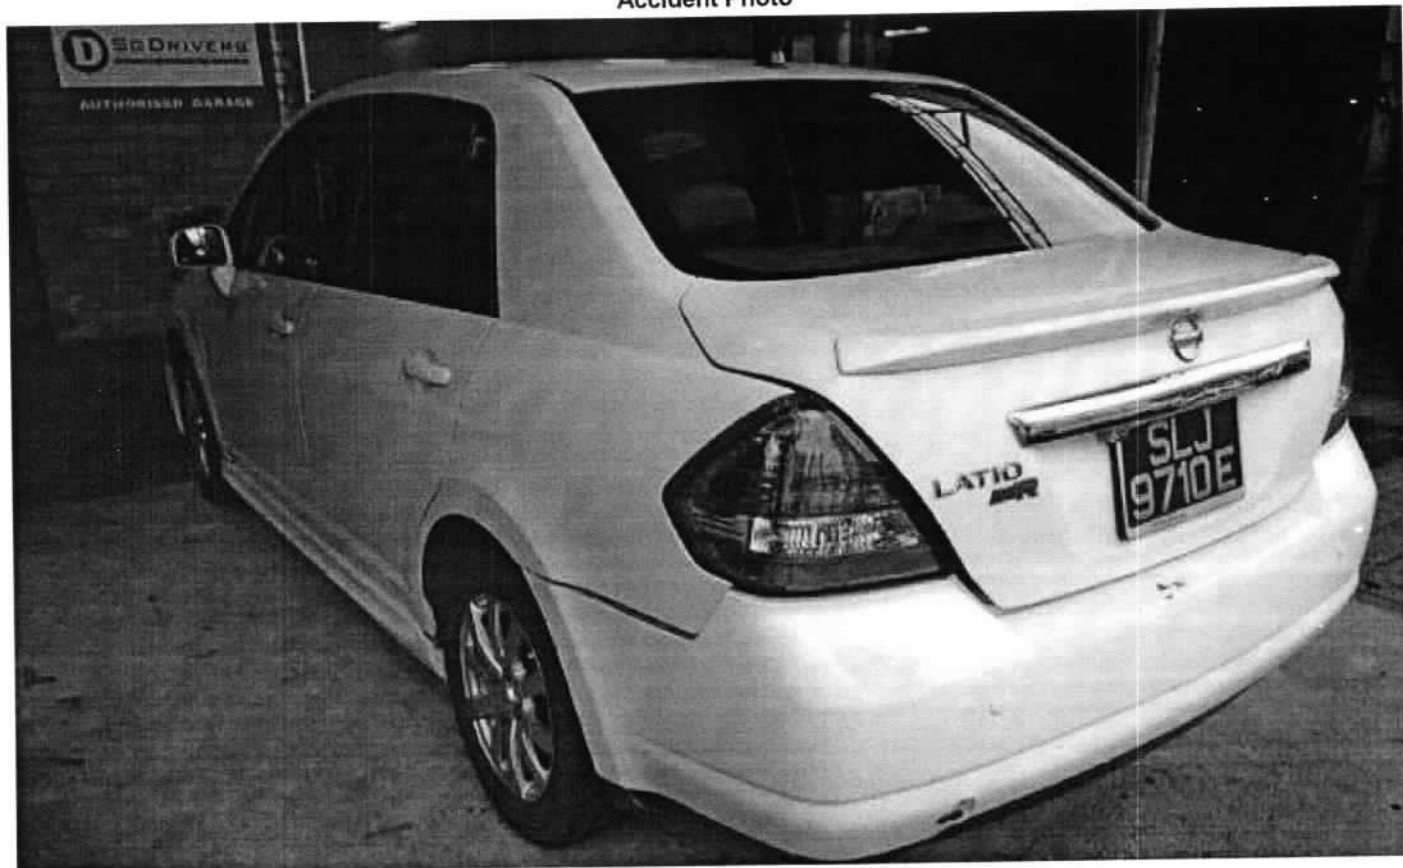
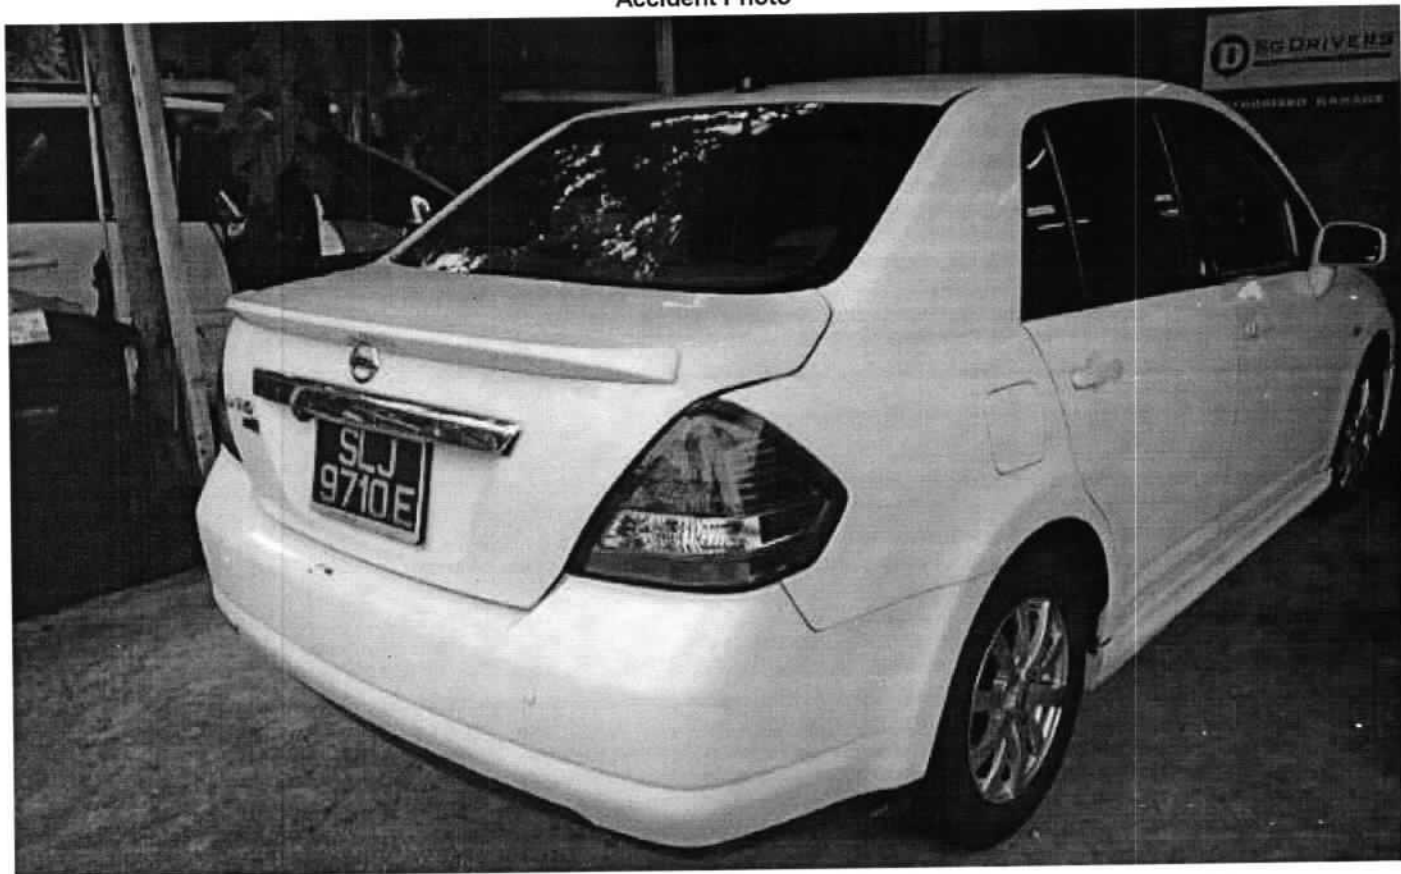
Accident Photo

The U/C / Chassis frame / Body Structure affected due to collision.

No.	Qty	Part No.	Particulars	Condition	Repairer's	Amount
1	1		*REAR BUMPER	Distorted	550.90 FL	*532.40 FL
2	1		*BOOTLID	Bent / Buckled	850.90 FL	*787.50 FL
3	1		*BOOTLID INNER LOCK	Twisted	97.90 FL	*97.90 FL
4	1		*BOOTLID STRIKER	Not Necessary	21.70 FL	*- FL
5	1		*BOOTLID INNER TRIM	Not Necessary	155.80 FL	*- FL
6	1		*REAR END PANEL	Badly Dented	491.80 FL	*434.40 FL
7	1		*REAR END PANEL TOP GARNISH	Twisted	167.80 FL	*92.40 FL
8	2		*TAILLAMP ASSY	Cracked	559.00 FL	*556.80 FL
9	2		*LH / RH REAR FENDER INNER SHIELD	Not Necessary	76.00 FL	*- FL
10	1		*REAR BOOT (INNER) OPENING SENSOR	Not Necessary	65.80 FL	*- FL
11	1		*REAR BOOT LOCK SENSOR	Cracked	65.80 FL	*65.80 FL
12	1		*REAR EXHAUST MUFFLER	Repair	468.70 FL	*- FL
13	2		*REAR EXHAUST MOUNTING	Not Necessary	50.00 FL	*- FL
14	1		*SET REAR BUMPER FASTENERS	Necessary	35.00 FL	*35.00 FL
15	1		*SET BOOTLID INNER TRIM FASTENERS	Necessary	32.00 FL	*32.00 FL
16	2		*SET BOOTLID CHROME GARNISH FASTENERS	Not Necessary	32.00 FL	*- FL

No	Particulars	Lab.Type	Repairer's	Amount
<b>Labour Items</b>				
1	TO PANEL BEAT AND RENEWAL OF ALL NECESSARY DAMAGED BODY PARTS	New	1,200.00	680.00
2	TO CHECK WIRING AND REWIRE	New	80.00	20.00
3	TO REMOVE AND REINSTALL BOOTLID COMPONENTS	New	80.00	60.00
4	TO REMOVE AND REINSTALL REAR BOOT UPHOLSTERY	New	120.00	60.00
5	TO REMOVE AND REINSTALL REVERSE SENSOR	New	120.00	50.00
6	TO REMOVE AND REINSTALL REAR EXHAUST MUFFLER	New	120.00	60.00
7	TO ANTI-RUST	New	140.00	60.00
8	TO PUTTY AND SPRAY-PAINT OF AFFECTED AREAS	New	1,200.00	900.00
<b>Gross Labour Cost (S\$)</b>			<b>3,060.00</b>	<b>1,890.00</b>
