To Inspect Vehicle No: SLP 4892P

Claim No: SNM19D201895

Manufacturer	TOYOTA
Model	PRIUS HYBRID-1.8 (A)

## VEHICLE DAMAGE INSPECTION REPORT

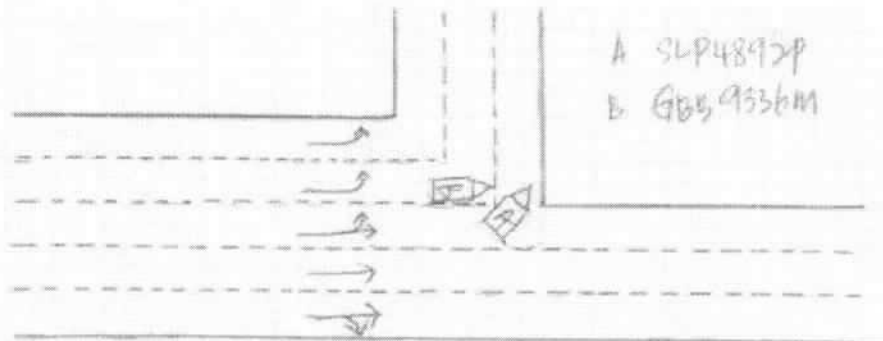
## SKETCH PLAN

I was driving along Marina Boulevard and signal to turn left into Phoenix Ave at third lane from the left, and the truck GBS9336M hit my left side of the car as he intended to go straight at left turn only lane.
