### **ACCIDENT DAMAGED VEHICLE INSPECTION REPORT (WITHOUT PREJUDICE)**

Registration Number	: SKT 1452 L	Mileage	: 56,422 km
Make & Model	: Mitsubishi Outlander 2.4 CVT	Chassis Number	: JMYXTGF3WZF00197C
Date of Registration	: 26 May 2015	Engine Number	: 4B12PL4690
Colour	: Blue	Engine Capacity	: 2,360 cc

**REPAIR DETAILS (SKT 1452 L)**

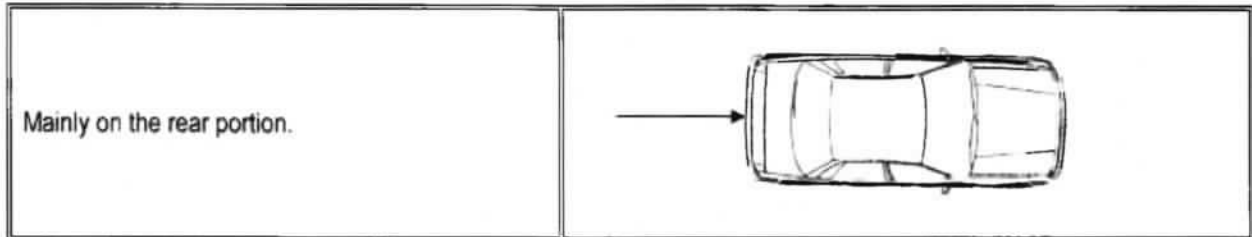
**(5) POINT OF IMPACT**

The impact of the collision has damaged/affected the tailgate, right rear combination lamp, rear end panel, rear bumper face and etc.

We have inspected thoroughly the actual damages found on the vehicle before we conclude as to whether the parts needed replacement or repairs. The estimated cost of repair submitted by the repairer is **\$13,489.10**. We have adjusted the cost to **\$10,322.70** and recommend that the repairs to be taken on a lump sum basis of **\$9,290.00**. In our opinion, the damaged parts are consistent with that caused by the accident.
