From: Shiau Chan (LKKAuto)
Sent: Tuesday, 7 May 2019 9:59 AM
To: Motor Claims
Cc: SUR
Subject: DIRECT SURVEY INSPECTION ON WORKSHOP -COMFORTDELGRO ENGINEERING PTE LTD, DOA: 05/05/2019, SHC 2216X (TP VEHICLE), GBG 9493R (OI VEHICLE)
Attachments: SHC2216 GIA.pdf; SHC2216 EST.pdf

VEHICLE DAMAGE INSPECTION REPORT

Our File No: CC3/TMI19007972/K1QD3N2

Handling Insurer:	Tokio Marine Insurance Singapore Ltd	Policy No:	MJ001454
Claimant Vehicle No :	SHC2216X	Insured Vehicle No :	GBG9493R
Date of Loss:	05/05/2019	Nature of Claim:	TP
		Claim No:	M1903243

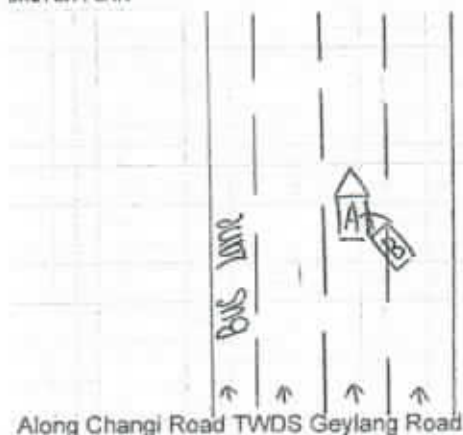
SKETCH PLAN

A - SHC 2216X
B - GBG 9493R

On 05.05.2019 at about 10:20 hours I was travelling along Changi Road TWDS Geylang Road
With no passenger onboard .
While travelling straight , suddenly Veh B (GBG 9493G) cut into my lane and collided into my
my taxi A - Right Portion .
As it took place too fast I could not take evasive action to prevent the
I have company video and photos at scene to supoort my claims .
No injury in this accident .
Veh B (GBG 9493R) - Mr Muhammad Azni Bin Abdullah I/C : S 8840014C

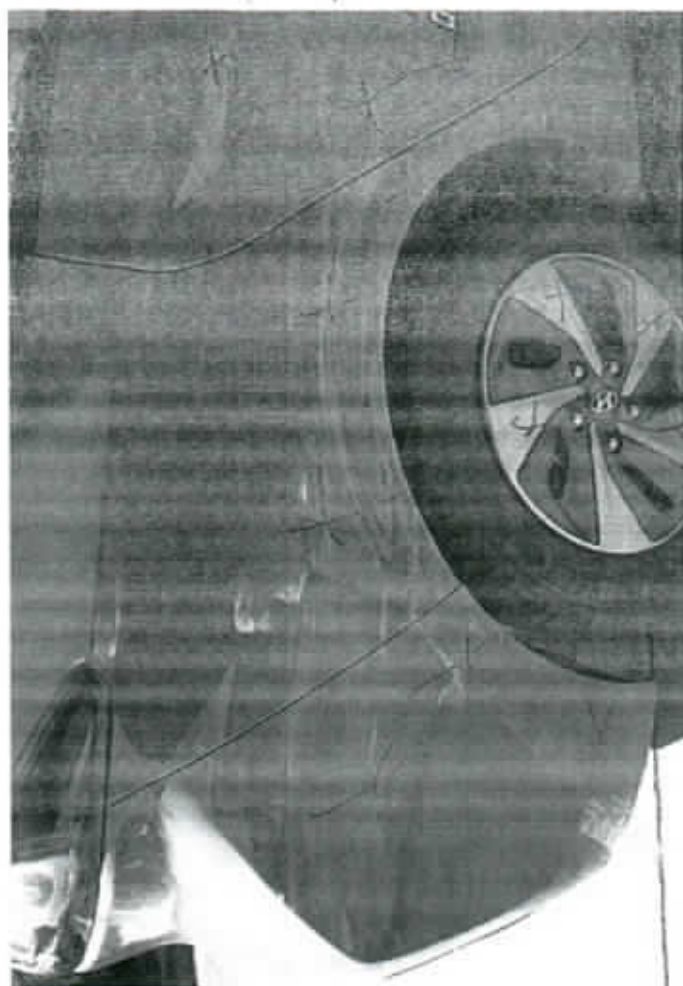
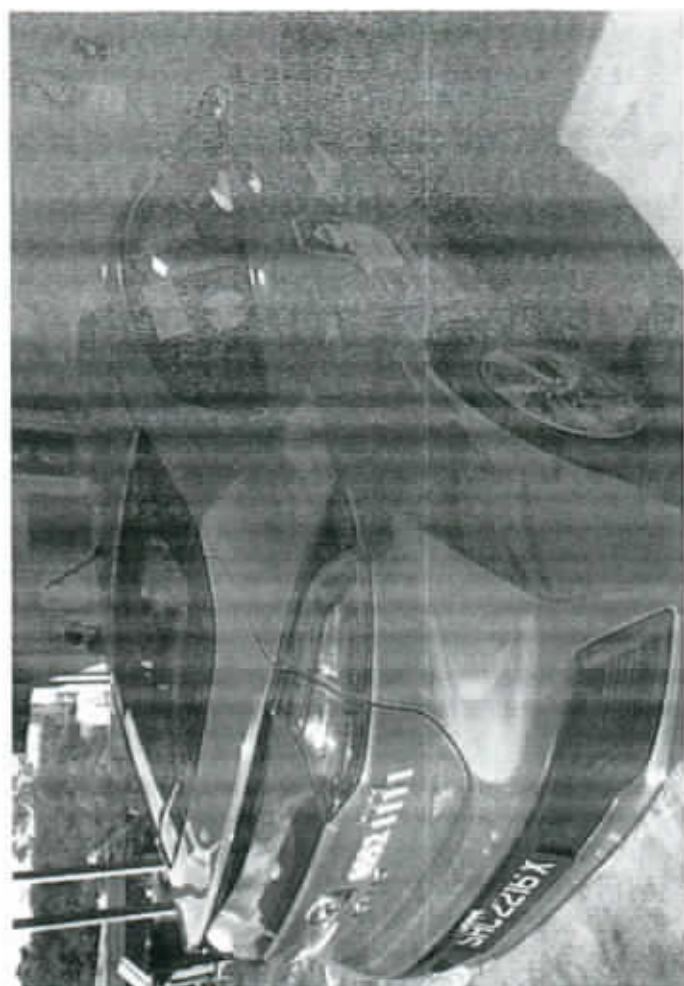
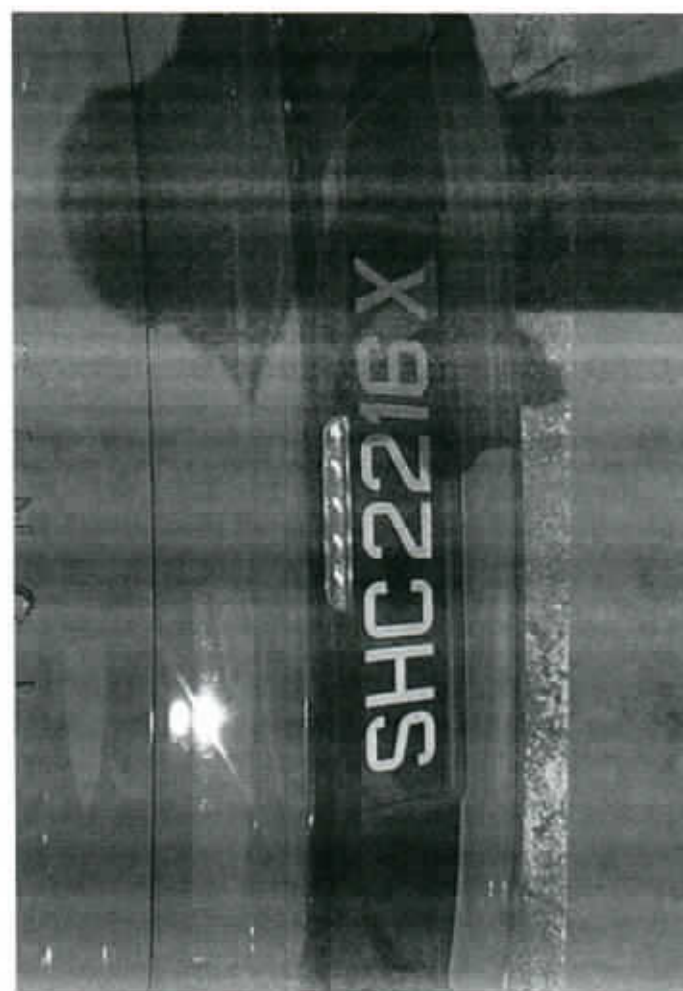
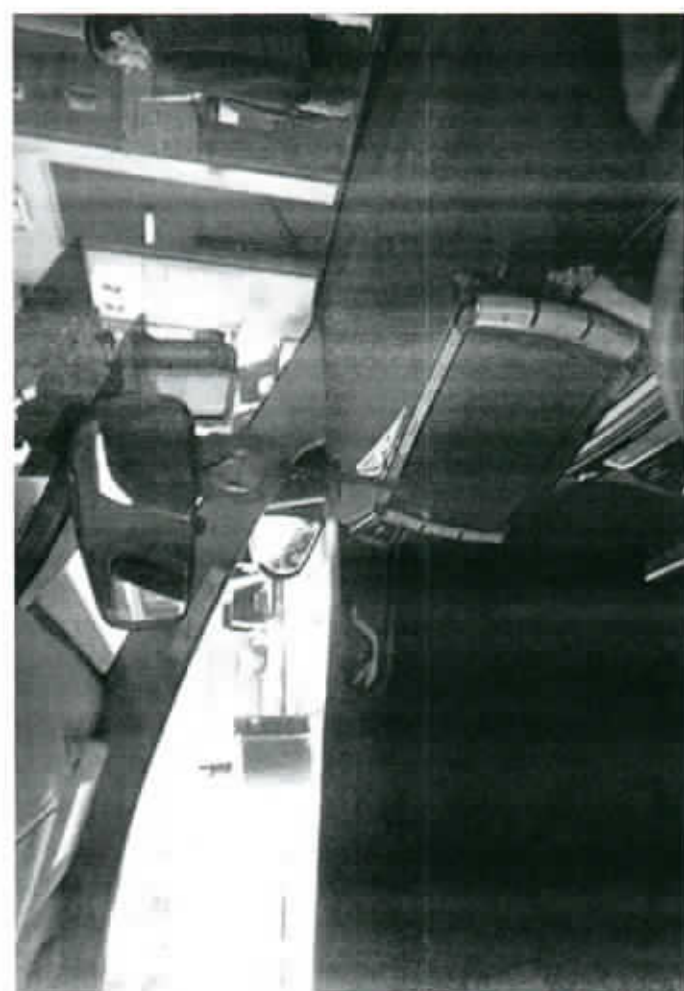
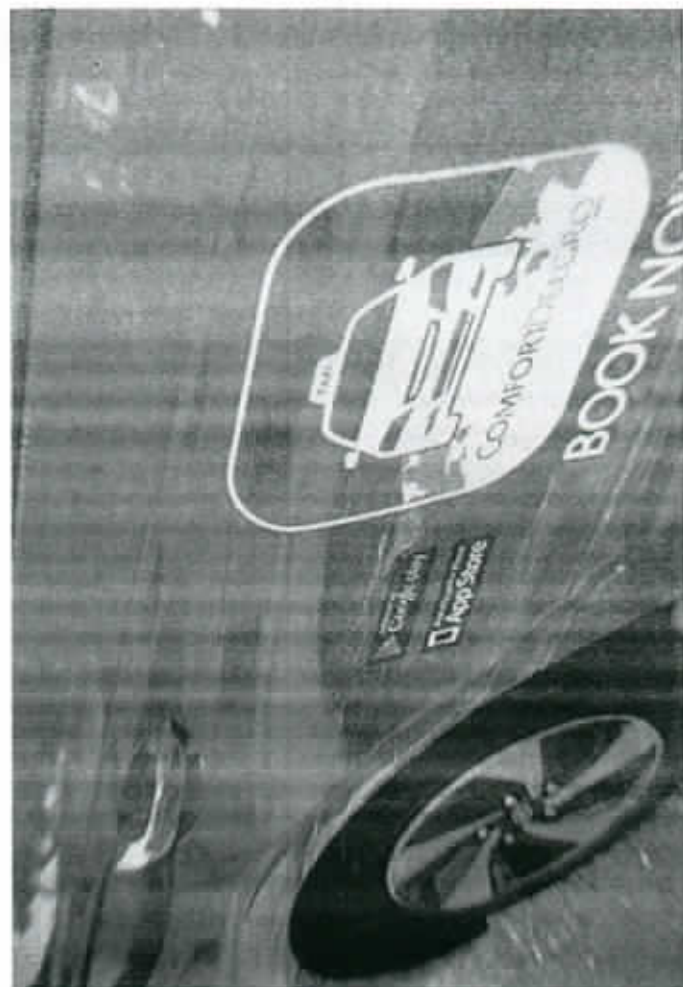
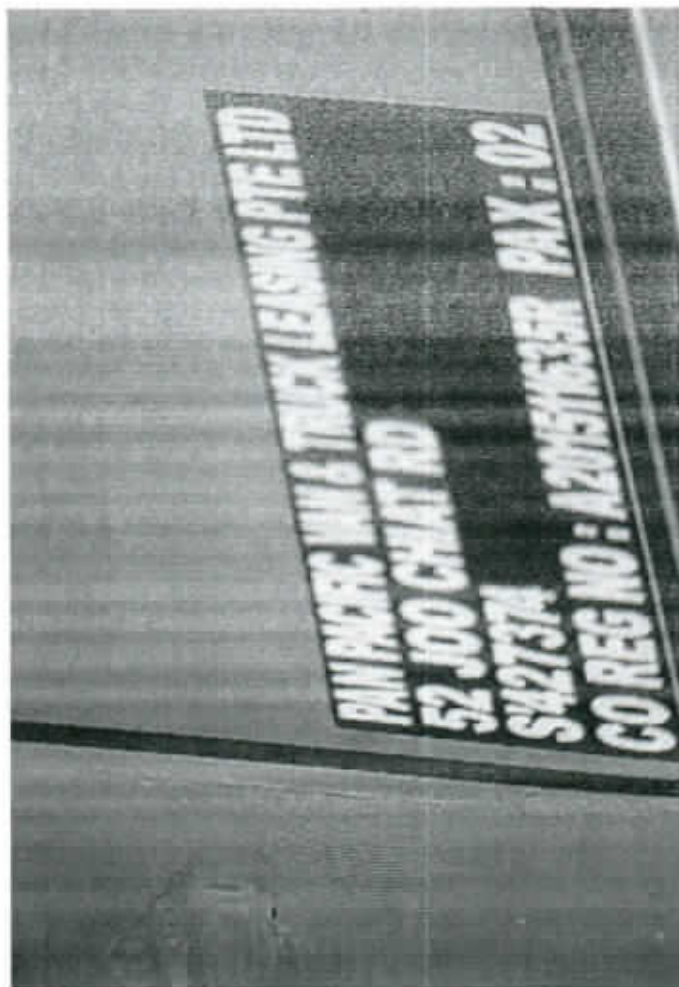
Remark: The veh had commenced its repair at the time of inspection.

Vehicle: SHC 2216X Reg: 8 Nov 2018
 Type: M.Cat / M.Cycle / Bus / Van / Lorry / T.O. / Prime Mover /
 Truck / Trailer or
 Make: Hyundai Zing cc: 1580
 Colour: Blue A/C: Ins / Std / Nil / NA
 Sp. Reading: 78221 Tr. Radio: Ins / Std / Nil / NA
 Eng/No: _____
 C/No: KMH C851C VK4115177
 Gen. Cond: Good / P / Poor / Burnt
 Steering: In order / J / Jammed / Leaked / Burnt or
 Brake: In order / J / Jammed / Leaked / Burnt or
 Modi: Nil / S/Rim / STD A/C or
 Tyre Size: F: 195/65R15
 R: _____
 BS / DUN / EXHNOVA / GY / FS / LIZA / M / OHTSU / PIR / SUM /
 TOYO / YOKO or _____
 Front: _____ Rear: _____
 R/Bal: 8 mm R/Bal: 8 mm
 L/Bal: 8 mm L/Bal: 8 mm
 D.O.A: 5/5/19 D.O.L: 6/5/19
 Survey held at: CDAC (Logan)
 Des. of Damages: Fnt / Rear / O/S / N/S / U/C / Rooltop or
o/s Body.
 The U/C / Chassis frame / Body Structure affected due to collision.

No.	Qty	Part No.	Particulars	Condition	Repairer's	Amount
1	1		*REAR BUMPER	Repair	459.40 FL	*- FL
2	10		*REAR BUMPER CLIPS	Not Necessary	22.00 FL	*- FL
3	1		*REAR DOOR - RH	Repair	1,789.90 FL	*- FL
4	1		*REAR DOOR PROTECTOR - RH	Repair	116.20 FL	*- FL
5	1		*REAR WHEEL COVER - RH	Grazed	346.00 FL	*346.00 FL
6	1		*REAR DOOR APP STICKER	Necessary	80.00 FS	*80.00 FS
7	1		*REAR FENDER - RH	Repair	2,020.10 FL	*- FL
					Sub Total (S\$)	4,833.60
					- List Item Discount on L Items 20.00/20.00% (S\$)	950.72
					Total Parts (S\$)	3,882.88
						356.80

No	Particulars	Lab.Type	Repairer's	Amount
<u>Labour Items</u>				
1	PANEL BEATING	New	750.00	200.00
2	SPRAY PAINTING	New	750.00	600.00
3	WIRING CHARGE	New	100.00	0.00
4	TUFF KOTE	New	100.00	0.00
5	REAR WHEEL ALIGNMENT	New	120.00	0.00
6	REMOVE / REFIX REVERSE SENSOR	New	120.00	0.00
Gross Labour Cost (S\$)			1,940.00	800.00
