MKS19057059 / Kan Fook Sing Motor Workshop - Defu
 ENTRY DATE & TIME: 03/05/2019 13:04
 SUBMITTED BY: Margaret Lee

ACCIDENT STATEMENT

ACCIDENT INVOLVING SLN 1735R AND SHA 4985G ON 17/04/2019

VEHICLE DAMAGE INSPECTION REPORT

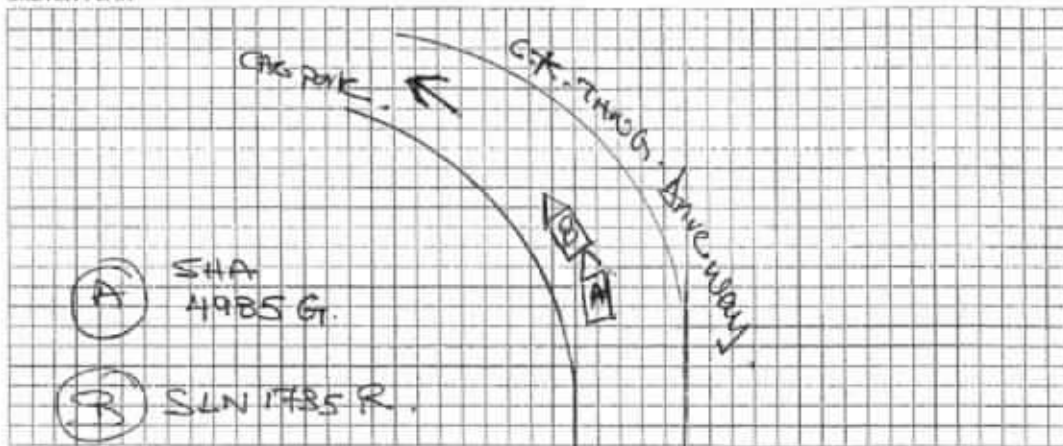
SKETCH PLAN

DESCRIBE CIRCUMSTANCES OF THE ACCIDENT

On 17 April 2019 @ 17:45 hr I veh A
 was driving slowly along the above location.
 while approaching the Bend (blind spot).
 Veh B in front suddenly E-brake for no
 reason. I veh A cannot stop in time
 and hit veh B rear. at the point
 of accident veh A no park.
