FINAL REPAIR BILL FOR VEHICLE NO. SKG 6198 G

AUTOMOBILE INSPECTION REPORT

PARTICULARS OF VEHICLE

VEHICLE REGN NO : SKG 6198 G
 OUR REFERENCE : PAS/HSHW/190402/TP
 INSPECTION REPORT DATE : 15-Apr-19

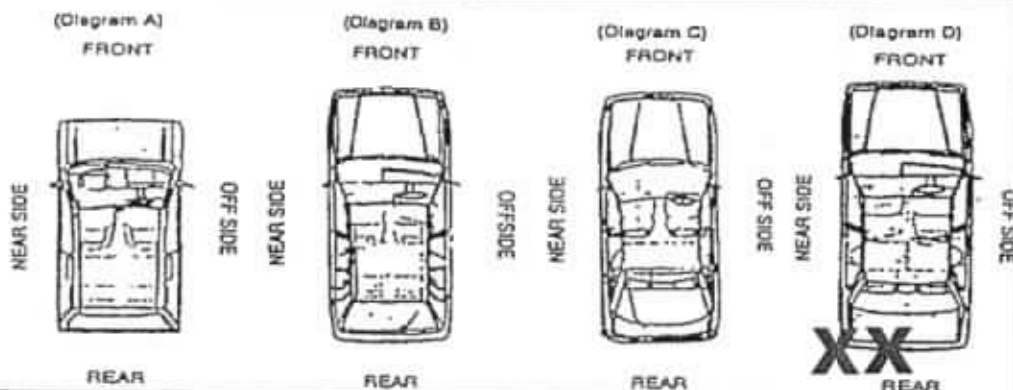
POINT OF IMPACT

Direction of impact/damage marked (→) (X)

The vehicle sustained impact on its Rear N/s Portion. (see Diagram D)

The rear bumper and lower spoiler were dented.

A static inspection was carried out on 26/03/2019 & our report is here with enclosed for your perusal. The Repairs Estimate submitted by M/s Hong San Hong Wei Pte Ltd as per attached Appraisal Schedule have been revised and scrutinised thoroughly by us & in our opinion, we consider it to be fair and reasonable. The repairer has agreed to effect repairs to the owners satisfaction & to roadworthy condition on an agreed Lump Sum Repair Basis of \$ 2,300.00 after deducting the Policy Excess Clause of \$ NA. As instructed, we have not authorised any of the repairs on your behalf.

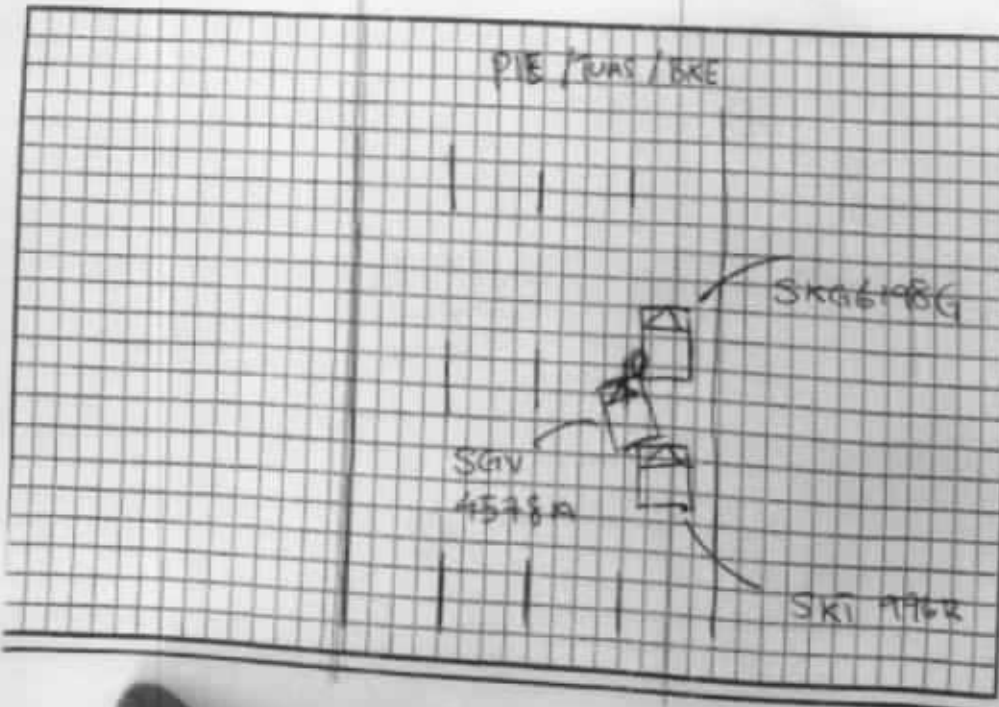
Sketch Plan

I SKG6198G was driving along PIE TOWARD TUAS 2KM BEFORE PIE/BKE on the 1st lane with a normal speed. As I was following the traffic ahead suddenly the vehicle in front make a jam brake. So I apply my brake to avoid the contact with the vehicle in front. Suddenly I felt an impact coming from my rear vehicle. I immediately stop my vehicle and get down from my vehicle and discover that the 3rd party SGV4578A had collided onto my rear vehicle. It involved 3 vehicles and the last vehicle registration number SKT996R. I manage to take some photos at the scene and exchange particular with the other party's. There was a traffic police that came to the scene to assist us, no injuries was involved.
