To Inspect Vehicle No: GW7868W

Make: Nissan Cabstar

ESTIMATE OF REPAIR

VEHICLE DAMAGE INSPECTION REPORT

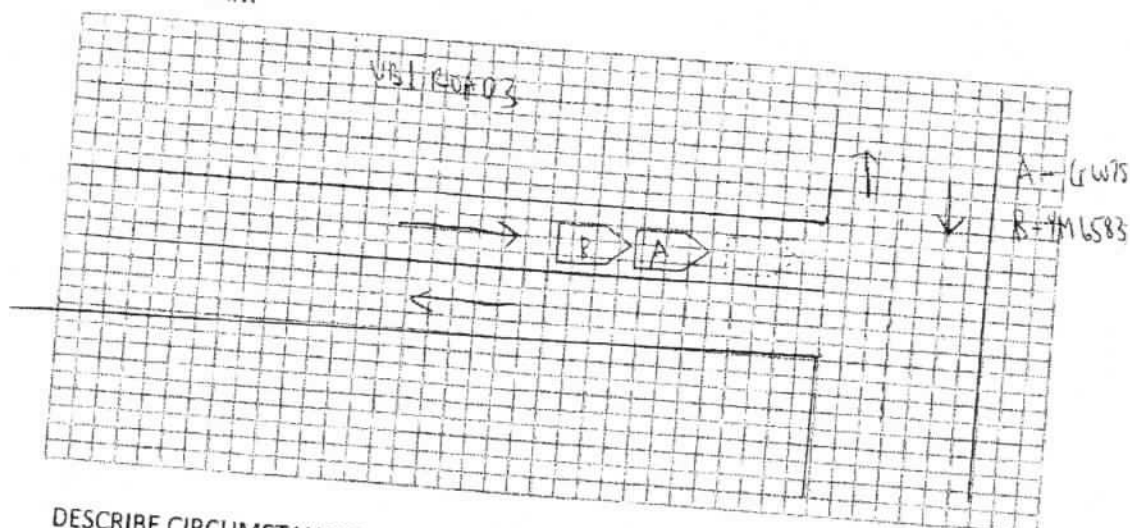
SKETCH PLAN:

I WAS TRAVELLING ALONG UBI ROAD 3. VEHICLE AHEAD SLOWED DOWN AND STOPPED AT THE T-JUNCTION WAITING TO TURN. I FOLLOWED SUIT. MOMENT LATER WHILE MY VEHICLE WAS STILL STATIONARY, VEH-B REAR-ENDED MY VEHICLE.
