**MC SUIT NO. 19245 OF 2018 – CLAIMANT: YUM FONG TRADING COMPANY PTE LTD  
ACCIDENT INVOLVING SKJ 4500P & SJM 561K ON 17.07.18 ALONG PIE**

Inspection of 2013 Mercedes Benz S300L (A)  
Registration No.: SKJ 4500 P  
Odometer Reading: 126449 km  
Chassis No.: WDD2211542A516631

### ADJUSTMENT ON REPAIR COST FOR VEHICLE NO. SKJ 4500P

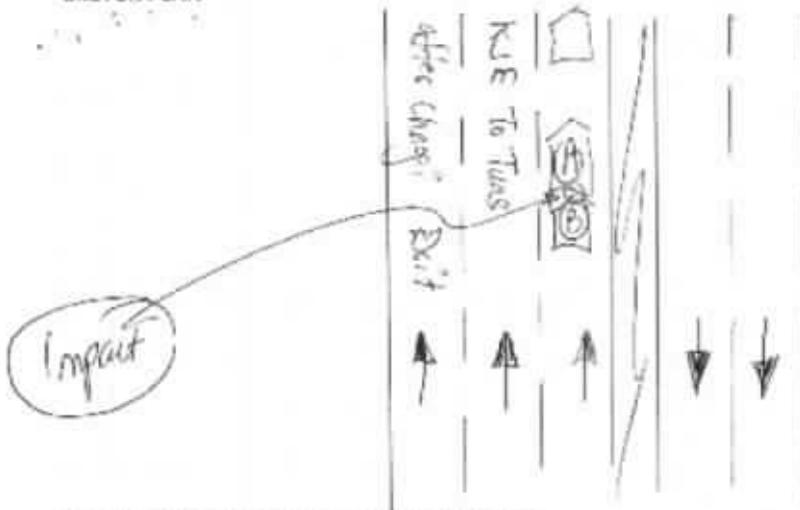
SKETCH PLAN

- (A) My vehicle = SKJ4500P
- (B) TP vehicle = SM561K.

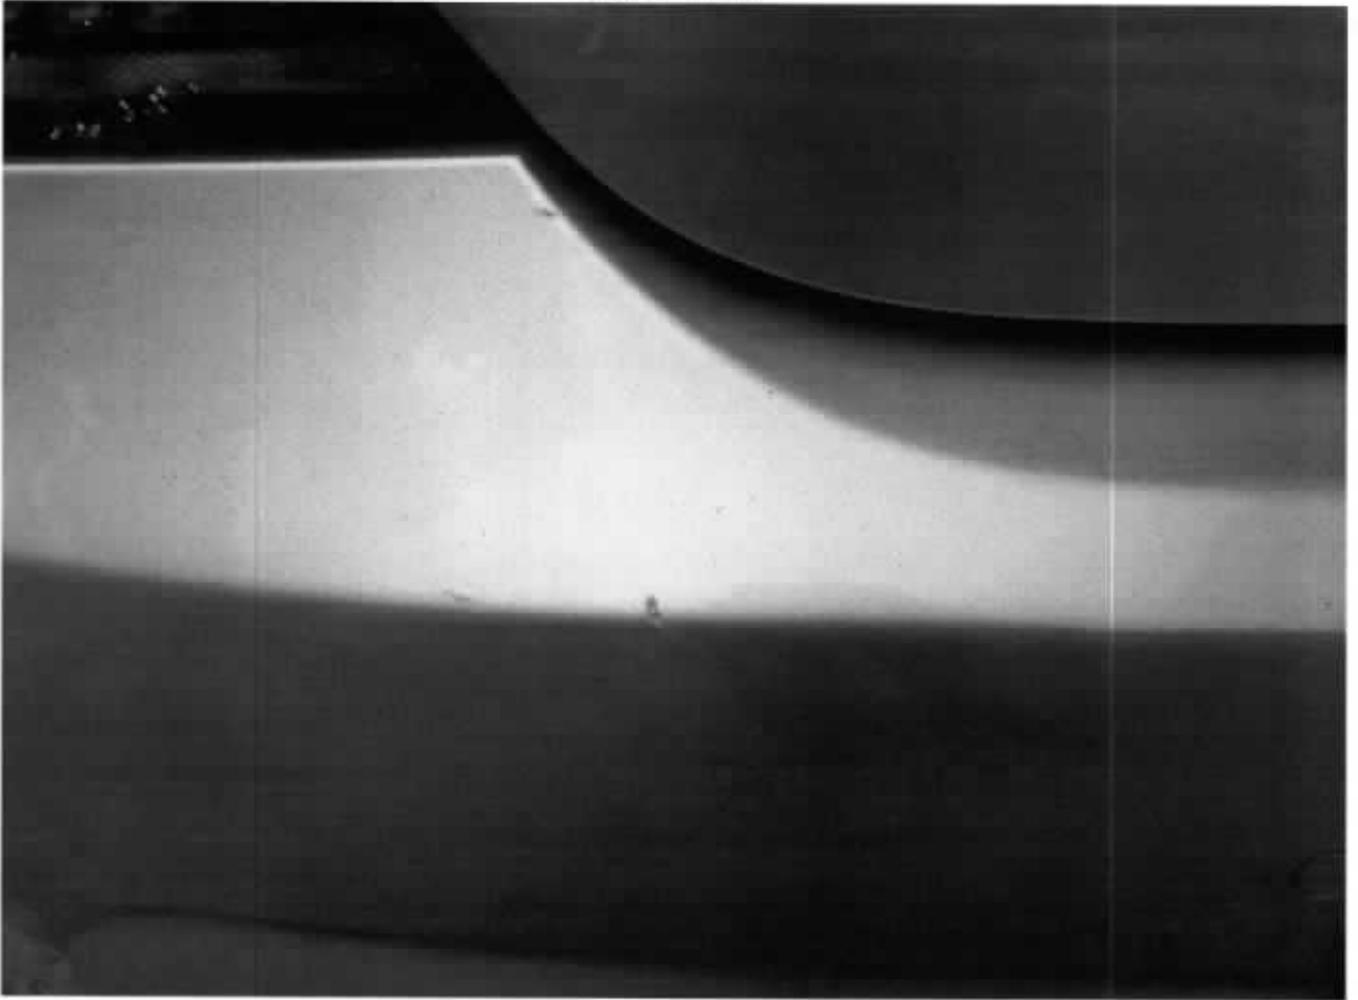
At the time of inspection, we noted that the vehicle has sustained an impact damages on the rear portion(s). For more detail of the damages, please see photograph attached.

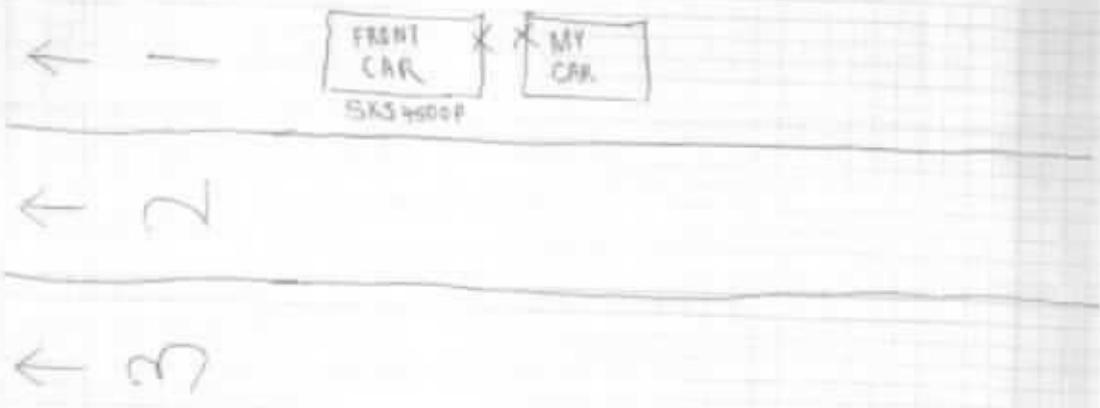
SKETCH PLAN

ON 17/07/2018 AT 7:30AM, I WAS TRAVELLING FROM CHIA CHU KANG TOWARDS PIONEER ALONG PIE (THRS). I WAS TRYING TO SWITCH FROM LANE 1 TO LANE 2 WITH SK34500P IN FRONT OF ME ~~BUT I WAS~~ <sup>AS I WAS TRYING TO PASS</sup> FOCUSING ON LANE 2 VEHICLES TO SWITCH LANE FOR SLIGHTLY LONGER TIME.

AS I AM TRYING TO EXIT AT THE SECOND EXIT AT PIONEER <sup>ROAD</sup> NORTH, I WAS FOCUSING ON LANE 2 VEHICLES TO SWITCH LANE <sup>AT</sup> BUT SPENT A ~~++~~ SLIGHTLY LONGER TIME TO CHECK AND WHEN I CHECK MY FRONT I SAW THAT MY CAR WAS ABOUT A METRE FROM SK34500P AND I JAMMED MY BRAKE BUT STILL KNOCK ON THE BACK OF SK34500P. DAMAGES ARE SHOWN ON THE IMAGES ATTACHED
